The Project for the Seawall Construction in Male' Island (Phase II)

1. Background of Project

2. Project Overview

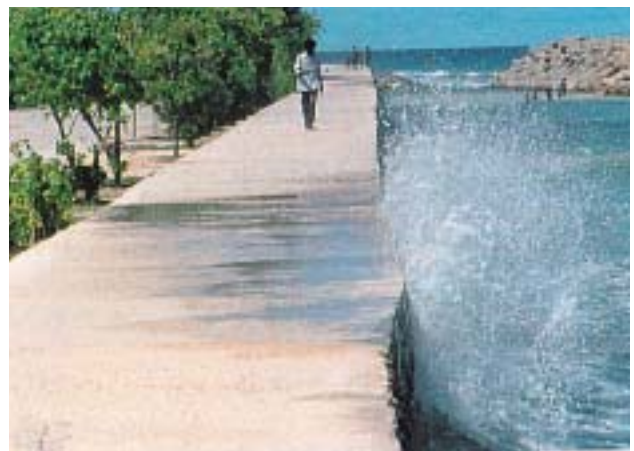
Seawall

At the time of this evaluation study, problems such as distortion, damage, sinking, erosion, and breakdown, which would affect the seawall's function, were not realized. Cracks were found at the part of the augmented concrete wall that is hit continually by waves, but certain measures and repair work were already completed.
