DAVAO CITY BYPASS CONSTRUCTION PROJECT (DCBCP)

Package I-1

ENVIRONMENTAL MONITORING REPORT No.2

(01 APRIL 2021 - 30 JUNE 2021)

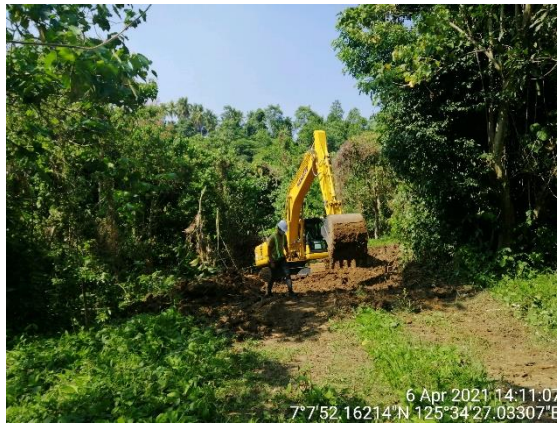
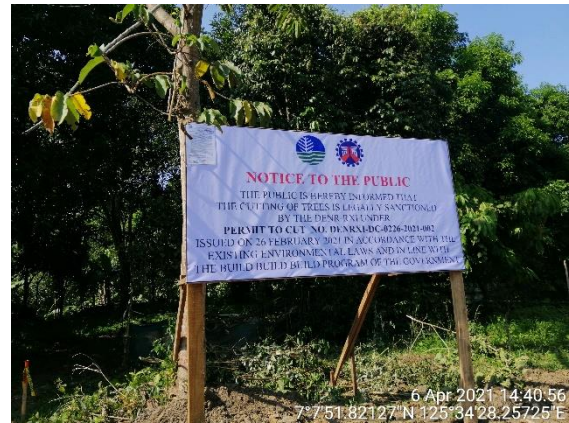
Earthworks, and clearing and grubbing activities at STA. 22+080;
Installation of billboards is used as form of Information, Education and Communication (IEC) activities

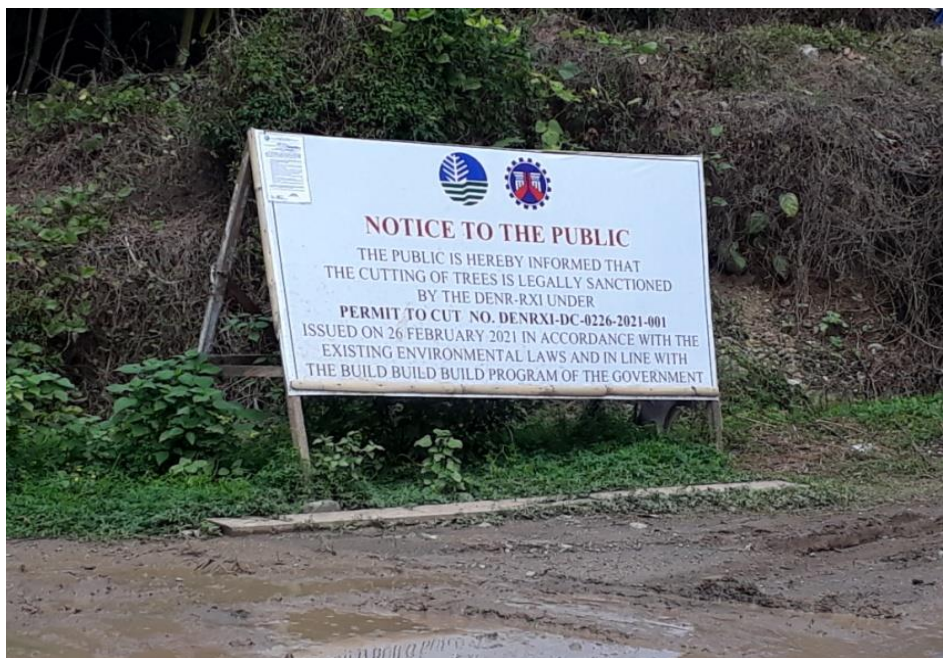
For IEC, billboards are installed in compliance with Permit to Cut Trees requirements (photo taken at Matina Bridge area on 07 June 2021)

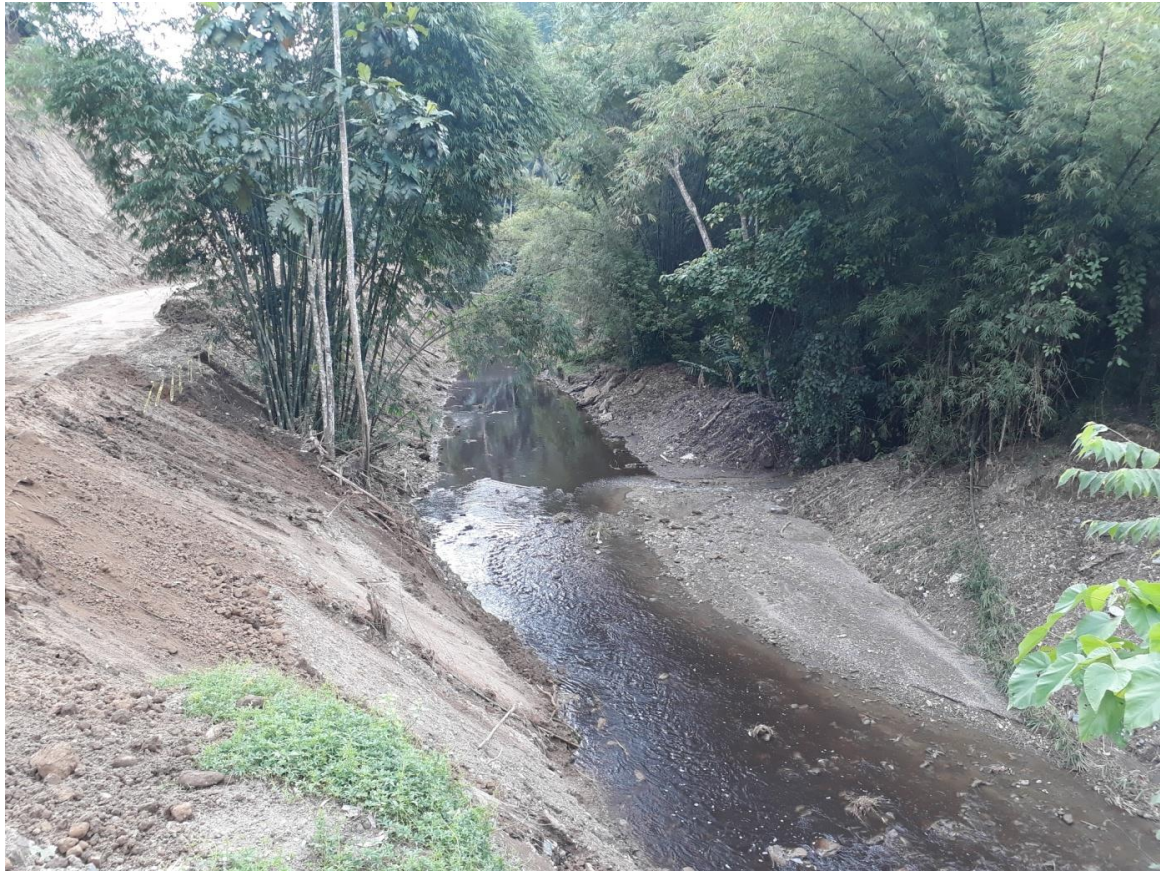
Photo taken on 18 June 2021 - Discoloration of water was observed. Based on the online research made by the contractor, it could be attributed to the leachate from the New Carmen landfill
