THE PROGRAMME FOR URGENT REHABILITATION OF FLOOD- DAMAGED INFRASTRUCTURES

SUBJECT : Submission for Intermediate Environmental Survey at Comoro, Bemos, Buluto and Maliana

**The Programme for urgent Rehabilitation for Flood-Damaged Infrastructures
Summary of Environmental Monitoring Data**

Project : The Rehabilitation of Buluto Irrigation Scheme
Subject : Environmental monitoring (Bemos)

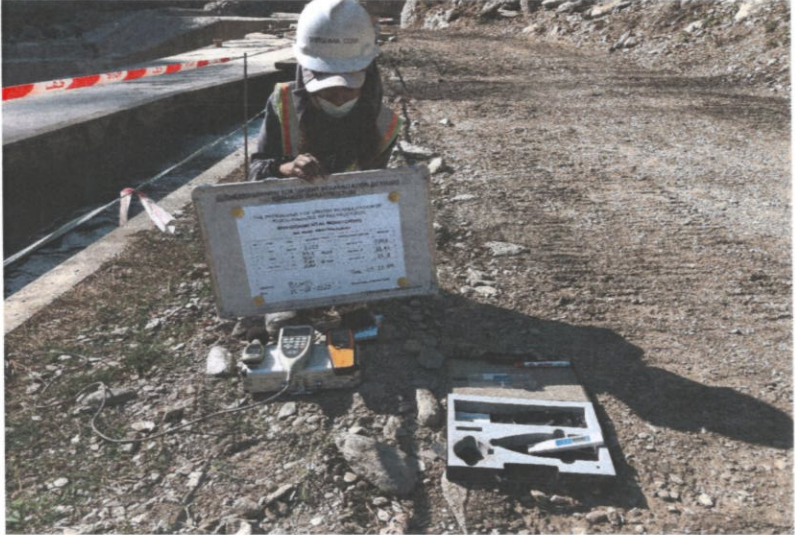
Date: 15 August 2023				Environmental Monitoring Noise, Dust, Vibration Survey

Item:	Results			Unit			
Dust/Air	Intake	0.002		mg/m3			
Noise	Intake	69.47		dB			
Vibration	Intake	25.3		dB

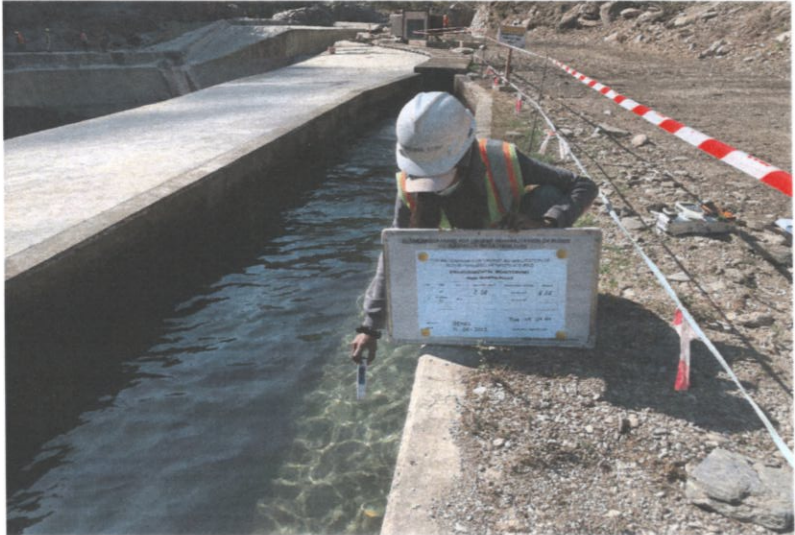
Date: 15 August 2023				Environmental Monitoring Water Sampling Records

Item:	Results						
Ph	Intake	8.28					
SS	Intake	121.4		NTU

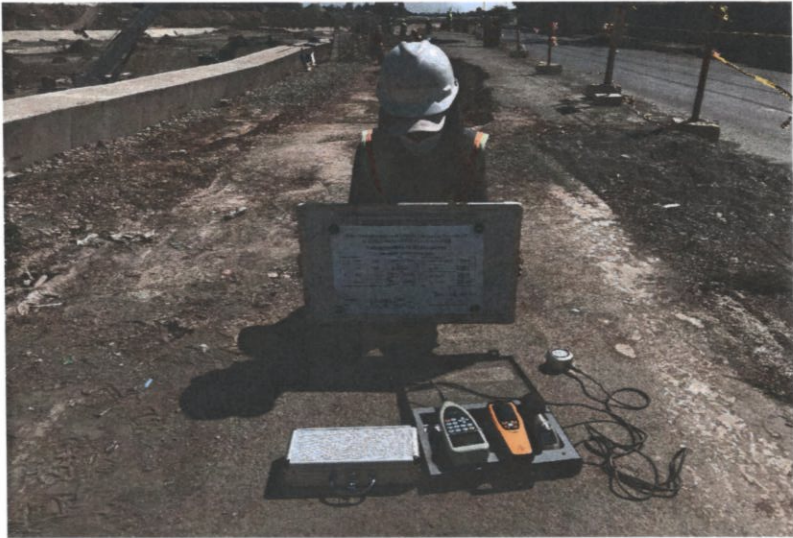
Date: 14 August 2023				Environmental Monitoring Noise, Dust, Vibration Survey

Item:	Results		Unit	
						Dust/Air	River (R6)	0.002	mg/m ³	
									Noise	River (R6)
						dB				
Vibration	River (R6)	28.07	dB							
			dB

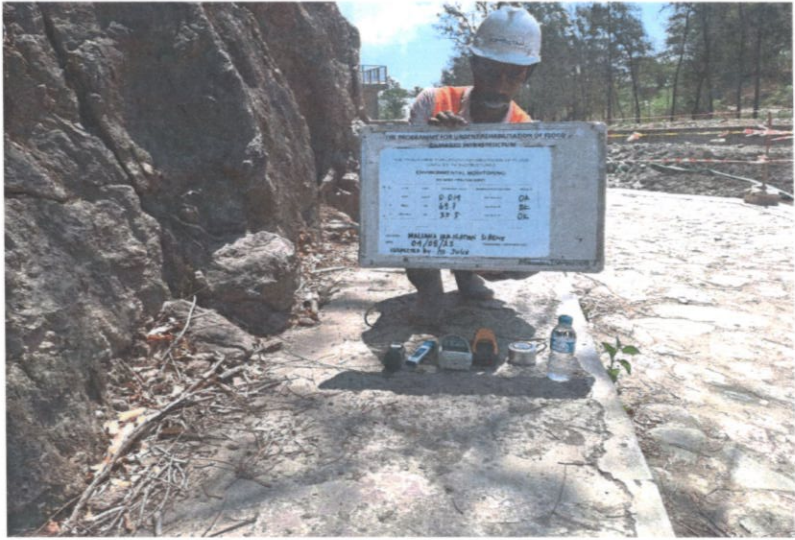
Date: 4 August 2023				Environmental Monitoring Noise, Dust, Vibration Survey

Item:	Results		Unit							
Dust/Air	Intake	0.014	kg/m3							
Noise	Intake	69.7	dB							
			dB							
Vibration	Intake	35.5	dB							
			dB

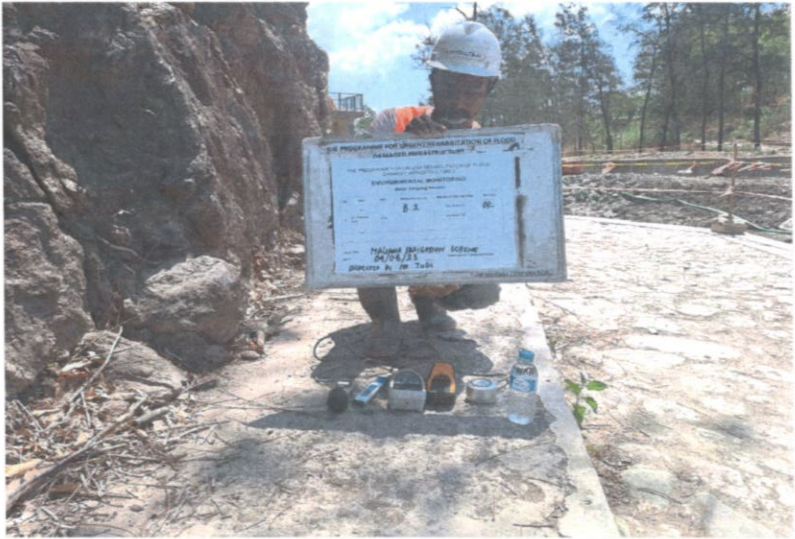
Date: 4 August 2023				Environmental Monitoring Water Sampling Records

Item:	Results									
Ph	intake	8.2								
SS	intake	122.2	NTU

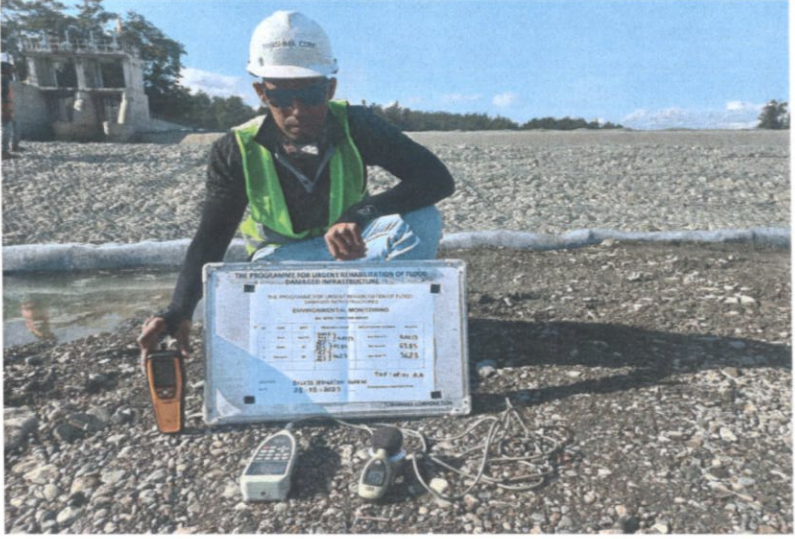
Date: 26 August 2023				Environmental Monitoring Noise, Dust, Vibration Survey

Item:	Results		Unit							
Dust/Air	River	0.003	kg/m ³							
Noise	River	69.83	dB							
Vibration	River	36.23	dB

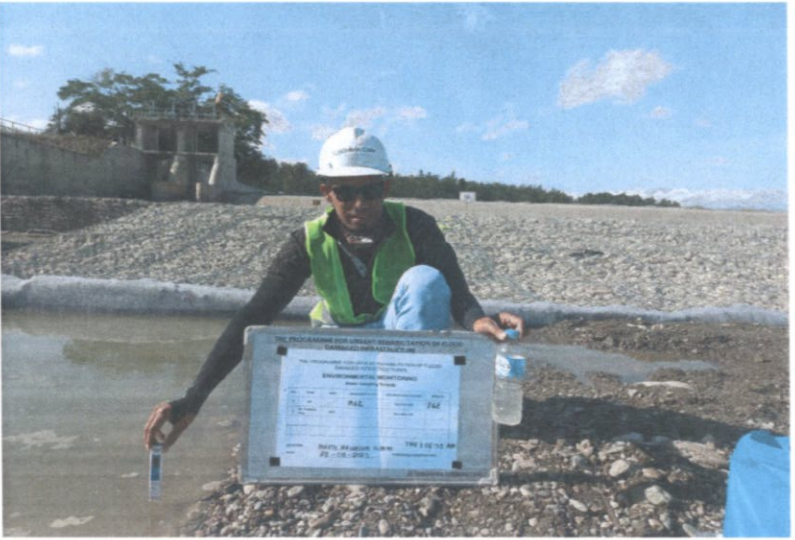
Date: 26 August 2023				Environmental Monitoring Water Sampling Records

Item:	Results									
Ph	River	7.62								
SS	River	125.8	NTU

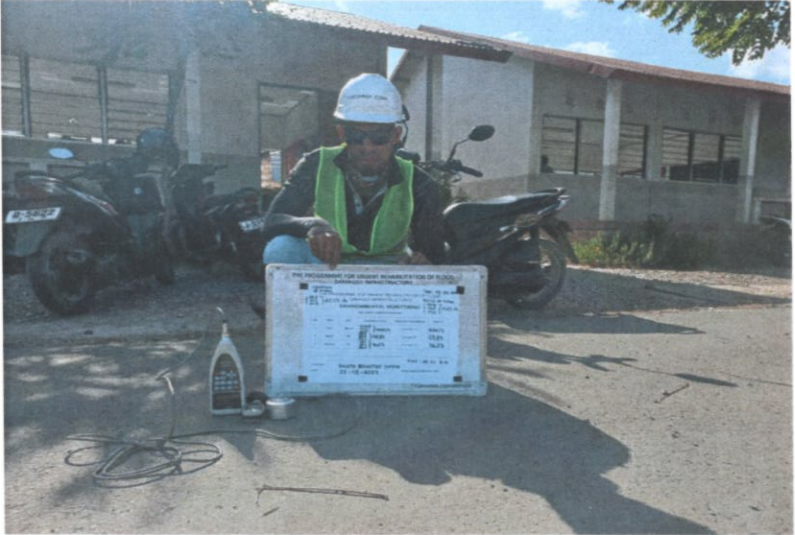
Date: 28 August 2023				Environmental Monitoring Noise, Dust, Vibration Survey

Item:	Results		Unit							
Dust/Air	School	0.003	kg/m ³							
Noise	School	69.83	dB							
Vibration	School	36.23	dB
