## Rehabilitation of Irrigation and Flood Alleviation Works

Report Date : October, 2002

Field Survey : August, 2001

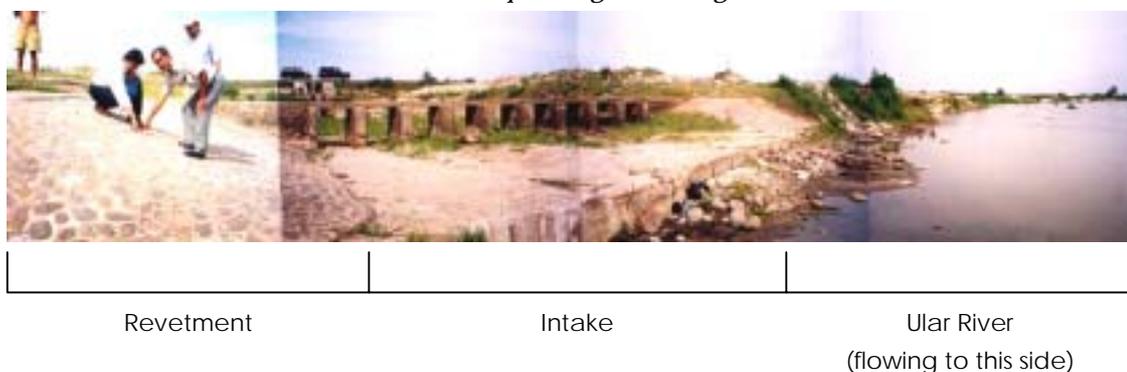
**Figure A-5 : View of Bendang Intake**

Inspection of the irrigation facilities revealed that the river degradation has prevented all of the intakes upgraded under the Sub-project from working as originally planned. The river degradation has been caused by intensive river-sand mining taken place in numerous locations since the late 1990's. In addition, the channels and sand settling basins were filled with deposits. It will be difficult to remove such deposits by means of ordinary O&M with the present staff, equipment, machinery and financial support levels (see Figure A-5).

*Senior technical officer is pointing to the original water level*

Possibly, this situation is the result not only of riverbed degradation, aggravated by sand mining in numerous locations, but also of the original characteristics of the Ular River, i.e., the steep gradient of the riverbed (more than 1/1,000), a rapid flow and a

heavy sedimentation load from upstream. Under such circumstances, providing a solid structure that is not only resistant to riverbed degradation but also well-equipped with effective deposit-arresting devices is of primary importance to ensuring a stable intake of irrigation water.

There is an urgent need to improve/rehabilitate the irrigation water distribution system. The original free intake system is inappropriate, but rehabilitation of the existing intakes is not enough to solve the current situation. Innovative measures are required to address this issue.

The project office of the local government has already prepared a basic plan for facility renovation, which consists of constructing a new weir upstream from the Ular River and installing connecting canals (link canals) on both sides of the river basin. Rehabilitation of Ular Irrigation System is included in Japan's ODA-assisted project, Water Resources Existing Facilities Rehabilitation and Capacity Improvement Project, Exchange of Note of which was signed in March 2002.

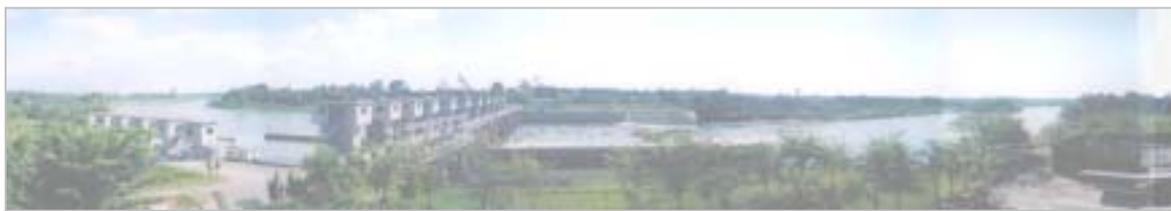
**Figure B-4 : A view of Perjaya Head Works**

- The facility itself is still in good condition, but some of the electronic devices in the

control center malfunction, i.e., the monitoring display (since 2001) and remote sensing gauges (since 1998). This impairs O&M appropriate activities.

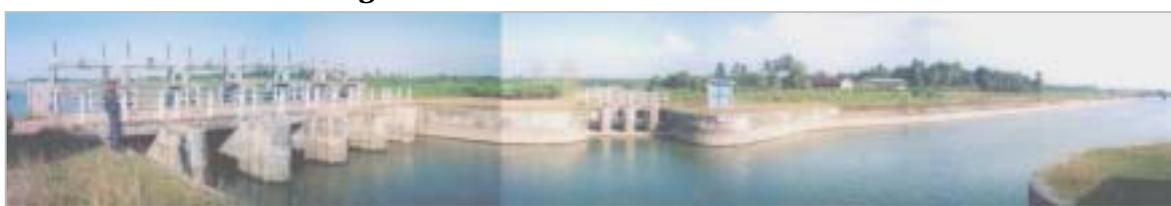
**Figure B-5 : A view of Main Canal**

- Both major canals are well maintained and have no serious sedimentation problems.

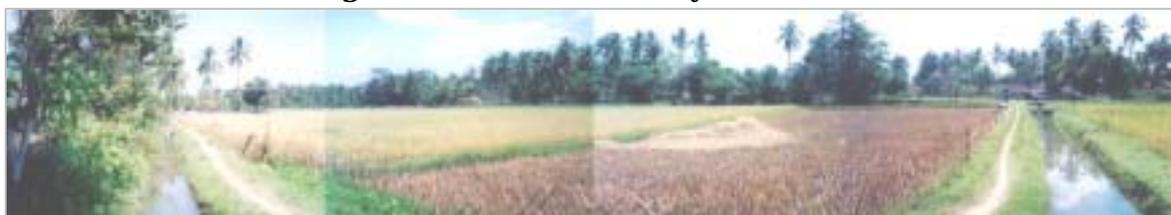
**Figure B-6 : A view of Tertiary Block**

- On-farm irrigation facilities (tertiary canal) are well managed by farmers.

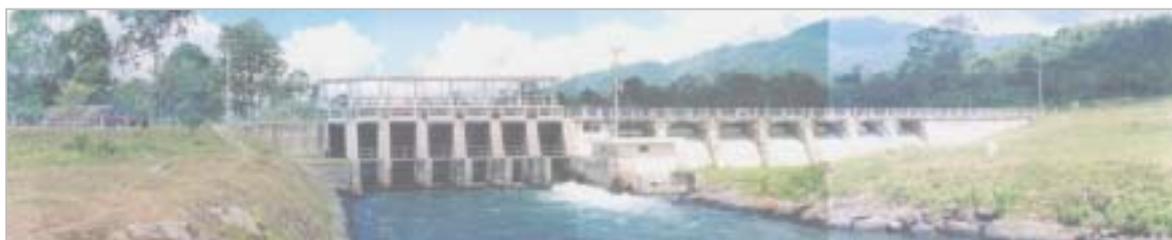
**Figure B-7 : A view of Ranau Regulating Dam**

- No problems could be found in the operating gates.

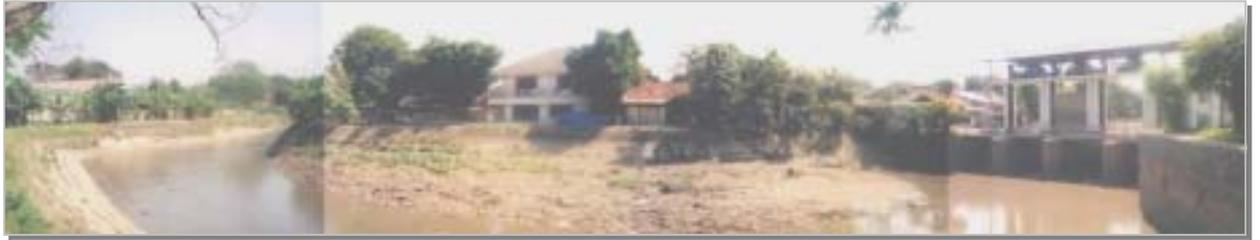
**Figure C-6 : A view of sedimentation in Sunter River  
(at the point of the Pulo Gagung Gate)**

The Mission for this evaluation visited the project site in July 2001 to inspect the current condition of the project facilities. The facilities themselves were still in good condition, but sedimentation (see Figure C-6) and garbage deposits were often observed. These should have been cleaned up properly by the O&M body in order to maintain the designed capacity of flood water discharge.

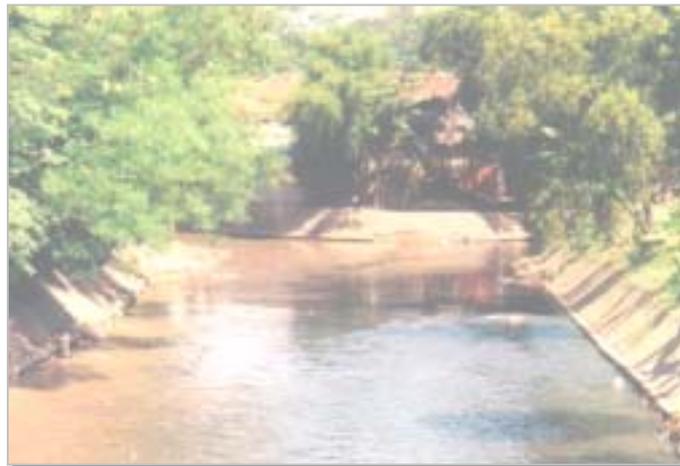
**Figure C-7: A view of the junction of the Cipinang and Sunter rivers**

In addition, water quality in the Cipinang River is getting worse (darker and offensive-looking). This effect, unrelated to the Sub-project, is actually a by-product of the operation of several textile factories upstream. They discharge waste water containing dyes into the river without sufficiently treating the waste with neutralizing agents. The factories are not in compliance with the Local Government's (Jakarta City) guidelines for discharging waste water. Although this situation is not caused by the Sub-project itself, appropriate remedial measures, i.e., the strengthening of Local Government Regulations, must be taken in order to improve the sanitary conditions of

*The Cipinang River flows from the right of the photograph, and the Sunter River from the left. It is easy to distinguish the dirty black water of the Cipinang River (right side).*

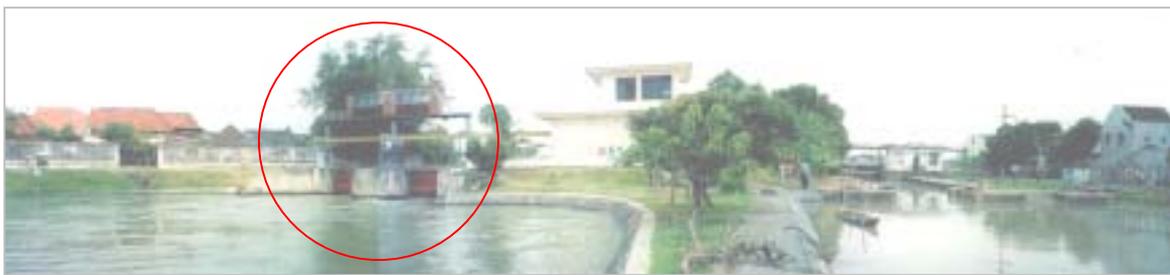
**Figure D-3 : A view of Wonokromo Sluice**

- The sluice gate was rehabilitated to keep the water level at a certain level for the use of PDAM (Regional Water Service Corporation) water intake.
- Five years have passed since the Sub-project completion, but the facility is still in good condition.
- Now the surrounding water space (Mas River) is utilized as a boat recreation area.

*The facility circled is the rehabilitated sluice*

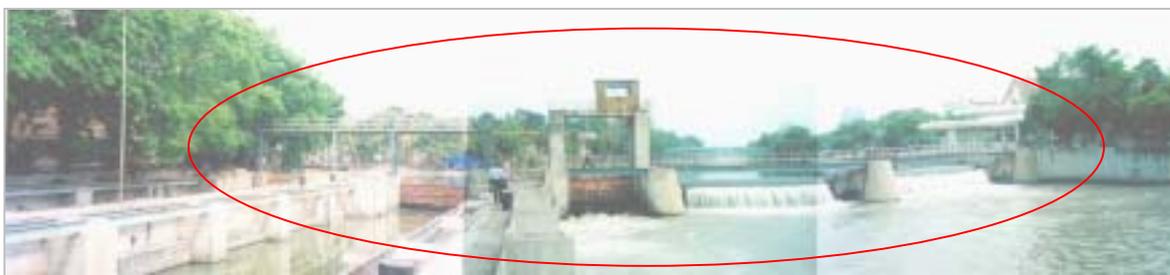
**Figure D-4 : A view of Gubeng Rubber Dam**

- The sluice gates as well as the rubber dams were rehabilitated to keep the water level at a certain level for the use of the PDAM water intake.
- Five years have passed since the Sub-project completion but the facility is still in good condition.

*Circled facilities are the rehabilitated ones (Left side : Sluice Gate, Right side : Rubber Dam)*

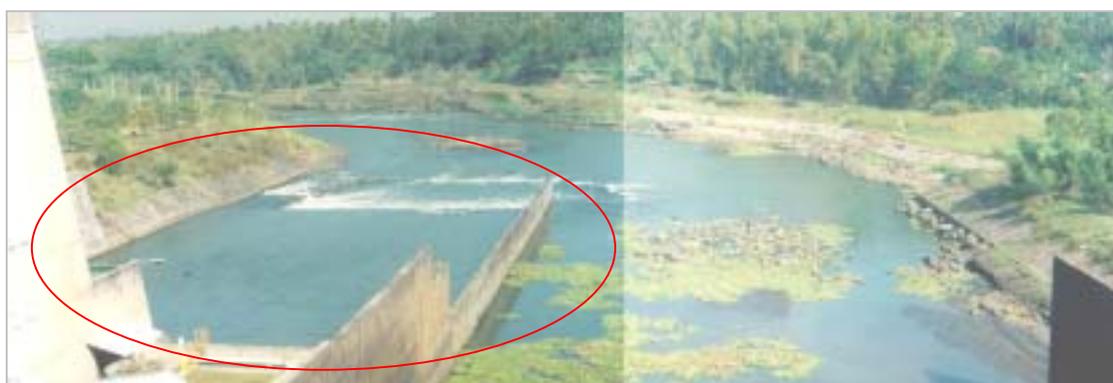
**Figure D-5 : A view of Wlingi Dam (Down Stream)**

- The riverbed protection (Groundsill) and the embankment were rehabilitated, and the guide wall was extended to maintain the original physical condition in front of the hydro power intake. The facilities are still in good condition.

*Red circled facility is rehabilitated. Left side is the Hydro Power Plant.*

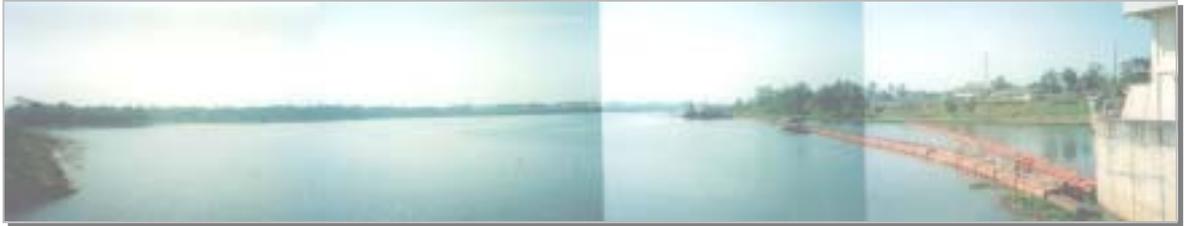
**Figure D-6 : A view of Wlingi Dam (Reservoir)**

- Some 5 million m<sup>3</sup> of sedimentation were dredged up under the project. Since then PJT has conducted periodic dredging of 200,000 m<sup>3</sup>/year until the present, at a cost of Rp. 3 million.

current accumulated amount of sedimentation is estimated at 2.5 million m<sup>3</sup>, against the initial effective storage volume of 5.2 million m<sup>3</sup>. This situation was caused by the inflow of sedimentation from four tributaries of the Brantas River: the Putih River, Ganggaran River, Jari River and Lekso River, all of which originate from Mt. Kelud. This sedimentation flow pace was more rapid than originally estimated (see Figure D-7).

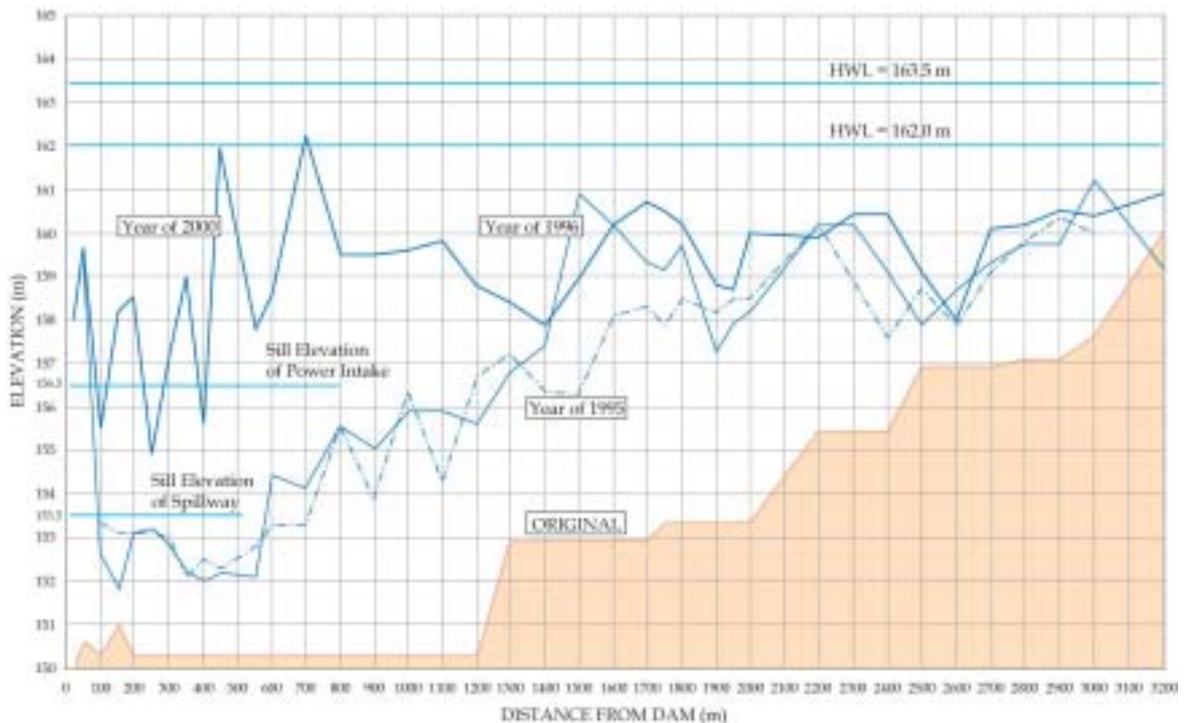
**Figure D-7 : Data on Sedimentation in the Reservoir**

note : Sedimentation volume has accumulated continuously since 1995 and is building up more rapidly in the near area than in the far area, because a large quantity of sedimentation (volcanic debris) flows from Mt. Kelud, through the tributaries of Brantas River which have confluence in the close area.

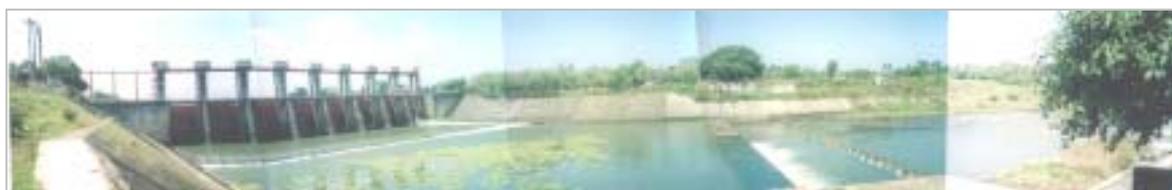
**Figure D-8 : A view of Lodoyo Dam (Downstream)**

- The riverbed protection (Groundsill) and the revetment were rehabilitated, and are still in good condition.

*Riverbed and protection wall were rehabilitated*
