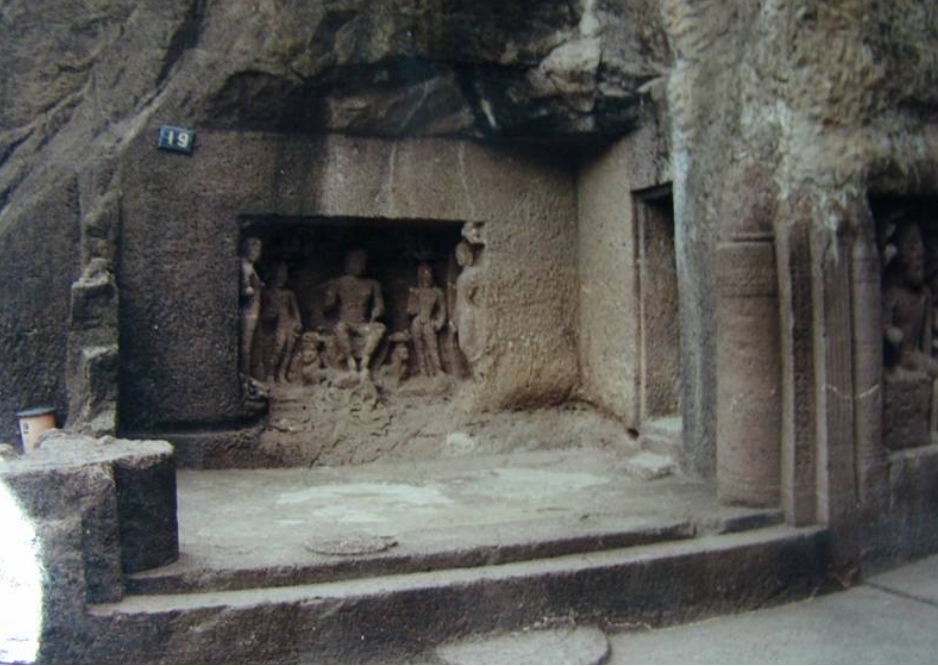
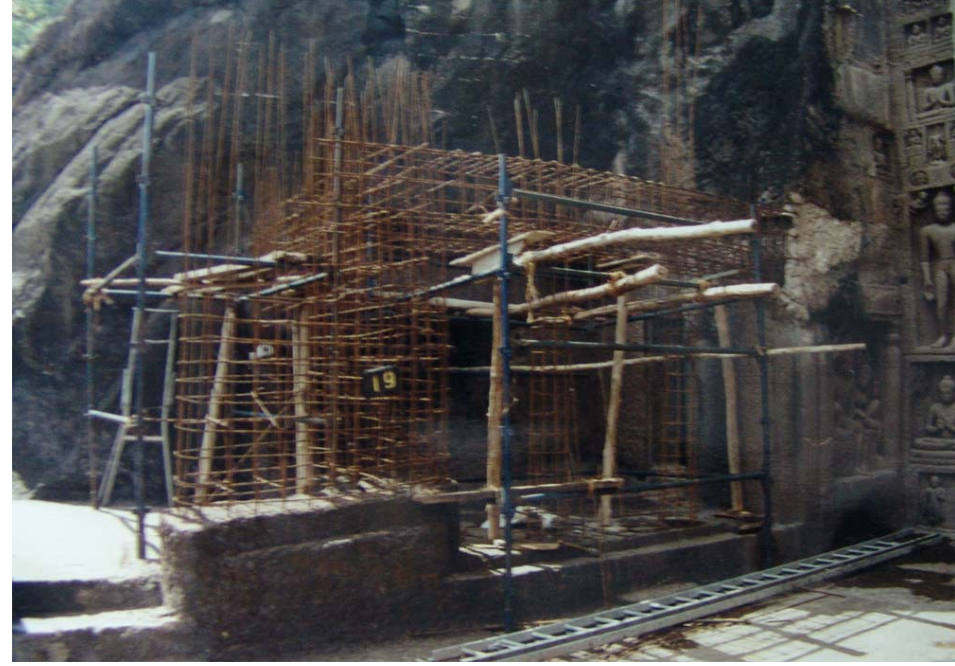
(Figure 26) Right shrine at cave 19 Before reconstruction (left) and during reconstruction (right)

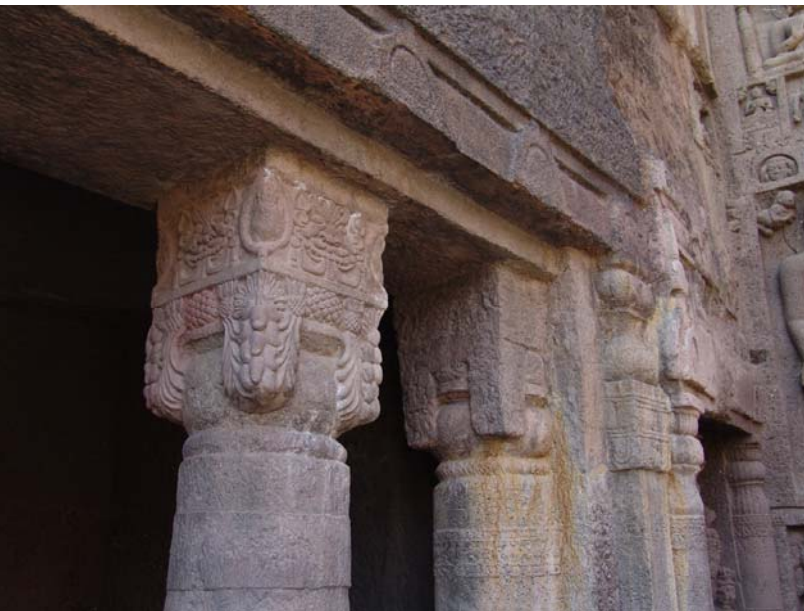
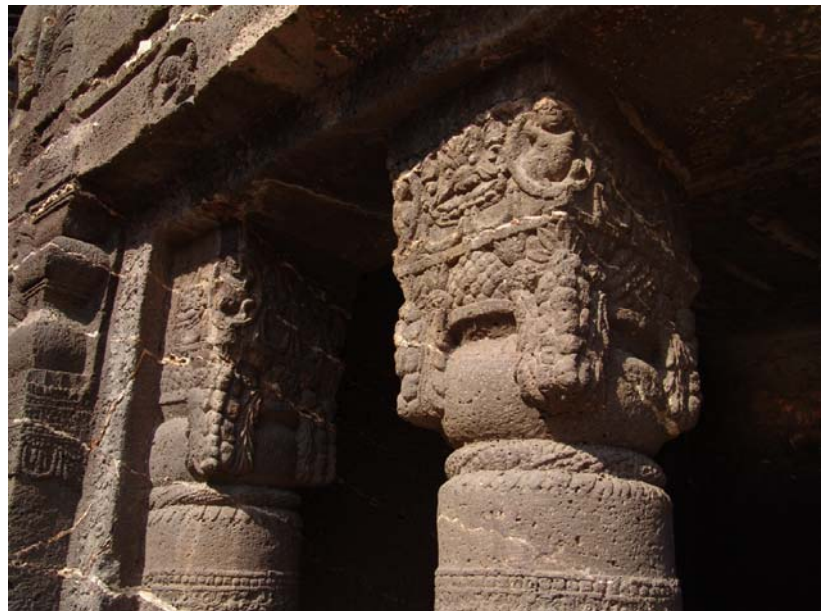
(Figure 27) Reconstructed column capitals (left) and original column capitals (right) in the right shrine at cave 19

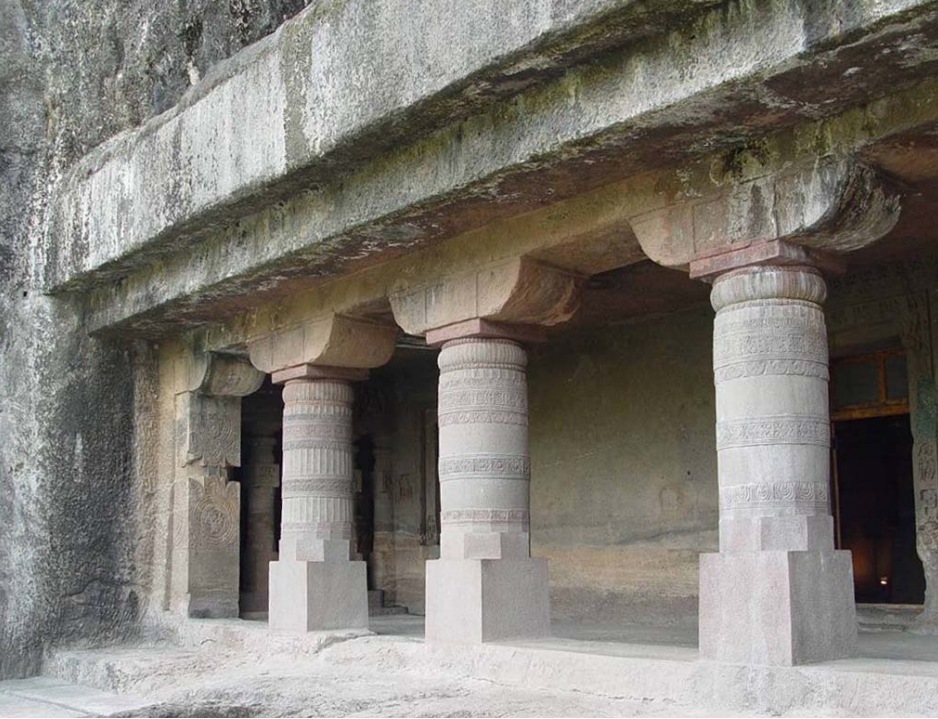
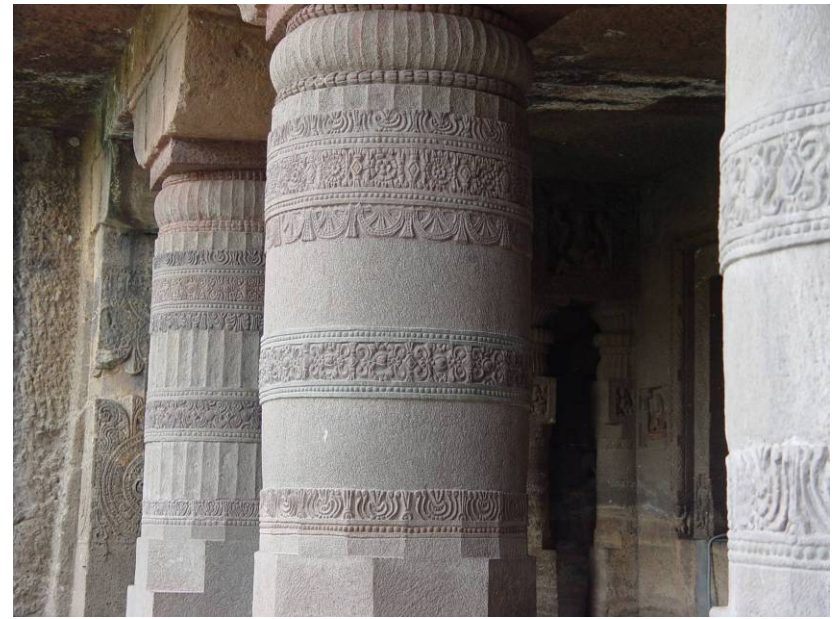
(Figure 28) Reconstructed facade at cave 21 (left) and detail of the colonnade (right)

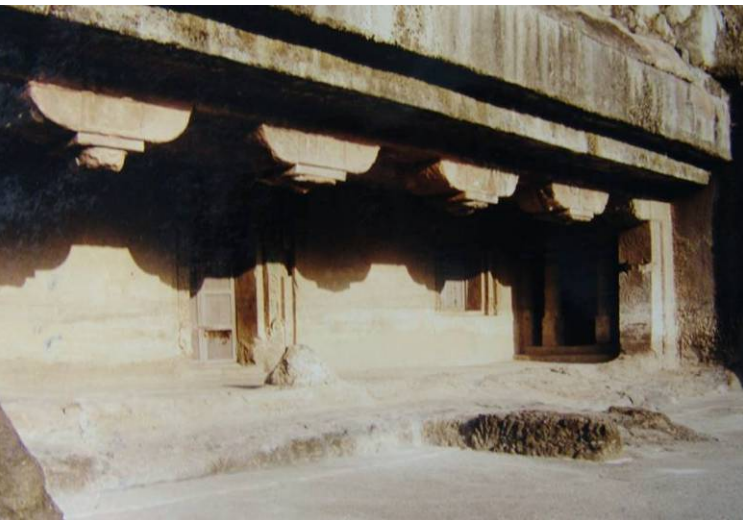
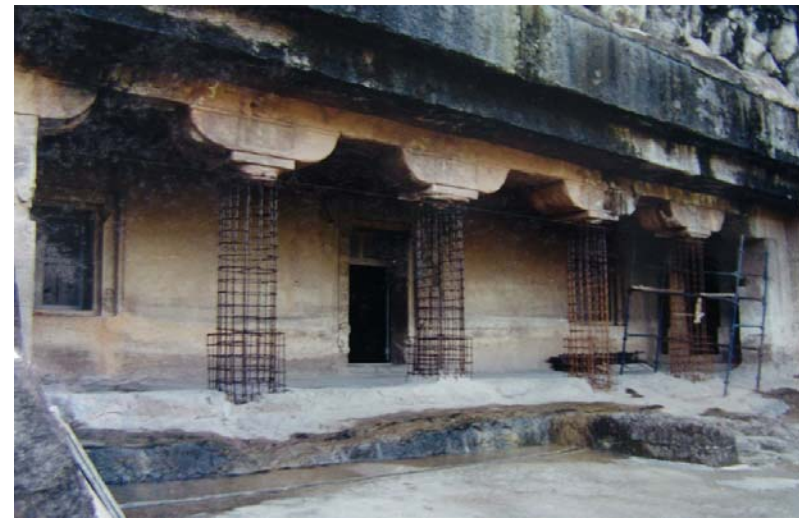
(Figure 29) Before reconstruction (left) and during reconstruction (right) of cave 21

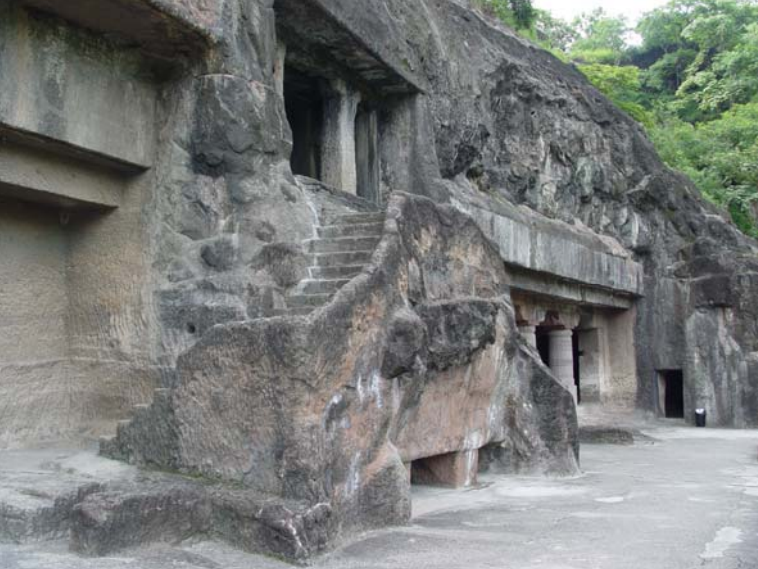
(Figure 30) Reconstructed facade of cave 22

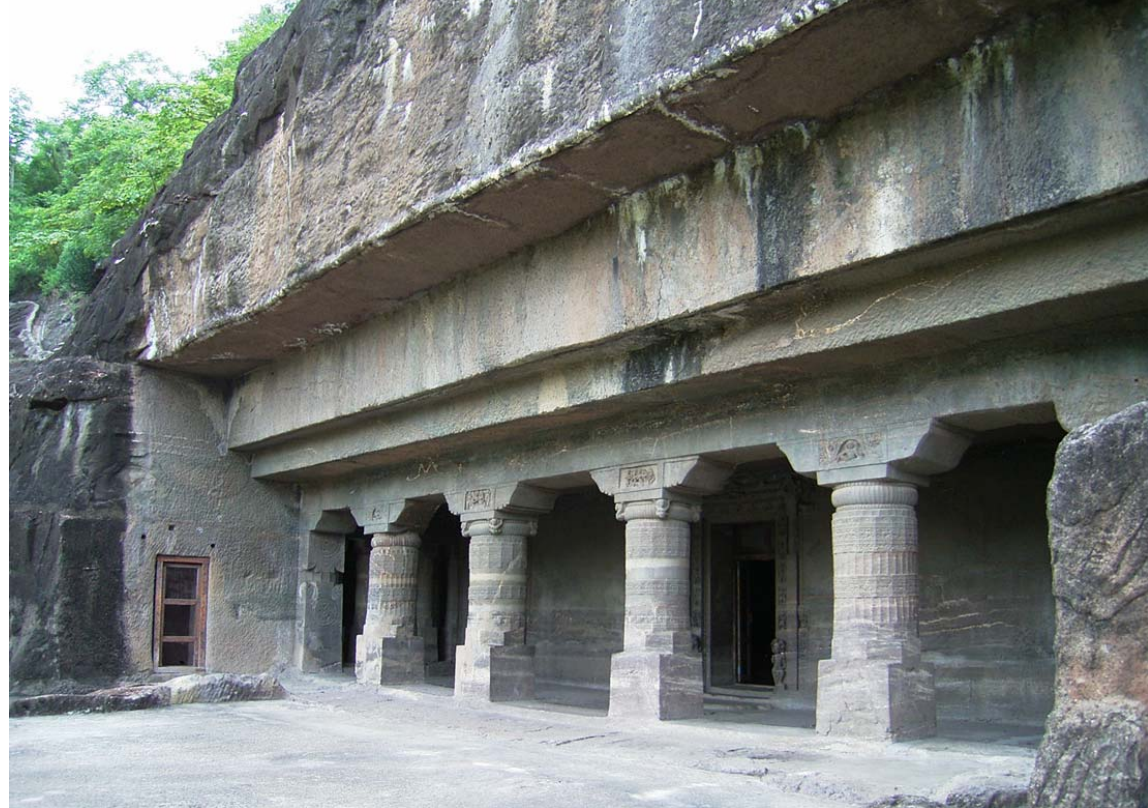
(Figure 31) Reconstructed facade of cave 23

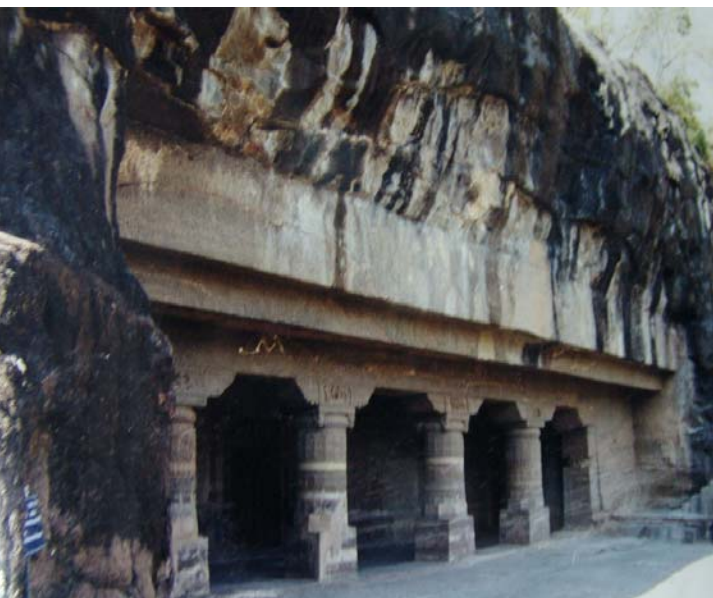
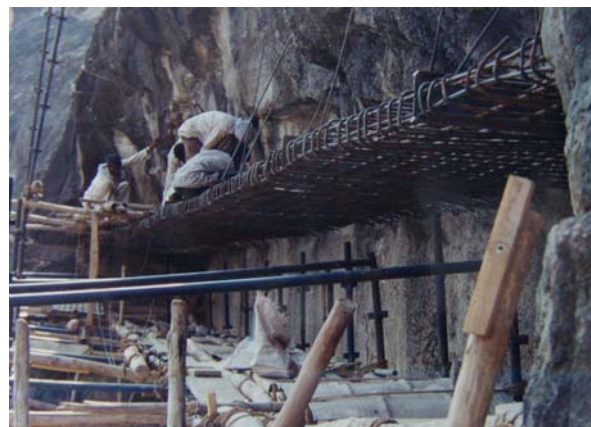
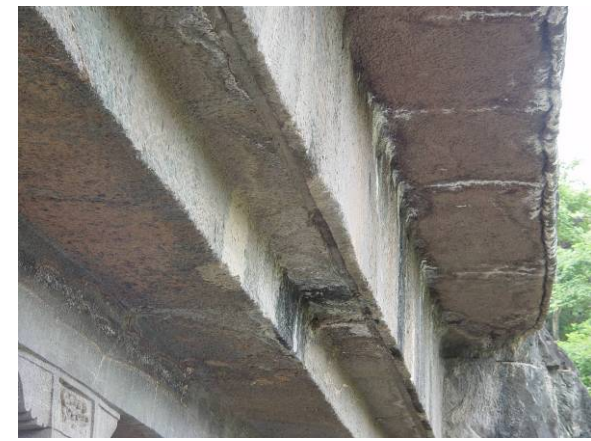
(Figure 32) Before reconstruction (left) and during reconstruction (right) and the reconstructed frieze at cave 23

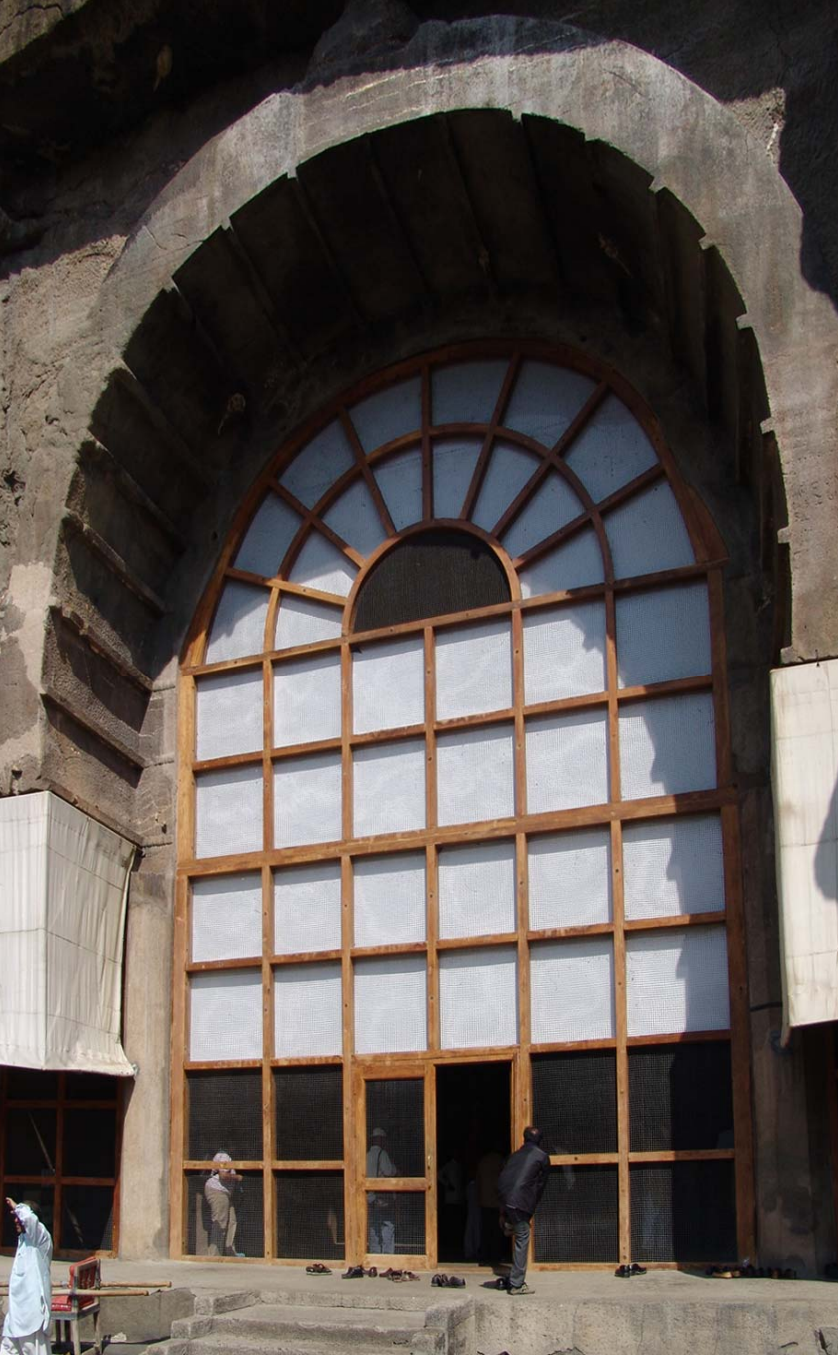
(Figure 33) Bat proof mesh at cave 10

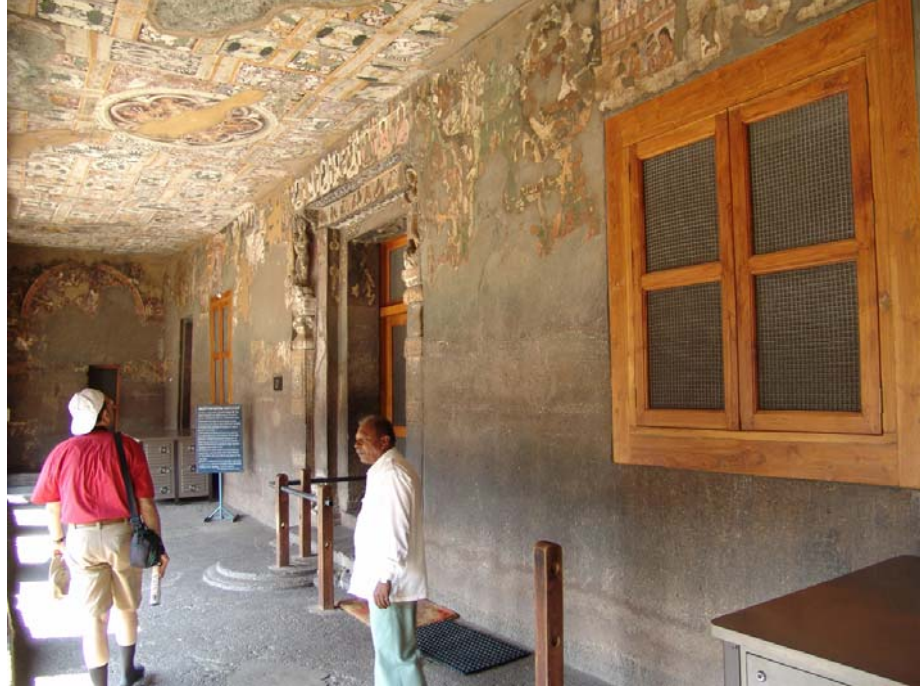
(Figure 34) Bat proof mesh at cave 17

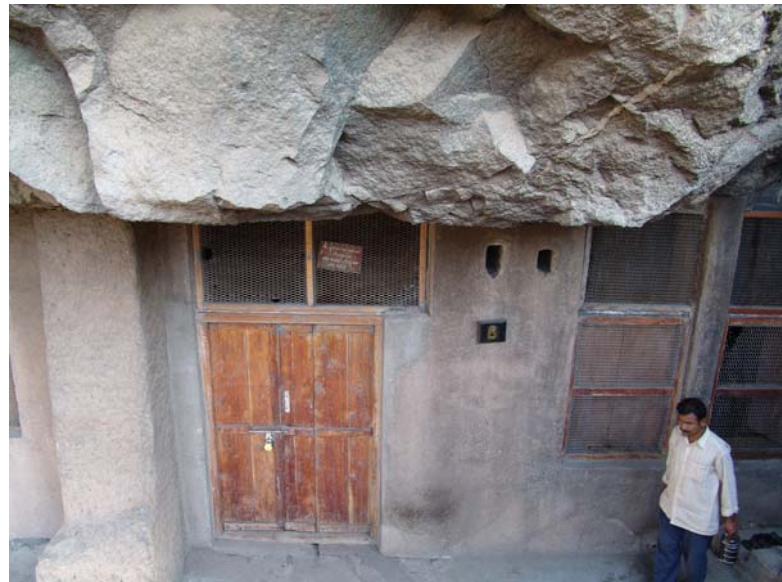
(Figure 35) Old bat proof mesh at cave 8

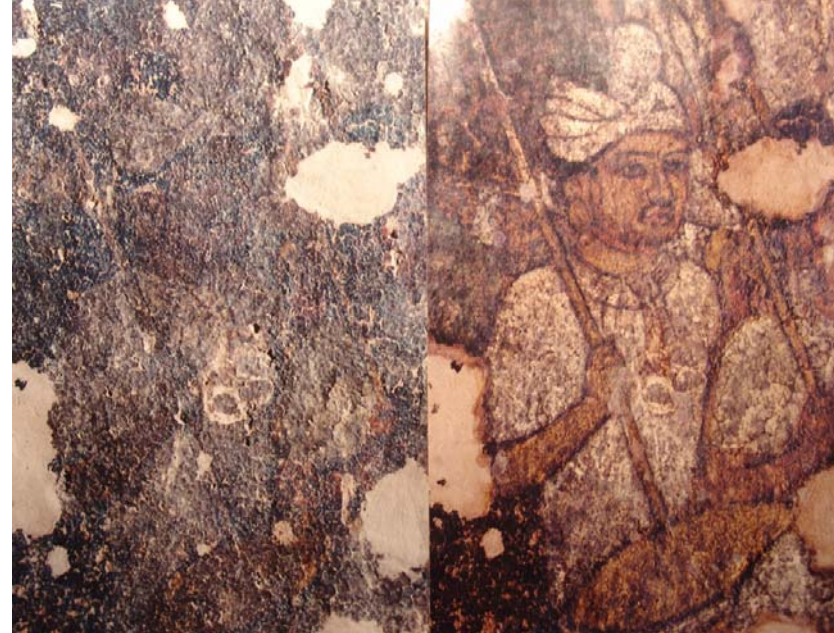
(Figure 37) Mural painting: before restoration (left) and after restoration (right)
