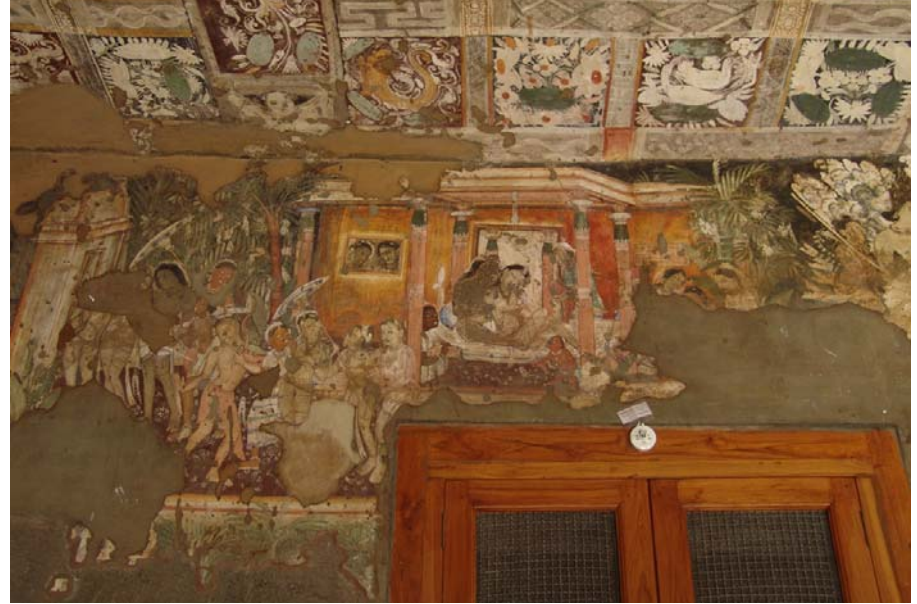
(Figure 38) Before restoration of mural paintings at cave 17 (right), detail of the same portion of the mural painting (left)

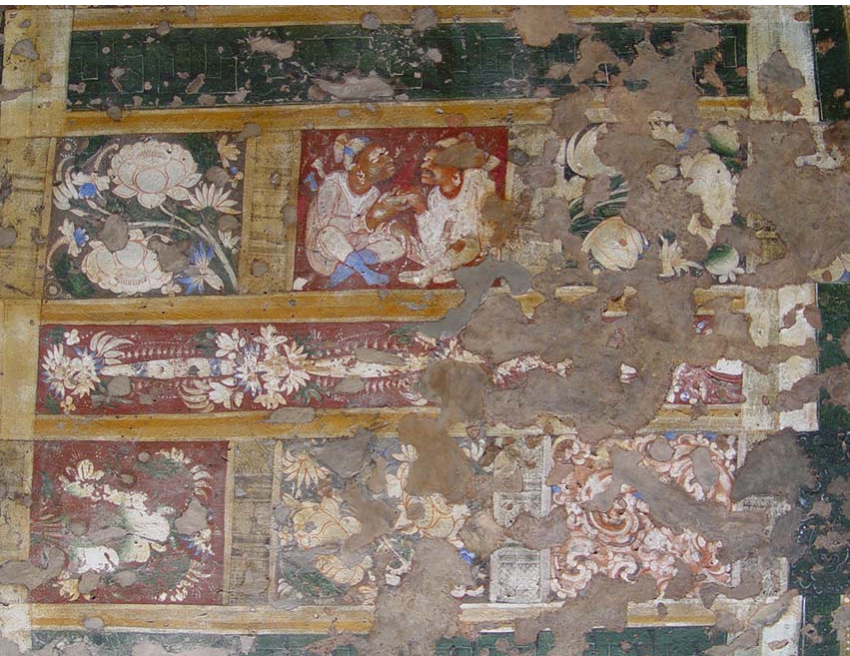
(Figure 39) Mural painting on the ceiling of cave 2 after restoration

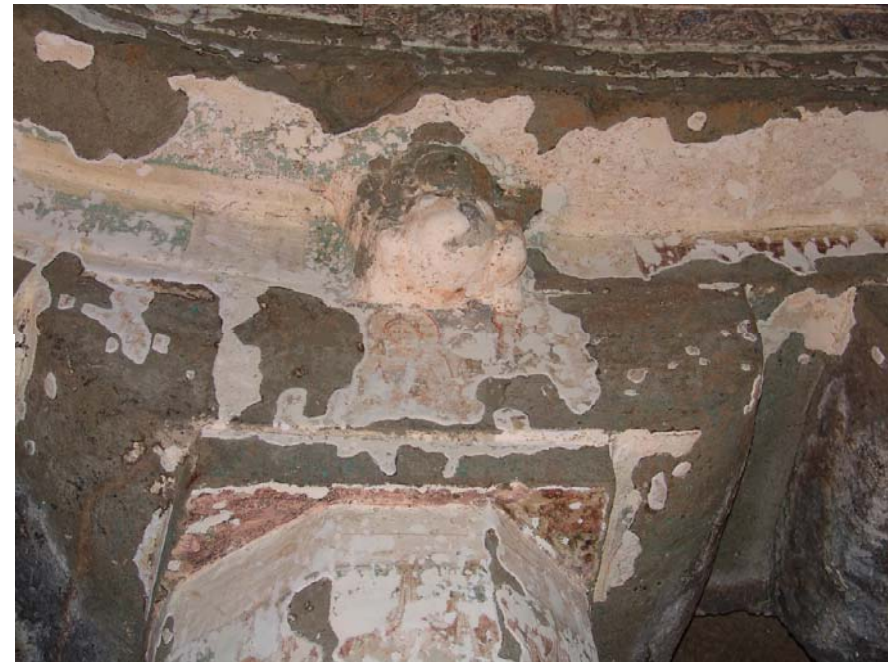
(Figure 40) Mural painting on a column capital in the cave 26 after restoration

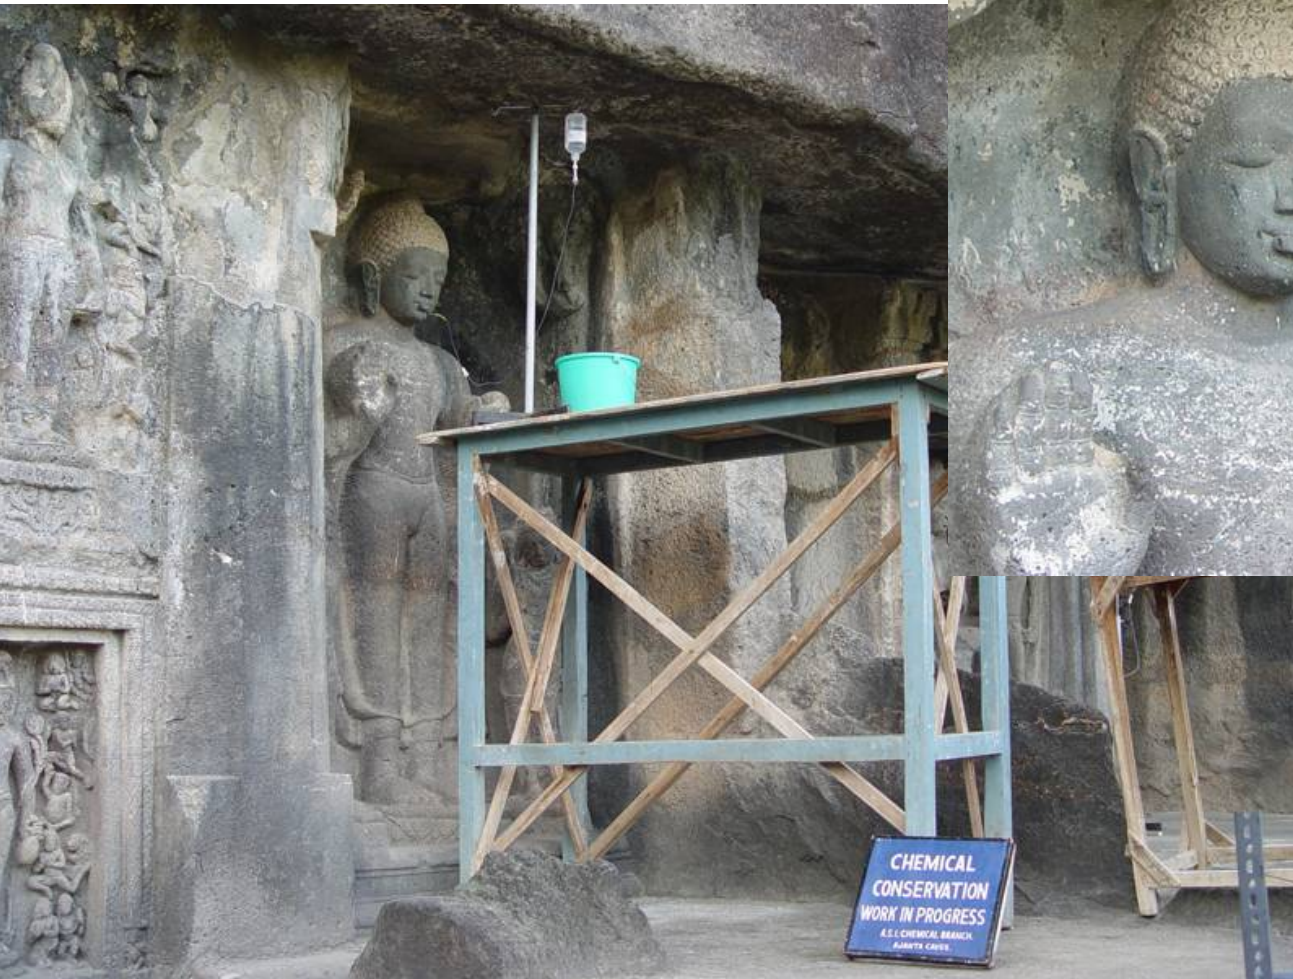
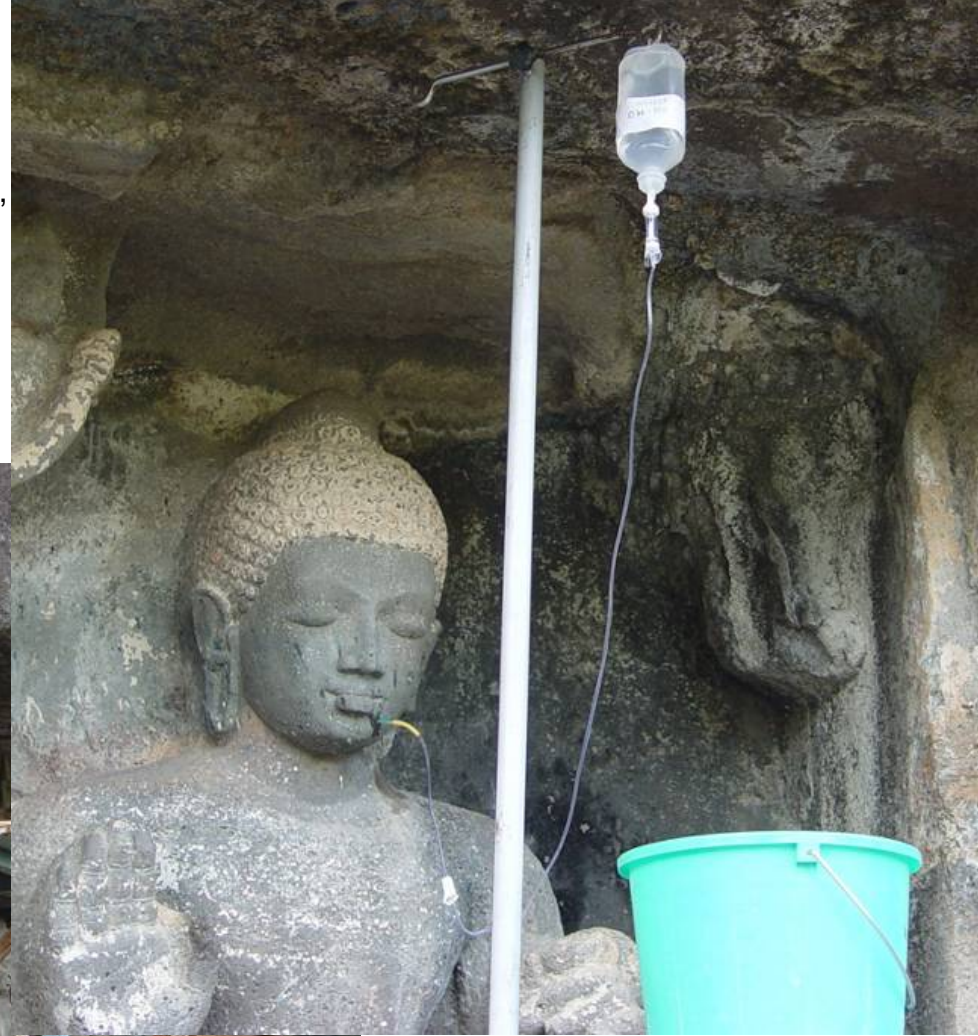
(Figure 41) Restoration work on sculptures at cave 26
Reinforcement treatment on fragile parts of the sculpture,
which is being carried out as part of phase II work.

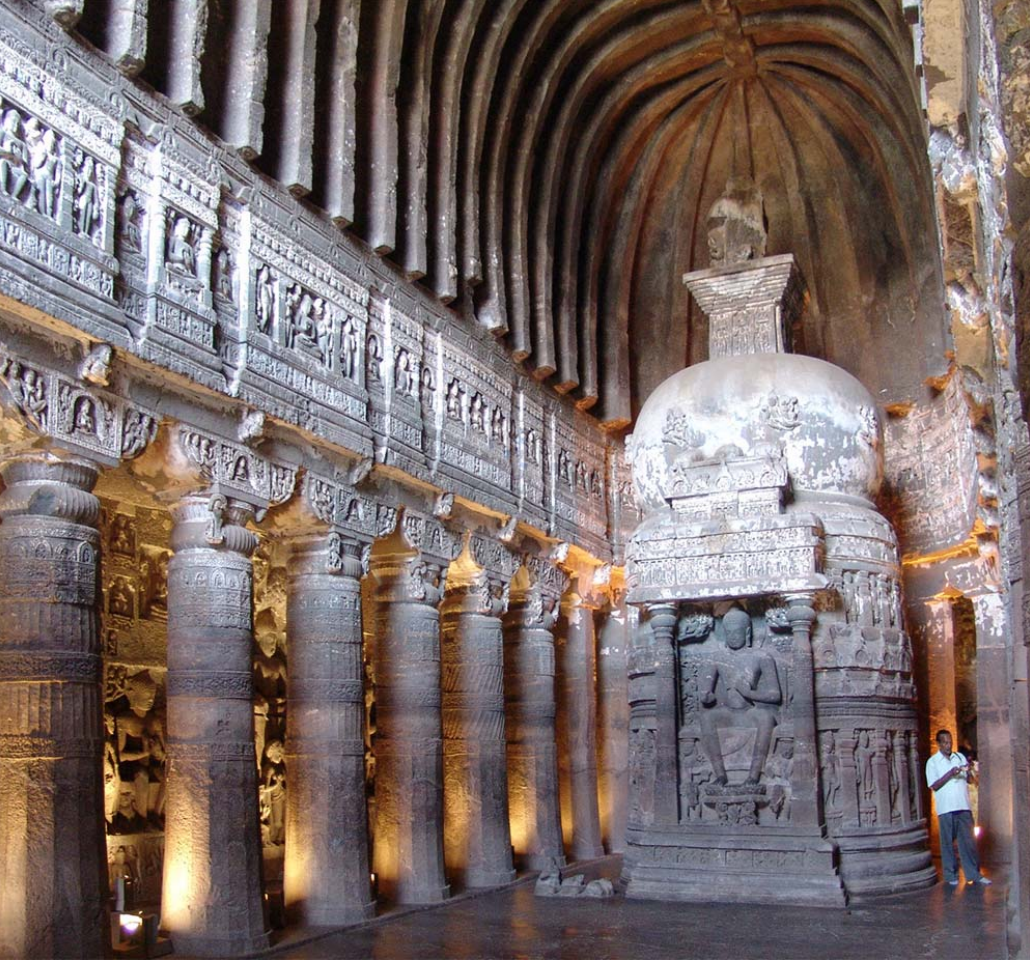
(Figure 42) Conventional lighting system using incandescent lights at cave 26

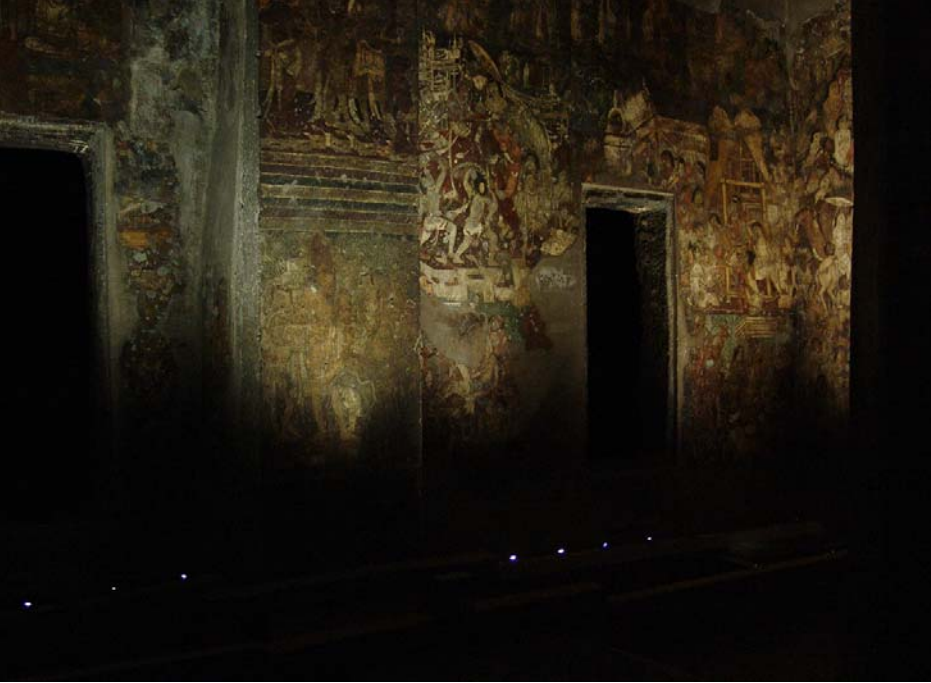
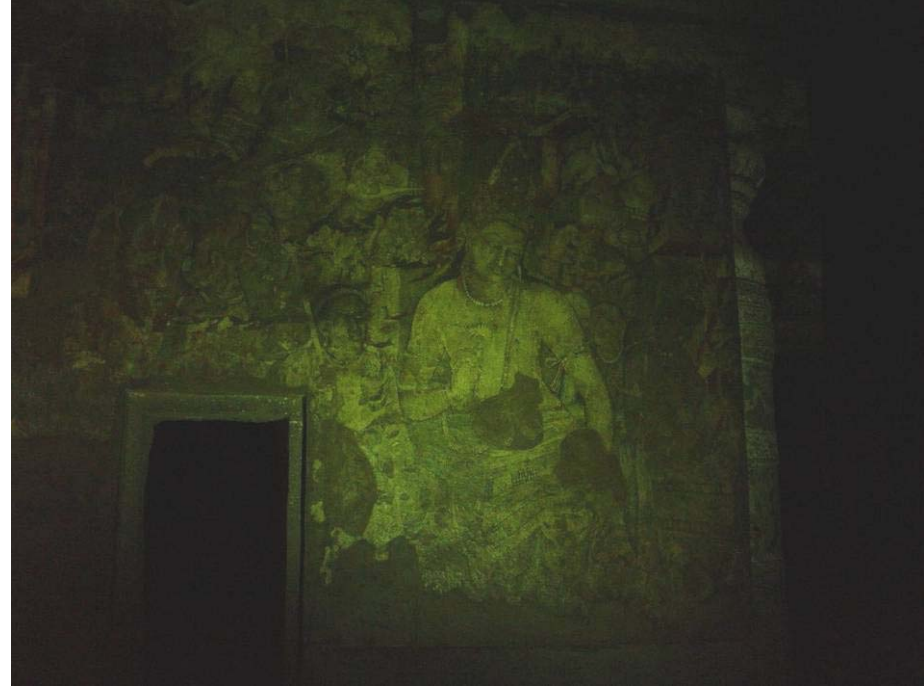
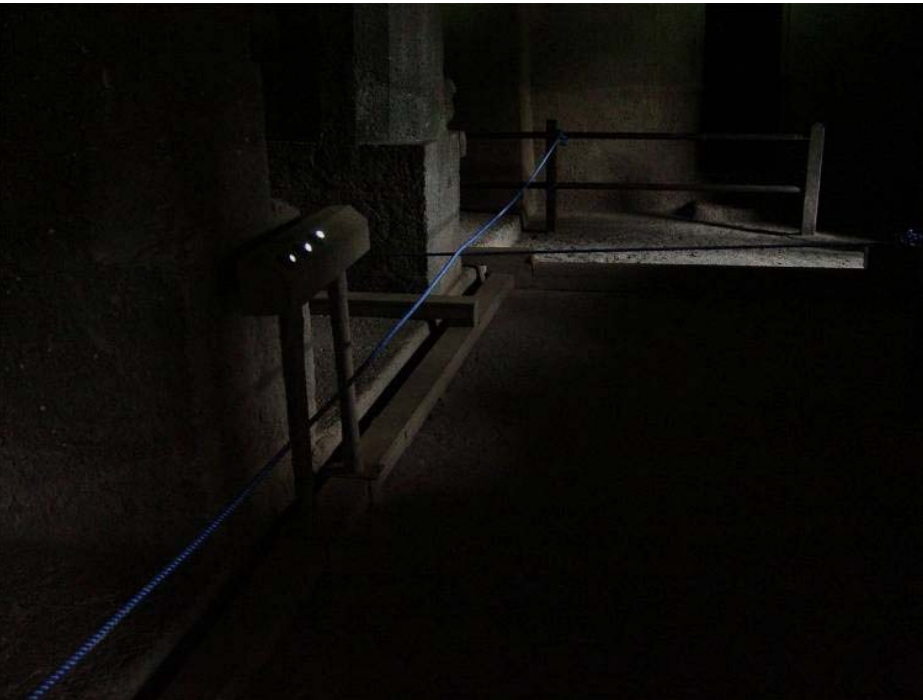
(Figure 43) Display using optical fiber lighting system adopted in order to protect the mural paintings (cave 1)
