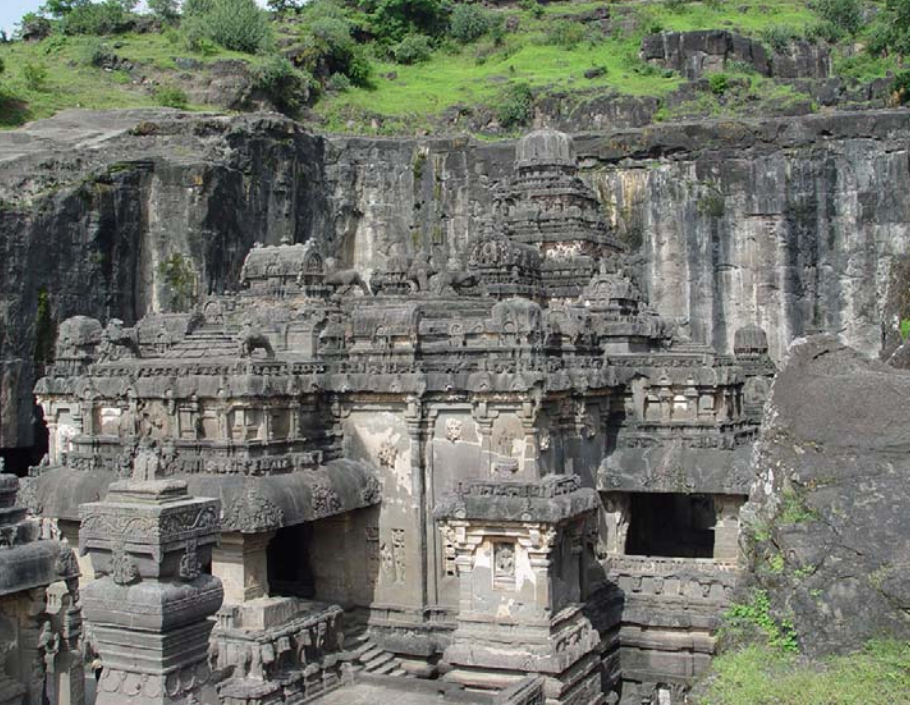
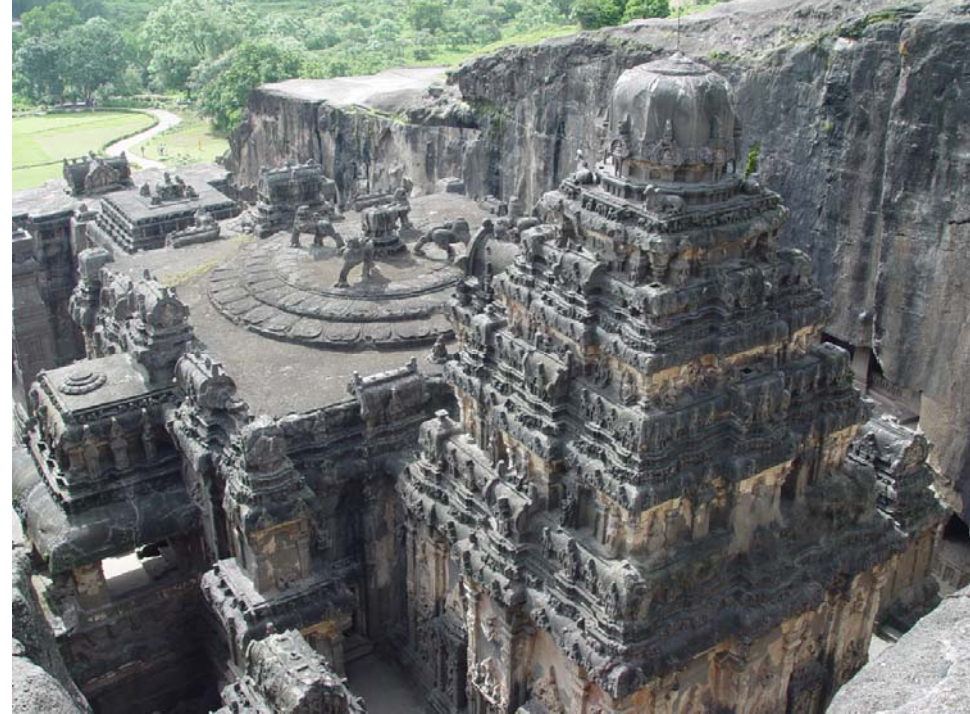
(Figure 55) Front view (left) and view from the back (right) of cave 16 (Kailasa Temple) after cleaning
Photos taken in August 2004. The surfaces of rocks are already turning black due to air pollution and growth of microorganisms.

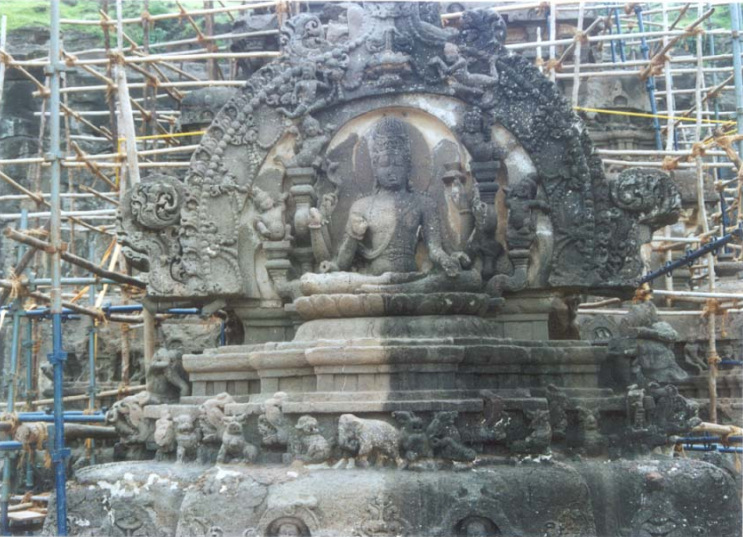
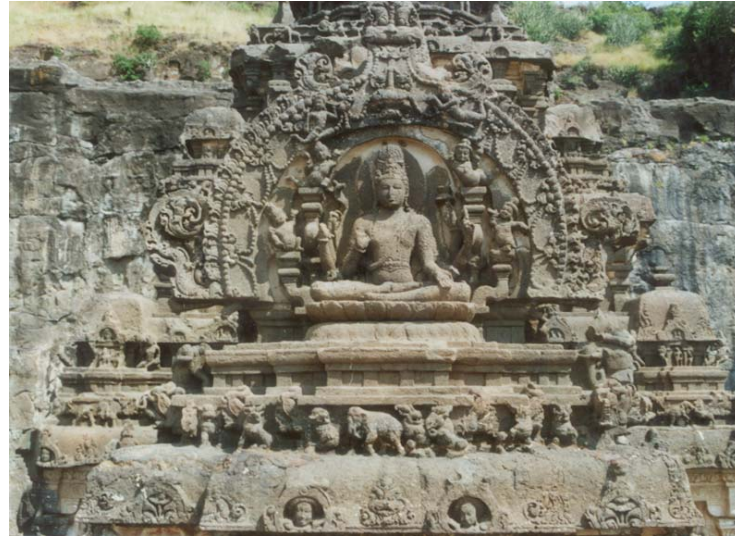
(Figure 56) Cave 16 During cleaning work (left) and after completion (right)

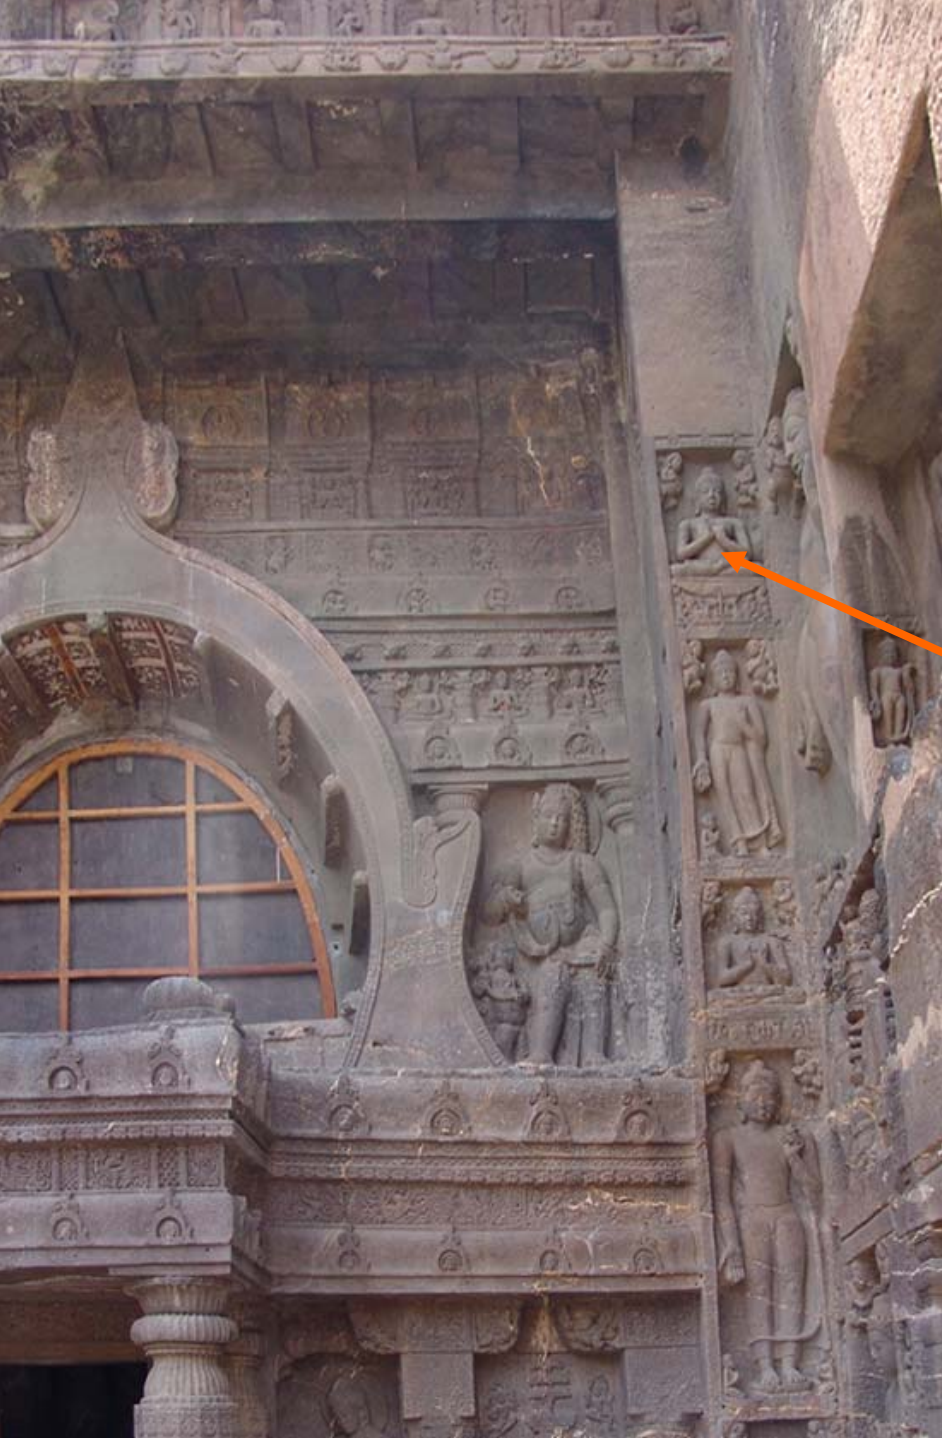
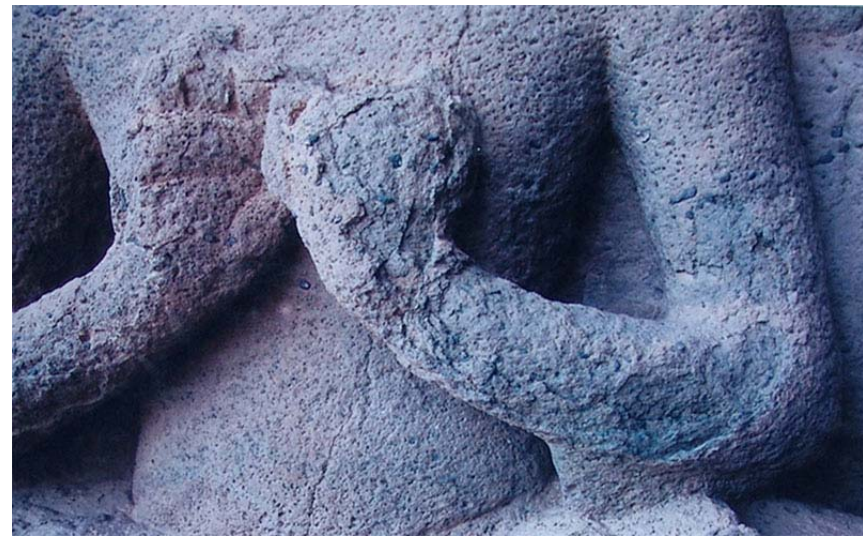
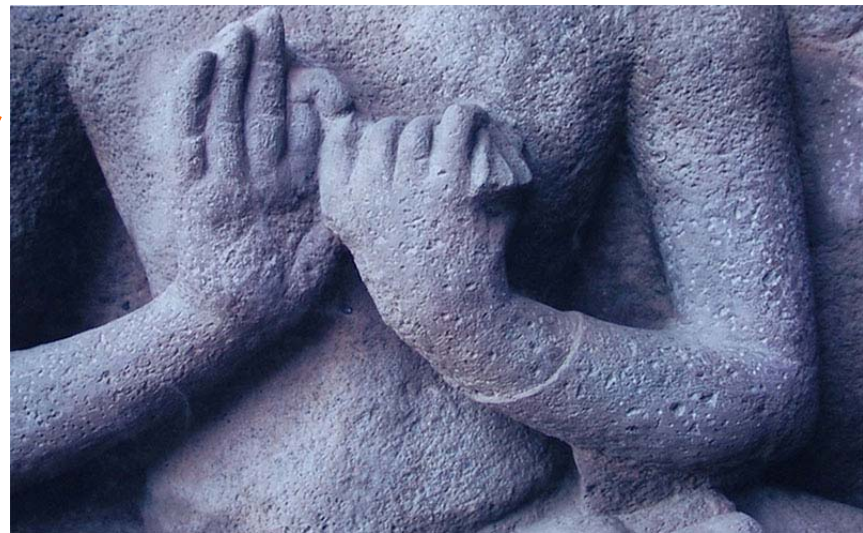
(Figure 57) Restoration and reconstruction of sculptures
Cave 19 of Ajanta historic site

Before restoration (above) and after restoration (below)

The original portions cannot easily be distinguished from the restored/reconstructed portion.

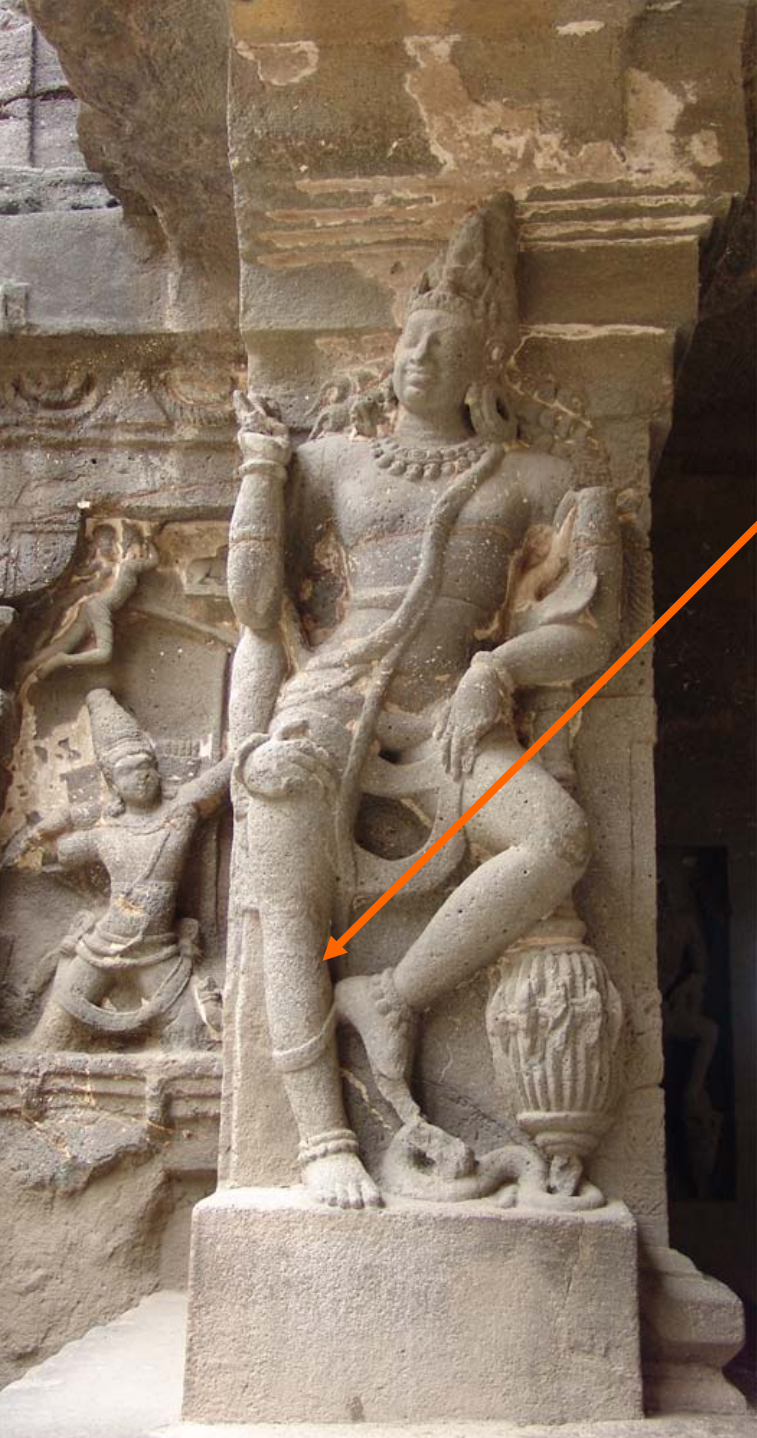
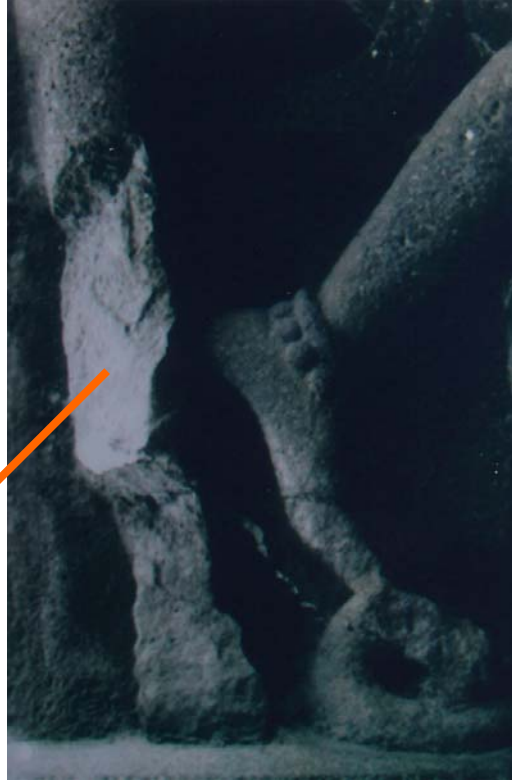
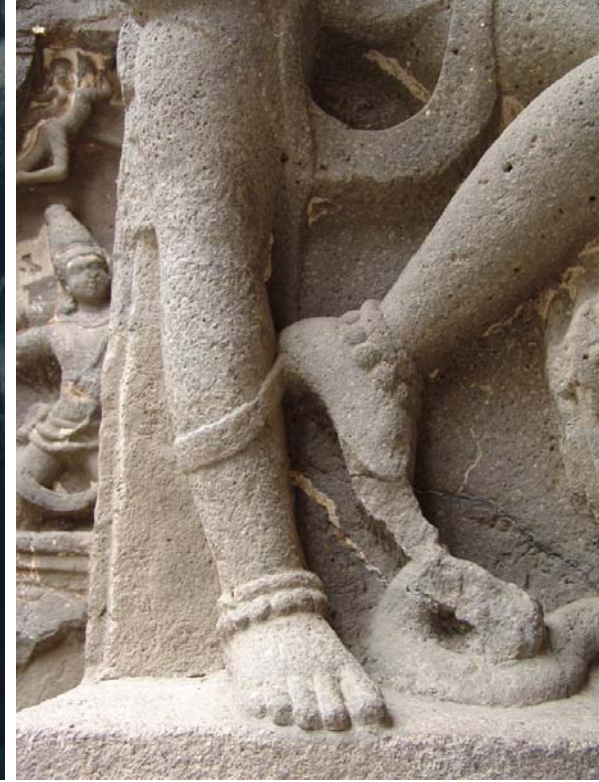
(Figure 58) Restoration and reconstruction of sculptures cave 16 of Ellora historic site

- Before restoration (left) and after restoration (right)

The original portions cannot easily be distinguished from the restored/reconstructed portions
