(Figure 65) Sculpture at cave 30 of Ellora historic site

(Figure 67) Distant view of cave 10 at Ajanta historic site

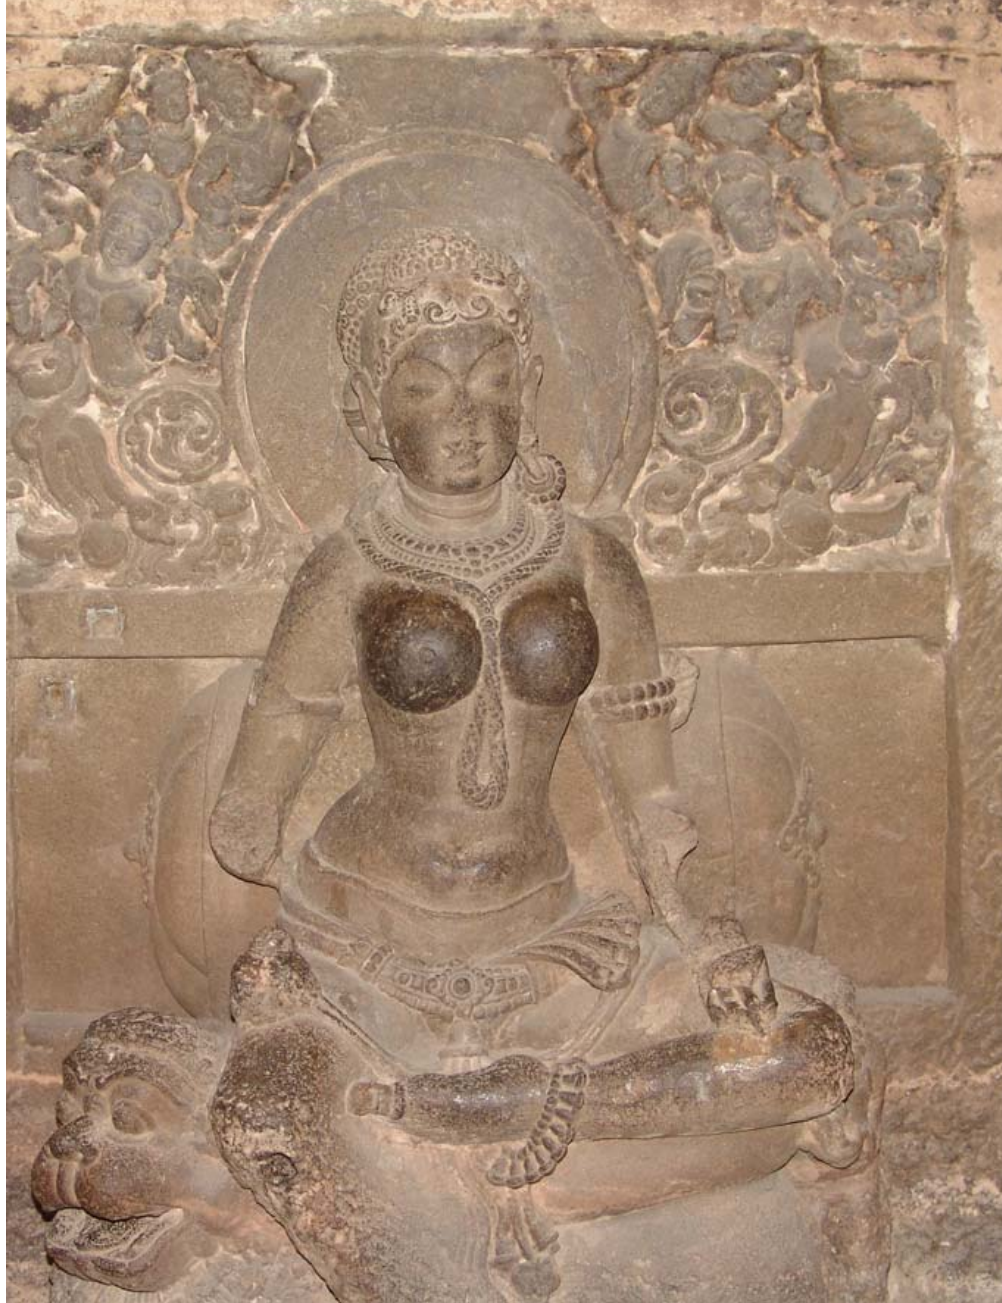
Some parts have become shiny from having been rubbed by many visitors.

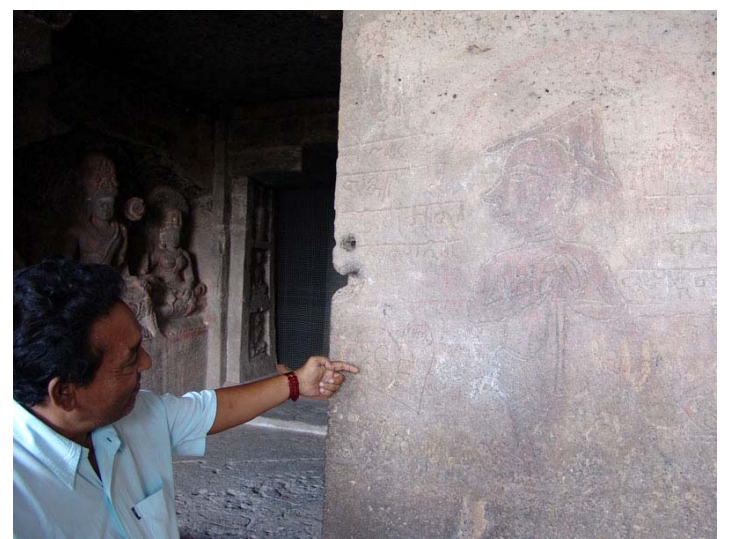
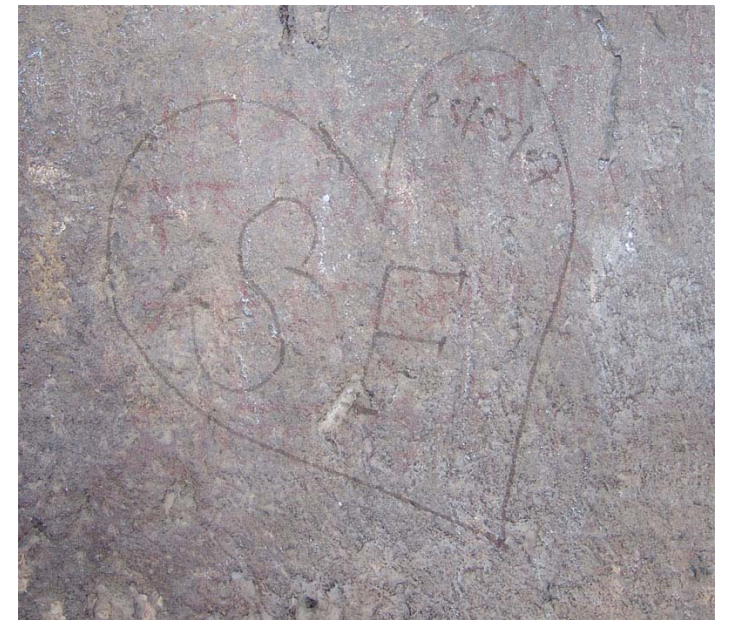
(Figure 66)

Graffiti in cave 12 of Ellora historic site

Written on May 25, 2007.

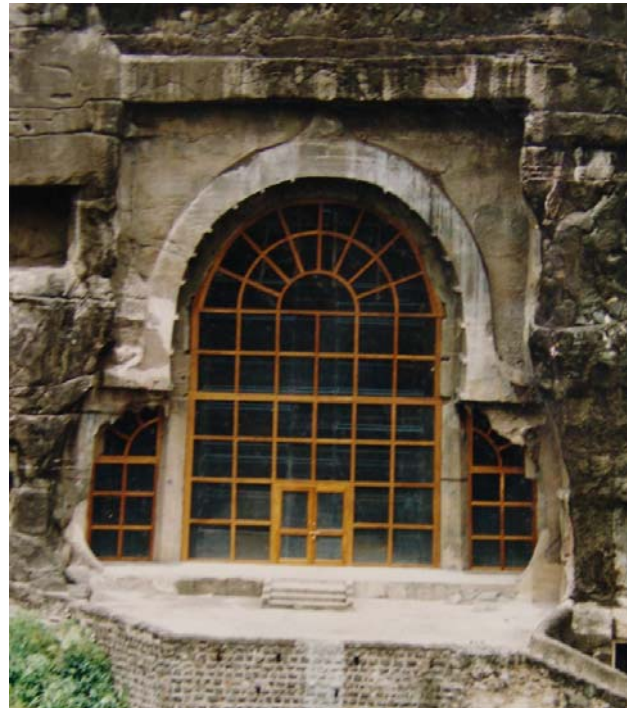
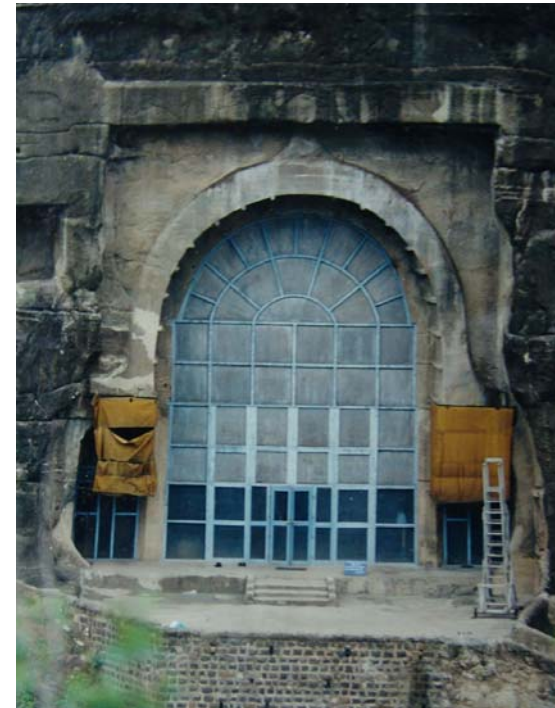
(Figure 68) Facade of cave 10 at Ajanta historic site

Bat proof meshes are installed at the entrance of cave 10 (left).

Former design was similar (right).
