### Environmental and Social Monitoring Form for Construction Stage

Photo Waste Storage and housekeeping

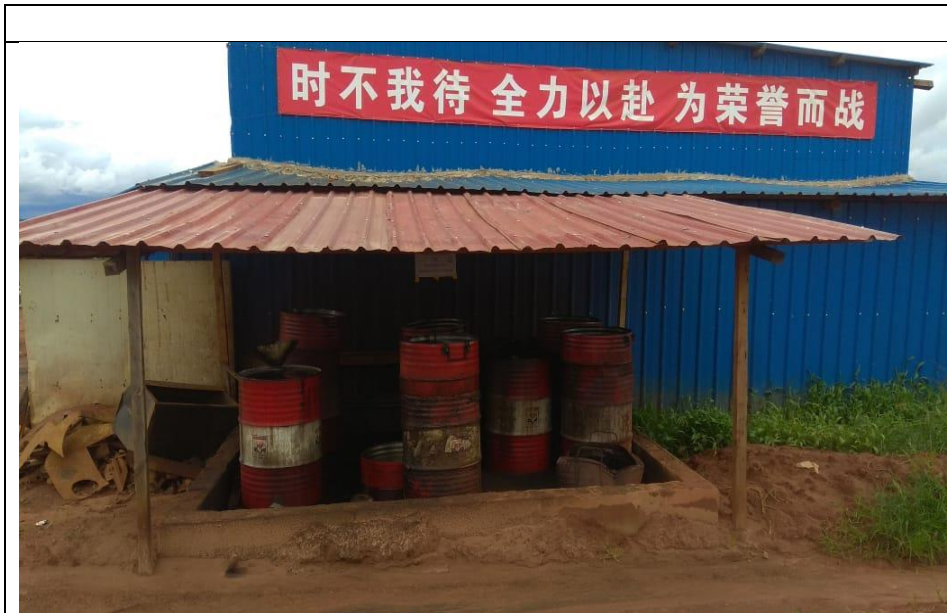
Storage area with spill containment base

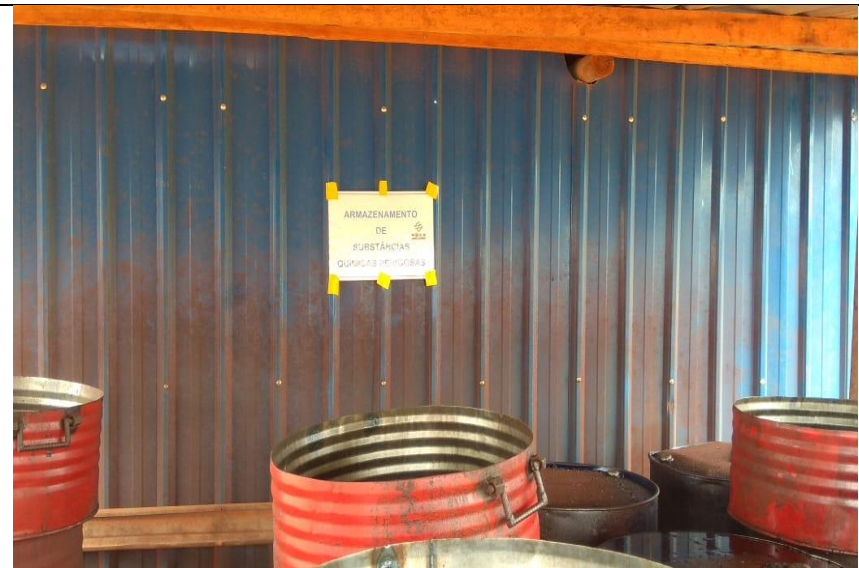
Now is labelled to facilitate segregation

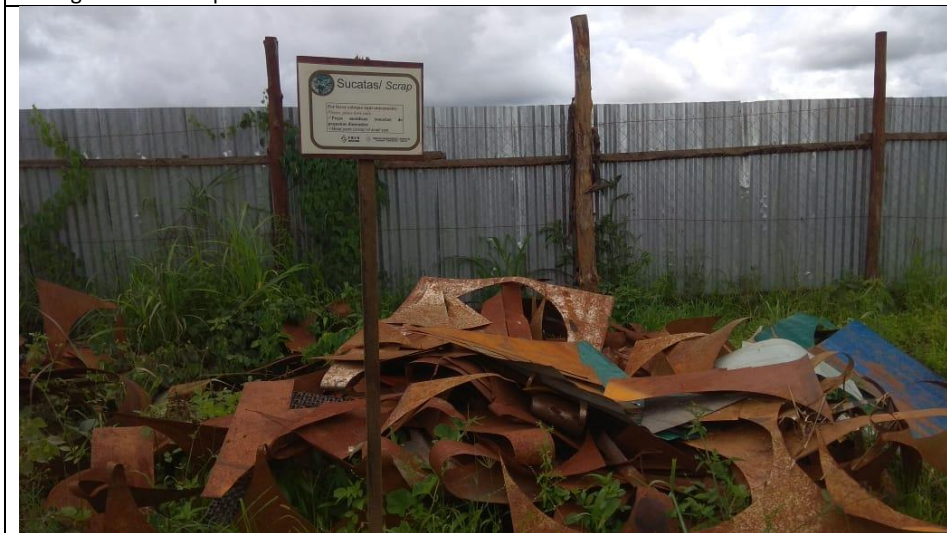
Storage area for Scrap, Metal

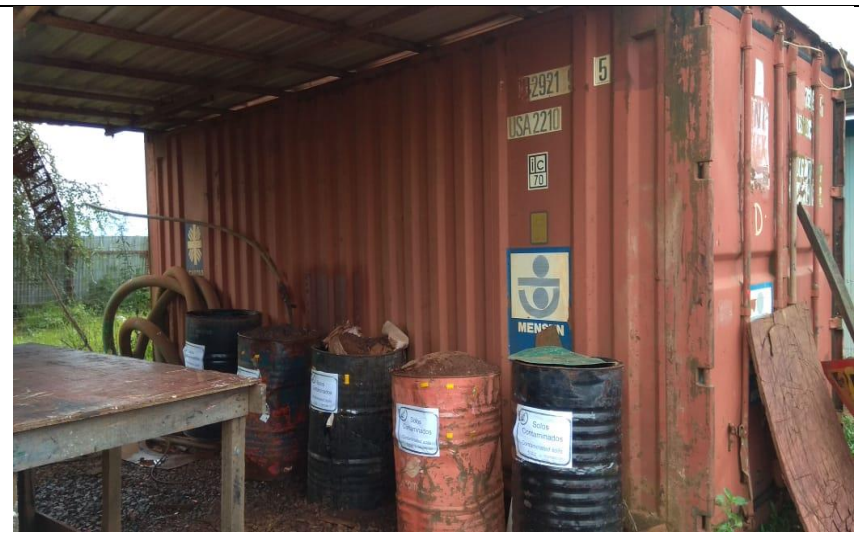
Storage area for contaminated soil

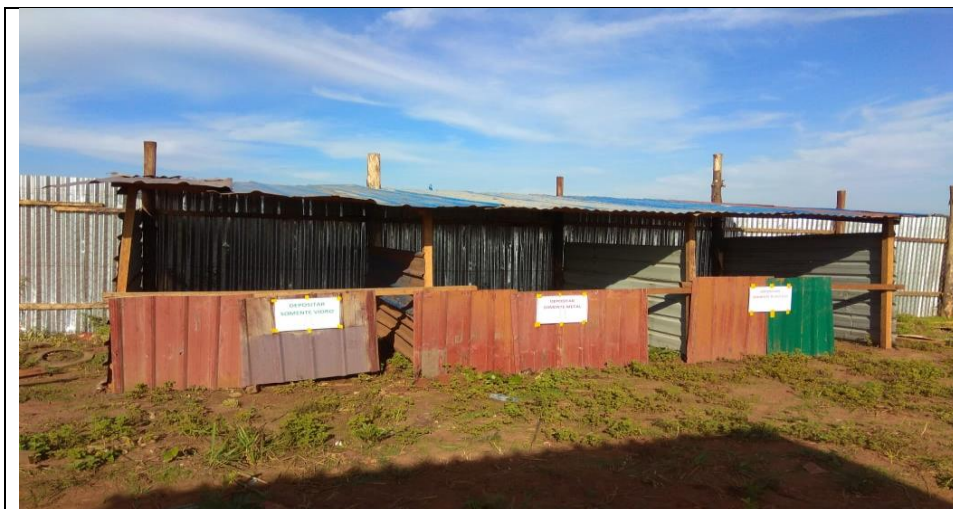
Temporary storage for Metal, Glass at Quarry

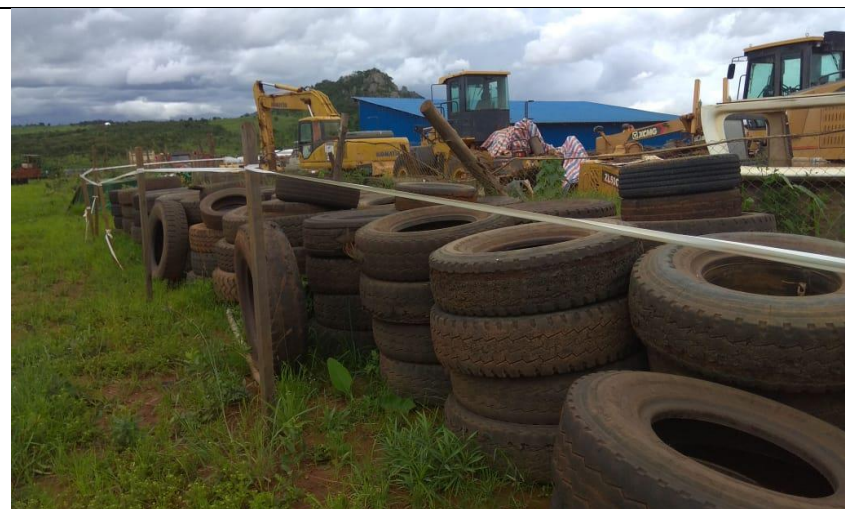
Storage area for used tyres

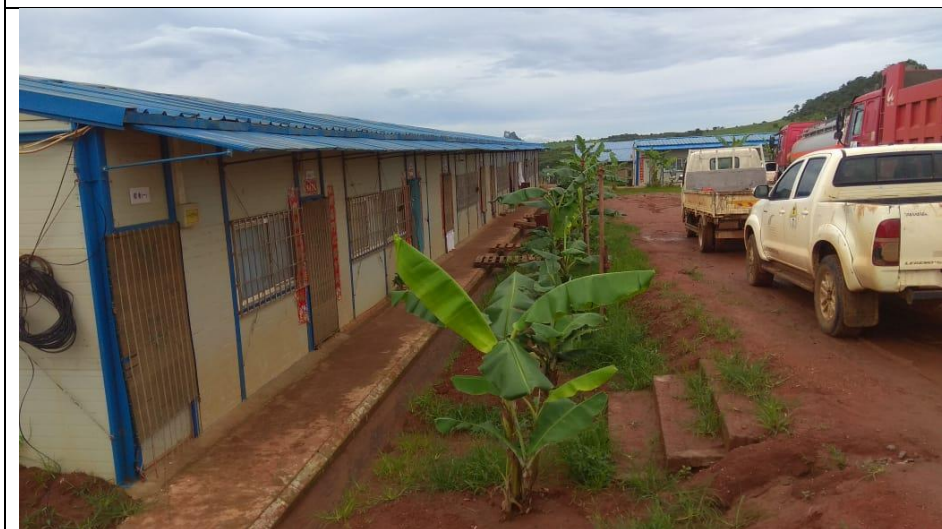
The site now is clean

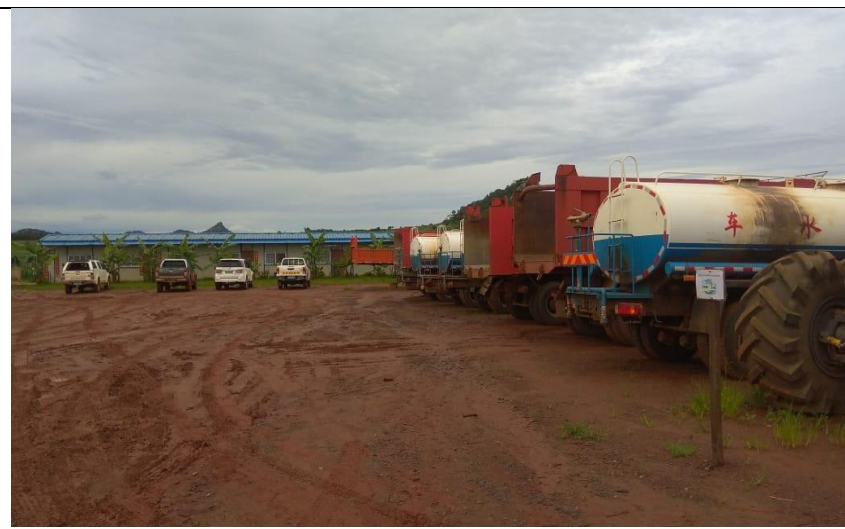
The site now is clean

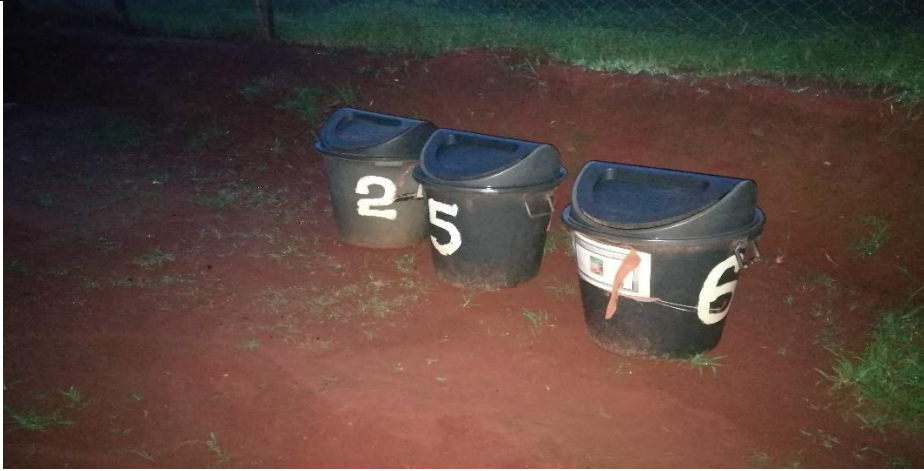
waste containers with covers

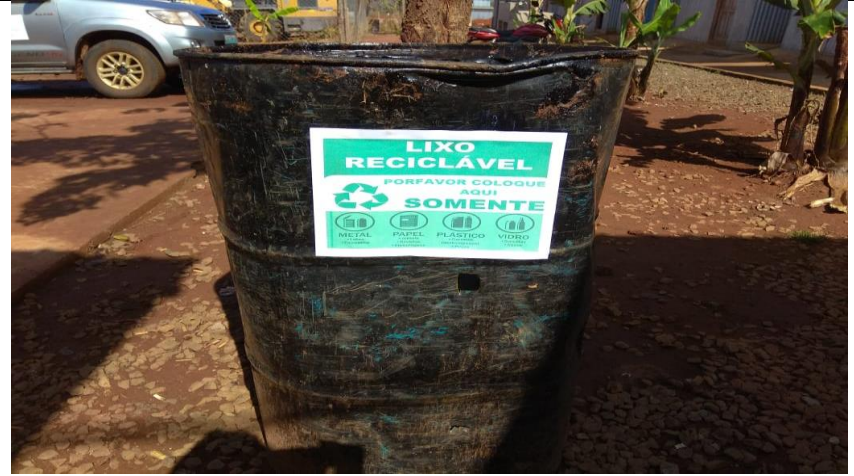
Storage for recyclable waste
