*Results of Inventory Survey for  
Proposed Rehabilitation Works in  
Roleang Chrey Headworks Rehabilitation Sub-project*

PREPARATORY SURVEY FOR IRRIGATION AND DRAINAGE  
SYSTEM REHABILITATION AND IMPROVEMENT PROJECT

Japan International Cooperation Agency

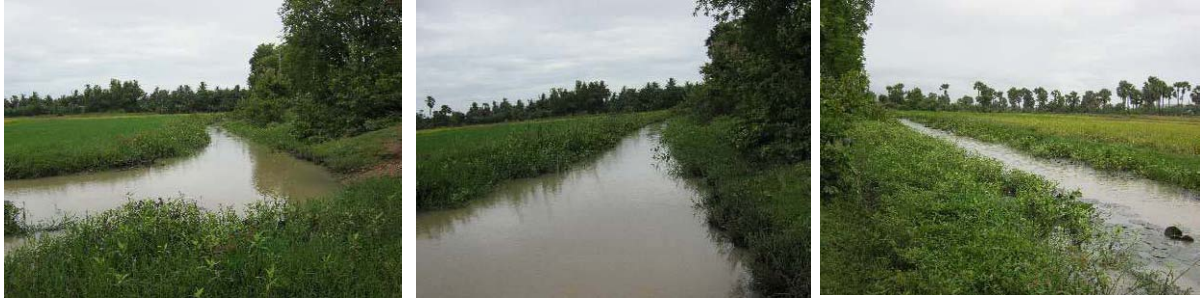
Canal No.: NMC	Proposed Works	Rehabilitation of Phum Thmey Andong Sla SC with construction of structures		Remarks: L = 3.1 km, (A = 300 ha) Improvement of Phum Thmey Andong Sla SC with 4 Turnouts and 3 Drain inlets
Station: 0.00+600	Map Ref. NAC-1	Coordinate	X: 0439329 Y: 1265317

Existing channel (just after turnout)		Upstream reach of existing channel		Middle reach of existing channel

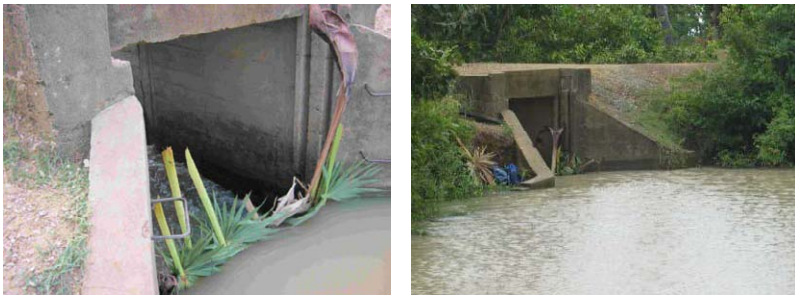
Canal No.: NMC	Proposed Works	Replacement of turnout for Phum Thmey Andong Sla SC		Remarks: Turnout for Phum Thmey Andong Sla SC (A=300 ha)
Station: 0.00+600	Map Ref. NAC-2	Coordinate	X: 0439329 Y: 1265317

Existing Turnout		Existing Turnout (Downstream View)

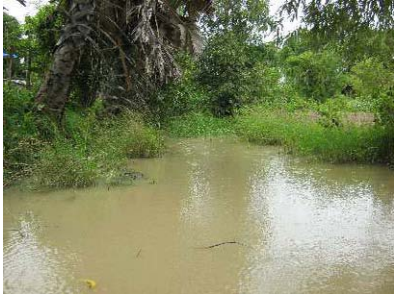
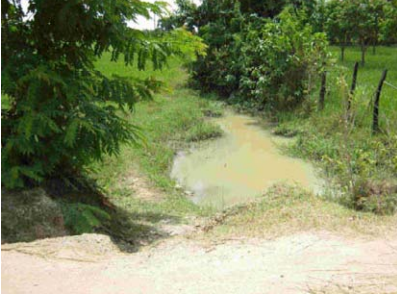
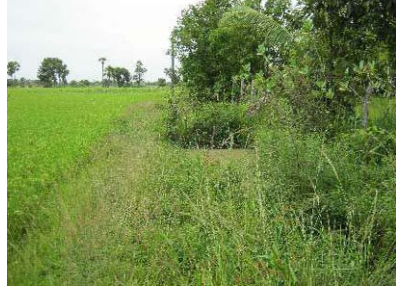
Canal No.: NMC	Proposed Works	Rehabilitation of Andong Thor SC with construction of structures	Remarks: L = 1.45 km (A = 120 ha) 4 checks / diversions structures
Station: 0.00+680	Map Ref. NAC-4	Coordinate X: 0439125 Y: 1265416

Upstream View		Existing canal	
			Downstream View

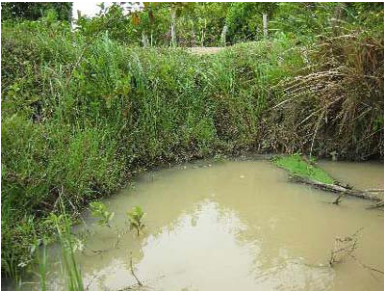
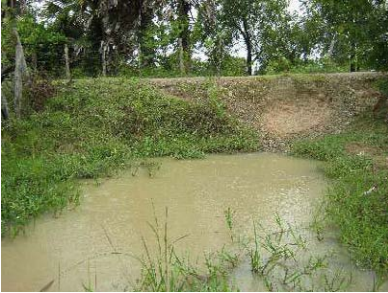
Canal No.: NMC	Proposed Works	Replacement of turnout for Andong Thor SC	Remarks: Replacement of concrete pipe for turnout for Andong Thor SC (A = 120 ha)
Station: 0.00+680	Map Ref. NAC-5	Coordinate X: 0439125 Y: 1265416

Upstream View		Downstream View

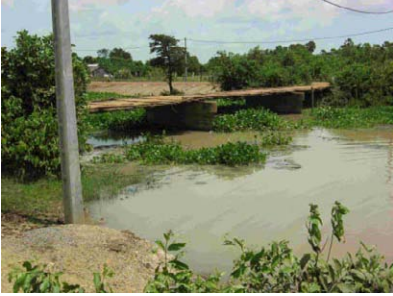
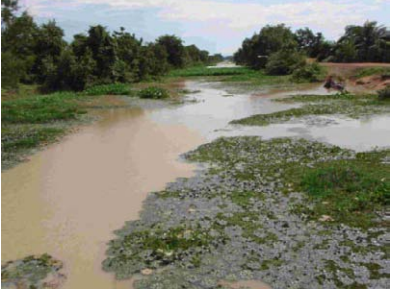
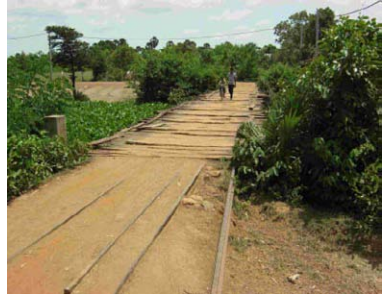
Canal No.: NMC	Proposed Works	Improvement of bridge		Remarks: Replacement of abatement of bridge
Station: 2.00+000	Map Ref. NMC-3	Coordinate	X: 0441313 Y: 1266615

<div style="display: flex; justify-content: space-around;"> <span>Upstream View</span> <span>Downstream View</span> <span>Existing bridge</span> </div>

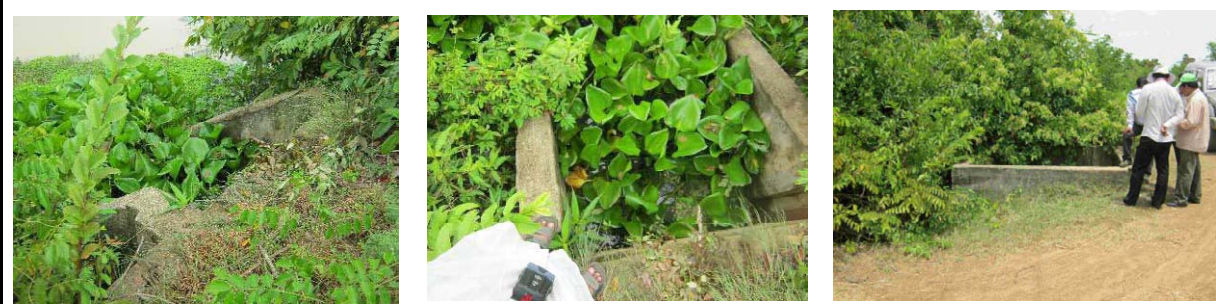
Canal No.: NMC	Proposed Works	Repair of turnout for Kravein SC	Remarks: Turnout for Kravein SC (A = 160 ha)
Station: 3.00+350	Map Ref. NMC-10	Coordinate X: 0442340 Y: 1267398

Existing turnout (Inlet)		Existing turnout (Inlet)	
		Existing turnout (Outlet box)

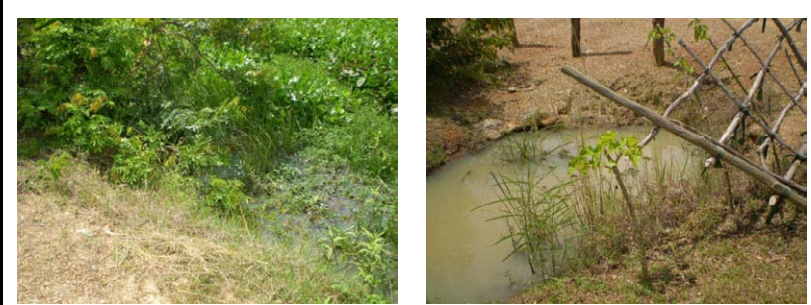
Canal No.: NMC	Proposed Works	Replacement of turnout for Sampove-1 SC	Remarks: Turnout for Sampove-1 SC (A = 100 ha)
Station: 3.00+450	Map Ref. NMC-11	Coordinate X: 0442385 Y: 1267452

Existing turnout (Inlet box)		Existing turnout (Outlet)

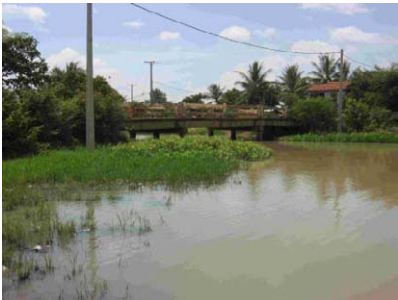
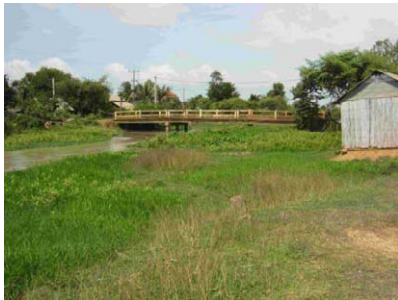
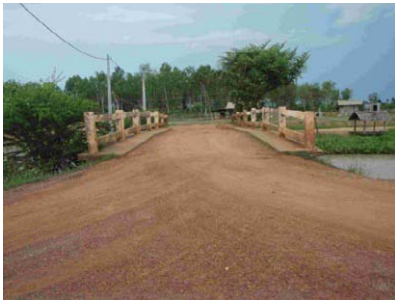
Canal No.: NMC	Proposed Works	Replacement of concrete bridge		Remarks:
Station: 5.00+250	Map Ref. NMC-17	Coordinate	X: 0444148 Y: 1268005

Upstream View		Downstream View		Existing bridge

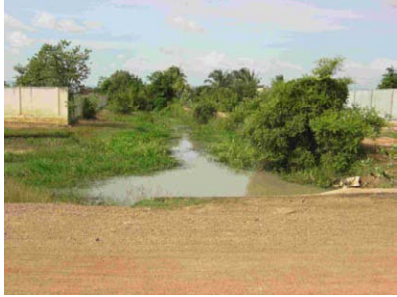
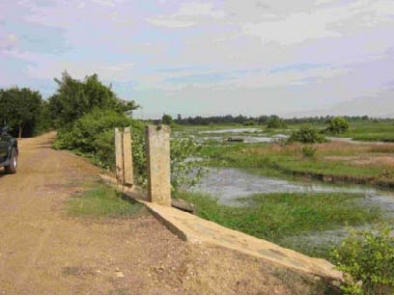
Canal No.: NMC	Proposed Works	Repair of turnout for Thmat Pong SC		Remarks: Turnout for Thmat Pong SC L = 6.2 km, (A = 265 ha)
Station: 8.00+800	Map Ref. NMC-24	Coordinate	X: 0447680 Y: 1269034

Downstream View		Existing turnout

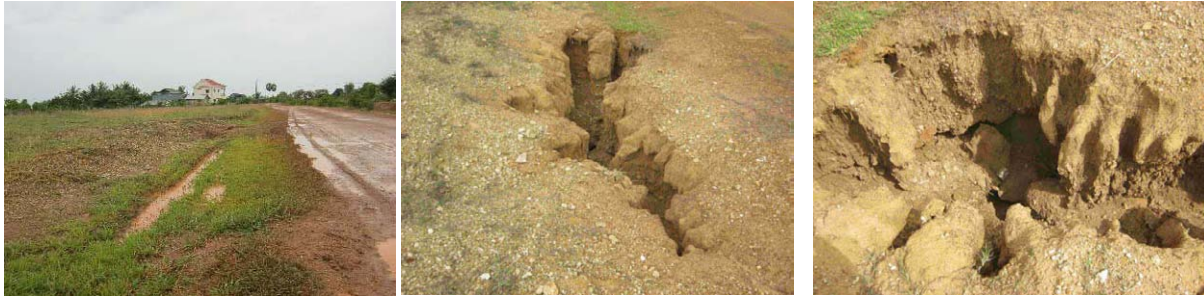
Canal No.: SMC	Proposed Works	Construction of drain inlet and field drain		Remarks: Both side : drain inlet Left side : drain canal
Station: 0+ 200 (B.P.)	Map Ref. SAC-1	Coordinate	X: 0440262 Y: 1263825

Preaent condition of embankemnt		Preaent condition of embankemnt		Preaent condition of embankemnt

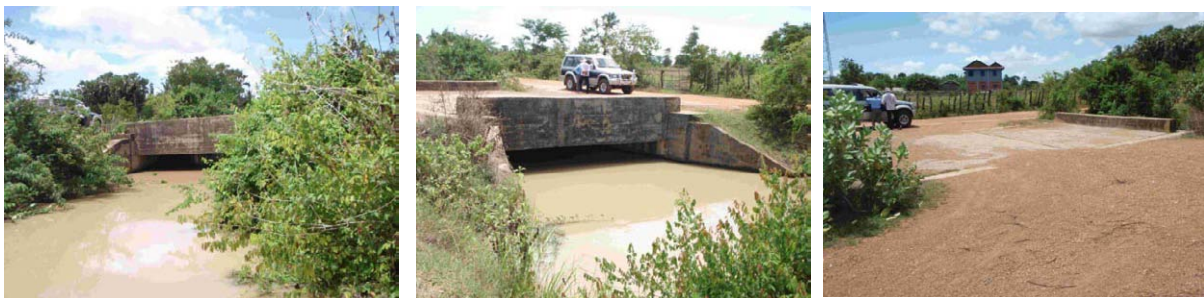
Canal No.: SMC	Proposed Works	Improvement of concrete bridge		Remarks: Bottom should be 1 m lower than existing level
Station: 0.00+580	Map Ref. SAC-2	Coordinate	X: 0439893 Y: 1263773

Upstream View		Downstream View		Existing bridge

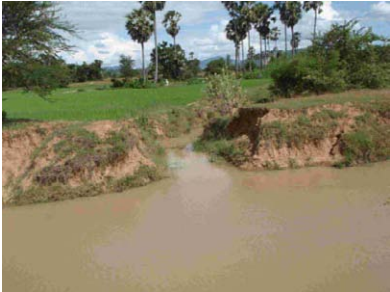
Canal No.: SMC	Proposed Works	Construction of turnouts (Right side)		Remarks: Turnout for Koh Té-2 SC (A = 110 ha)
Station: 4.00 + 750	Map Ref. SMC-9	Coordinate	X: 0444752 Y: 1265073

Presentr condition (No structure)

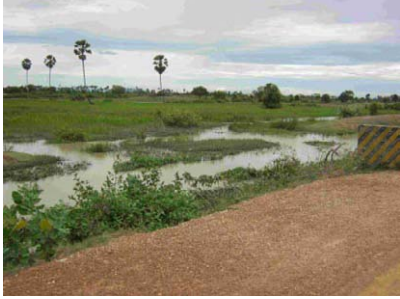
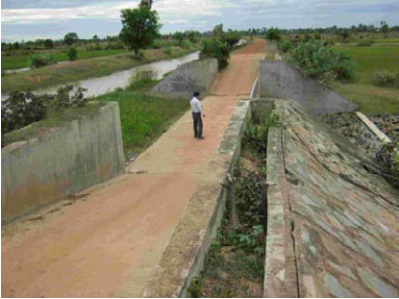
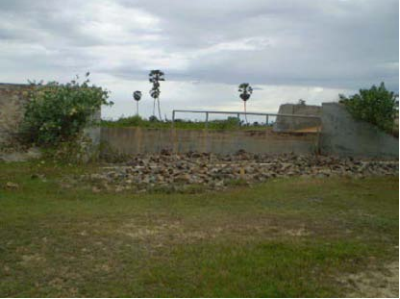
Canal No.: SMC	Proposed Works	Construction of embankment at level crossing reservoir		Remarks: Embankment (Right side, L = 700 m) with provision of new drainage gate and improvement of spillway
Station: 7.00+150	Map Ref. SMC-18	Coordinate	X: 0446993 Y: 1264648

<p style="text-align: center;">Level crossing reservoir                      Existing spillway                      Existing spillway (View from downstream)</p>

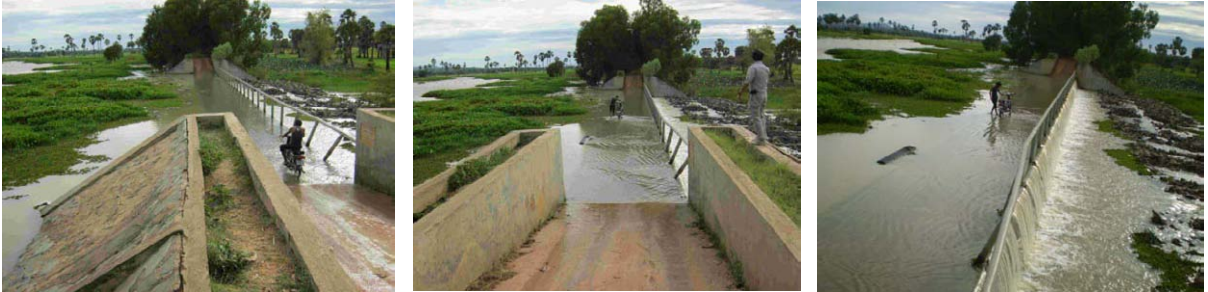
Canal No.: SMC	Proposed Works	Repair of spillway	Remarks:
Station: 9.00+400	Map Ref. SMC-24	Coordinate X: Y:

Existing spillwat		Existing spillwat (View from inspection road)	Existing spillwat (spillout)

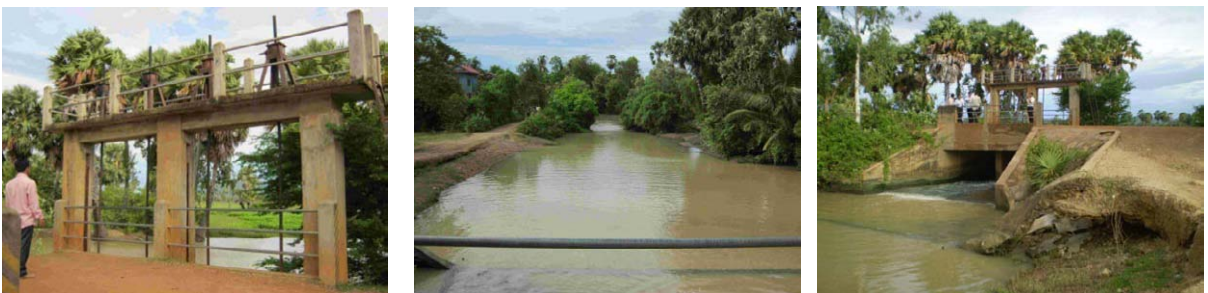
Canal No.: SMC	Proposed Works	Repair of Bak Thmenh gate for Bak Thmenh drainage canal	Remarks: Repair of Bak Thmenh gate for Bak Thmenh drainage cane
Station: 9.00+620	Map Ref. SMC-25	Coordinate X: 0448981 Y: 1263728

Existing drainage gate		Downstream view from drainage gate	View from drainage canal

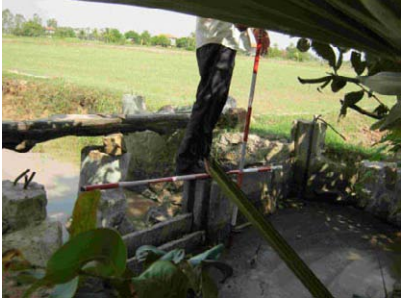
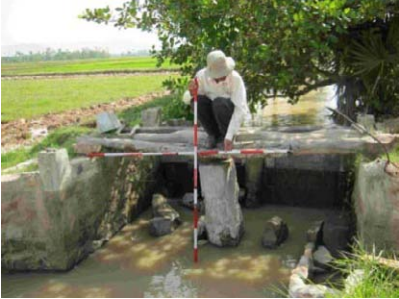
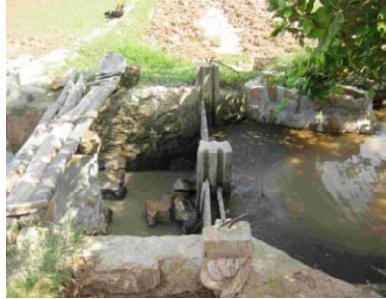
Canal No.: C21	Kind of structure: Check structure (Water obstruction)	Remarks:
Station: 3.00+870	Coordinate< Northing: 1221126 Easting: 0457214	Totally broken

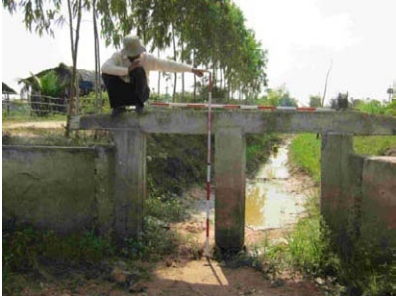
Canal No.: C22	Kind of structure(s): Check structure	Remarks: - Totally broken - Groove takes water into secondary canal, Length: 9500m
Station: 9.00+690	Coordinate< Northing: 1221900 Easting: 0461237
