# ***ANNEX D***

*Results of Inventory Survey for Irrigation and Drainage*

*Facilities in Kandal Stung – Bati Irrigation System*

*Rehabilitation Sub-project*

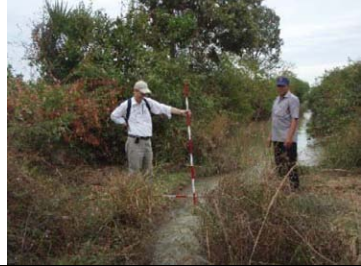
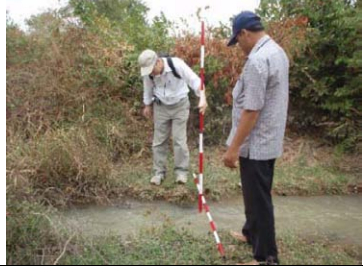
Canal No.: KC-1	Kind of structure(s): Canal Section	Remarks:
Station: 3.00+000	Coordinate< Northing: 1261003 Easting: 480597

3,000	480597	1261003	Canal Section	Slope of canal is covered by thick grass and trees, no maintenance is made for long time	C	
3,020	480628	1261003	Turn Out (Broken)	Turnout was broken and location is higher than rice field	D	Pipe dia=0.3m
3,420	480994	1261005	Regulator	New structure and functioned well	A	Constructed by TSC, MOWRAM in Dec. 2010 (Financial Assistance of JICA)
4,020	480994	1261005	Drain Inlet W=4m, dia=1m	New structure and functioned well	A	Constructed by TSC, MOWRAM in Dec. 2010 (Financial Assistance of JICA)
4,060	481506	1261011	Drain Inlet W=4m, dia=1m	New structure and functioned well	A	Constructed by TSC, MOWRAM in Dec. 2010 (Financial Assistance of JICA)
4,180	: 481612	1261008	Pipe Culvert on commune road	New structure and functioned well	A	Constructed by TSC, MOWRAM in Dec. 2010 (Financial Assistance of JICA) (Double) W=4m, dia=1m
4,850	481943	1261011	E.P, Pipe Culvert on provincial road	New structure and functioned well	A	Constructed by TSC, MOWRAM in Dec. 2010 (Financial Assistance of JICA) (Double) W=6m, dia=1.5m

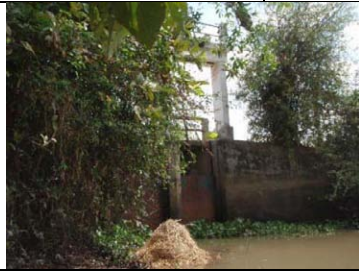
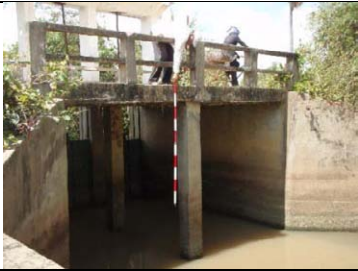
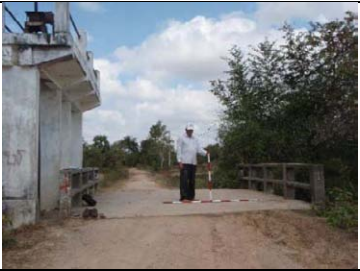
Canal No.: KC-3-1	Kind of structure(s): Intake on Stung Touch River	Remarks: 3 gates
Station: 0.00 (B.P)	Coordinate< Northing: 1258313 Easting: 4841835

Sta.	E	N	Structure	Condition	Evaluation	Remarks
0	4841835	1258313	B.P. Intake gate with 3 gates	Gates are functioned, though one spindle is bended	B	No substantial rehabilitation would be needed
			Bridge on Commune road	In good condition	B	W=5.5m, L=4.2m
400	482077	1258306	Turnout	Brick made	C	L=5.2m, dia=0.6m
500	482250	1258310	Canal Section	No obstruction is found, though some trees grow on canal slope and banks	C	
800	482473	1258309	Check Structure,	No gate is equiped	C	w=1.6m, L=3.5m
900	482590	1258308	Wooden Bridge on commune road	Cross points of two Pol Pot canals, only temporary wooded foot bridge is provided by farmers	D	only one log to pass
1,000	482723	1258310	Canal Section	No obstruction is found, though some trees grow on canal slope and banks	C	
1,500	483183	1258312	Bamboo check Private	For fishing only,	-	
2,000	483675	1258319	Turnout	Broken and clogged	D	dia=0.4m
2,200	483893	1258320	Check Structure,	Wing wall for check made by sand bags are damaged, no function due to too narrow flow area, no gate	D	W=2m, L=3.5m

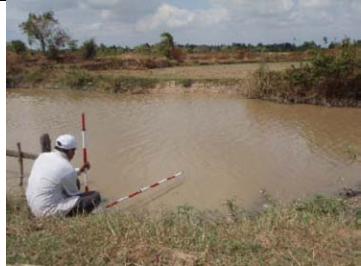
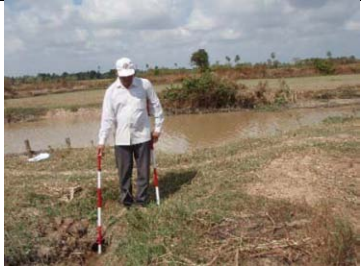
Canal No.: KC-3-1	Kind of structure(s): Turnout	Remarks:
Station: 2.00+300	Coordinate< Northing: 1258319 Easting: 483954	Broken

2,300	483954	1258319	Turnout	Broken and clogged	D	dia=0.4m
2,500	484153	1258320	Canal Section	No obstruction is found, though some trees grow on canal slope and banks	C	
2,900	484449	1258321	Box Culvert with groove,	Across canal 85 (local name), No R&L banks, road is completely eroded	D	w=3m, L=1.5m
3,000	484577	1258339	Canal Section	No obstruction is found, though some trees grow on canal slope and banks	C	
3,200	484815	1258340	Pipe Culvert Private	Road connected to house	B	W=2m, L=7.5m, dia=1m (3 culverts)
3,400	485043	1258323	E.P. Bridge on NR-2	Good condition	A	W=6m, L=8m, (3 spans =1.8m),

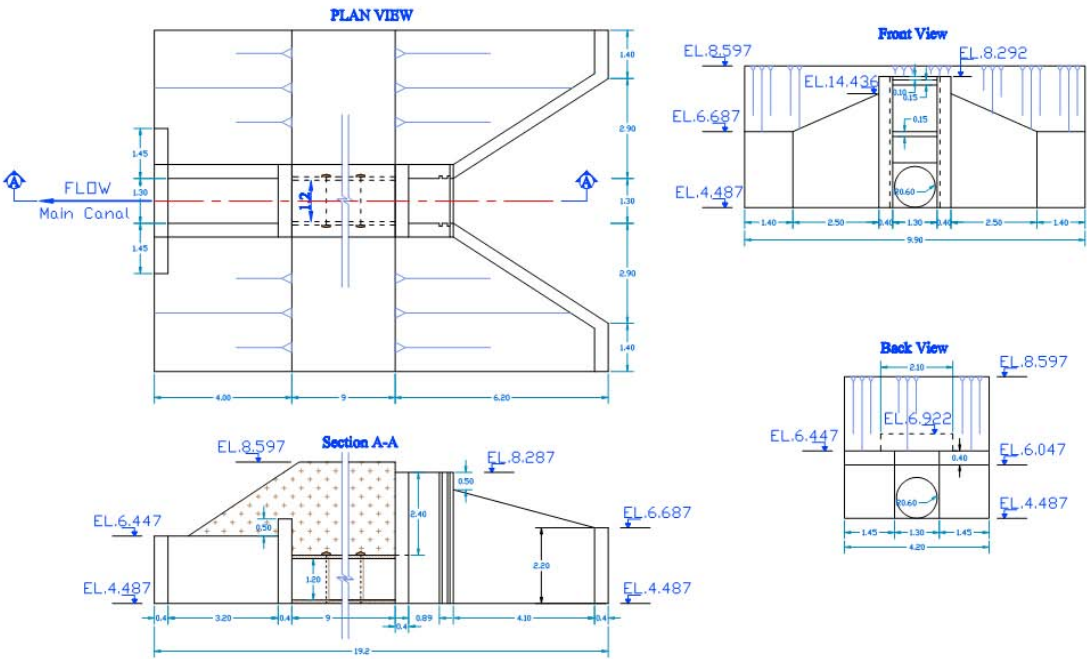
Station No.		Reservoir Name	Srass Pram Bei
Coordinate:	X = 511426	Name of structure(s)	Intake pipe culvert at the north reservoir embankment
	Y = 1238406	Diameter culvert 1.2m (1 row)

Photo Details			
Condition / Problem: The structure is possible used and constructed in Pol Pot time.			
Dimensions & Sketches:
