## 9. Environmental Monitoring Report

# ENVIRONMENTAL MONITORING INSPECTION AT AUM AND KAPIURA

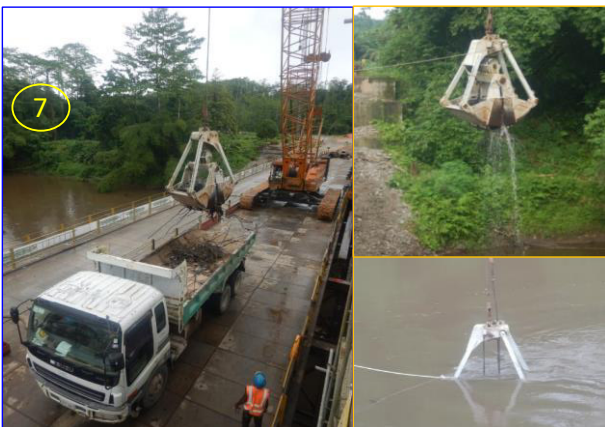
NO.	Check Item	Measurement	Remarks
1	Construction waste	Treatment of construction around work site	Cleaning and Housekeeping (refer to photo no.7)
2	Living waste	Treatment of living waste around campyard	Collecting of waste materials from site and campyard (refer to photo no.8)

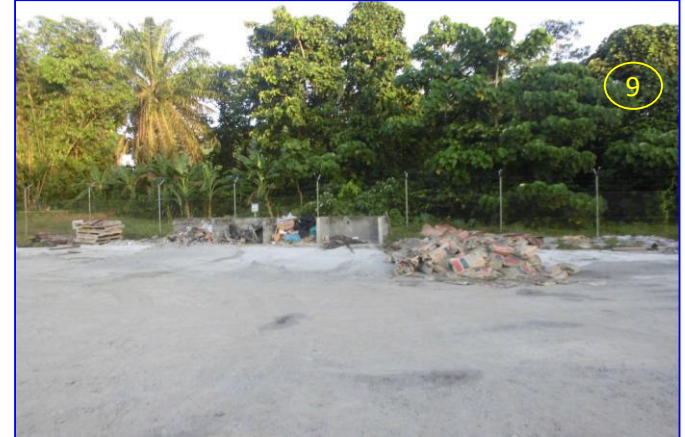
NO.	Check Item	Measurement	Remarks
1	Ecosystem	Condition of vegetation and biota around the work sites	Keep the batching plant area clean, spray water in dusty place(refer to photo no.9)
