# Guidebook of World Bank and JICA Field Trip

## Nobiru, Matsushima, Shiogama, Shichigahama, Tagajo and Sendai port

25 July 2011

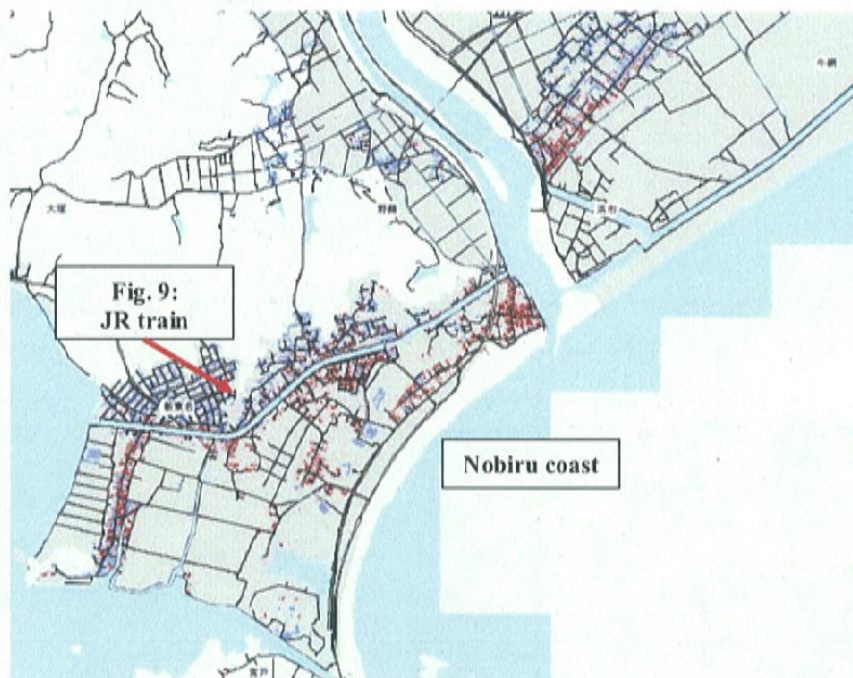
Higashi-Matsushima is one of the locations that residence has high tsunami awareness since they suffered damage from the past tsunamis. Many researches regarding tsunami hazard map and evacuation behavior were performed. Figure 5 shows overall damaged houses in Higashi-Matsushima city. About 8 m height tsunami caused damage to seawall (Fig. 6) and control forest (Fig. 7 and 8). Also his city has many JR train stations locates close to shoreline of Ishinomaki Bay. Research on tsunami risk to the JR train was started since 2010 but still on the way and too late for the 2011 tsunami. Example of damaged JR train is shown in Fig. 9.

Fig. 5 Tsunami affected area in Higashi-Matsushima city (Blue: surviving house, Red: washed away house and Gray: inundated area)

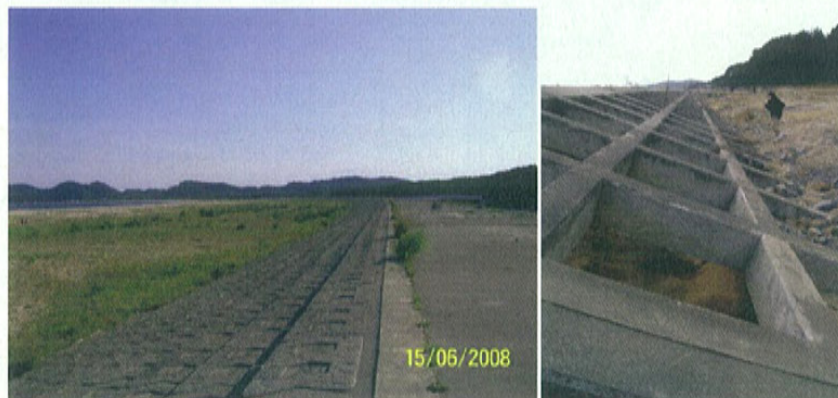
Fig. 6 Seawall along Nobiru coast before and after tsunami

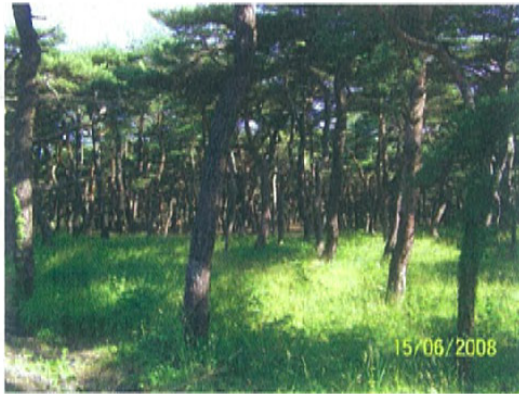
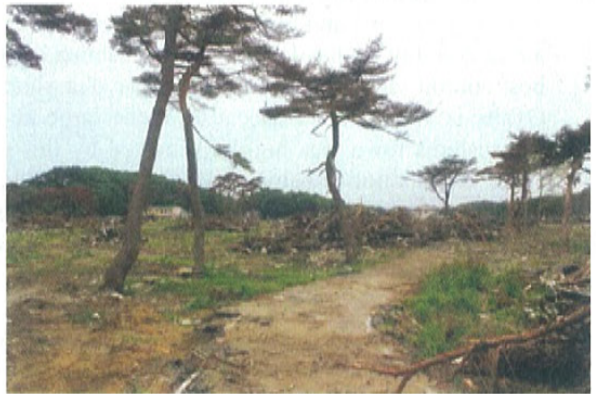
Fig. 7 Control forest along Nobiru coast before and after tsunami

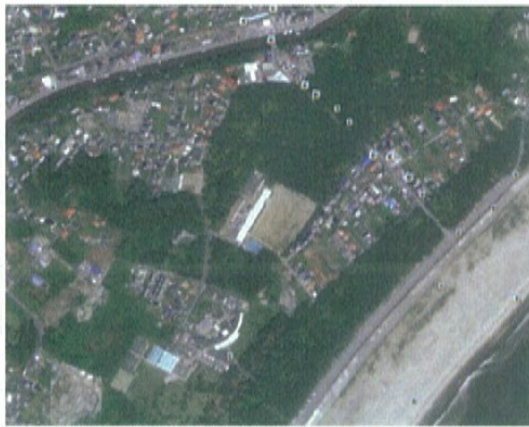
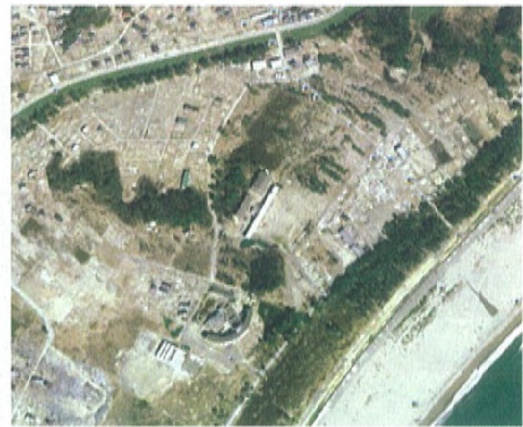
Fig. 8 Satellite image showing a comparison of control forest before and after tsunami

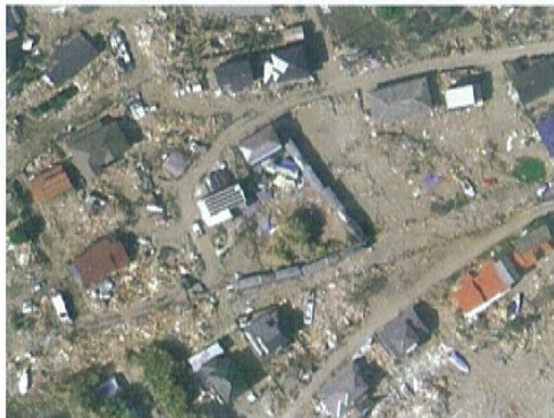
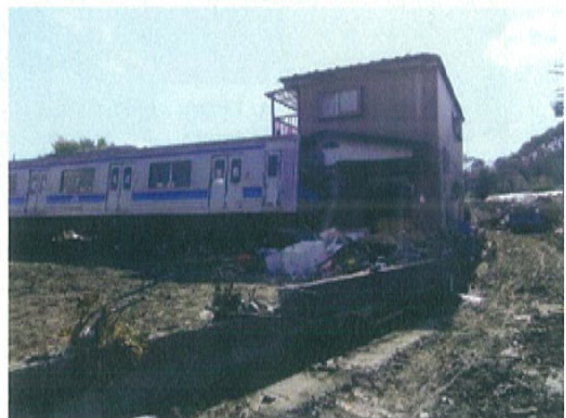
Fig. 9 Damaged JR train found between Tona and Nobiru station
