FCSEC Technical Report
Volume 3

The Mayon 2006 Debris Flows

The Destructive Path of Typhoon Reming

This paper discusses the result of damage investigation and disaster survey of Region V conducted by Japanese Survey Team together with JICA Experts and staff from FCSEC from 10-16 December 2006.

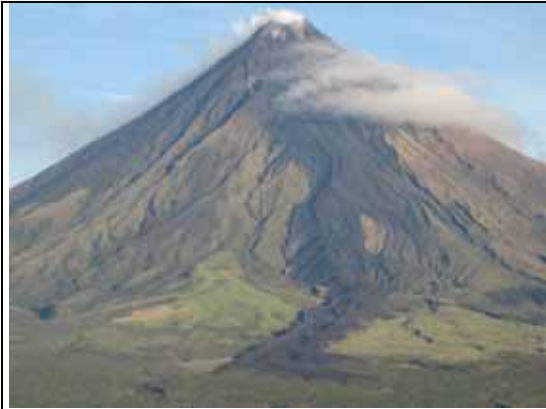
Figure3 Wide photo of Mt. Mayon showing the Busay gully where widespread debris flow occurred.
Source : JICA-FCSEC-Japan Survey Team December 2006

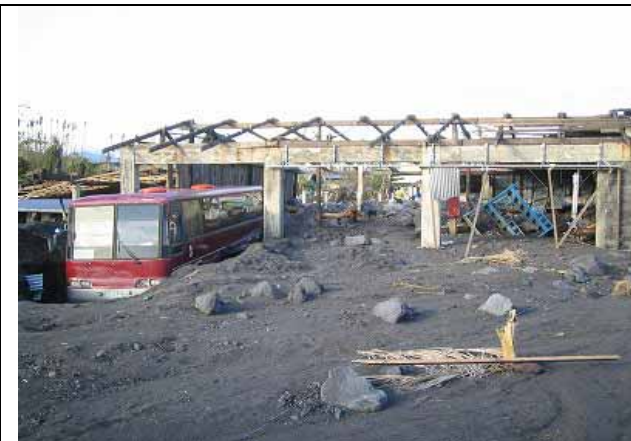
Figure9 Main roadway was buried by debris flow even public transportations were immobilized.

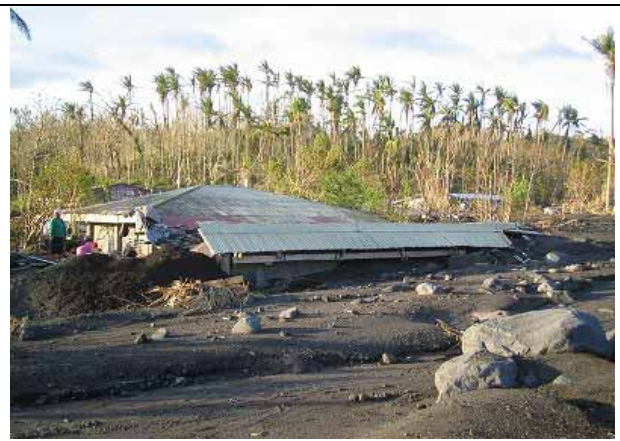
Figure10 The debris flow surged rapidly down Mayon and deposited in communities situated below, burying communities.

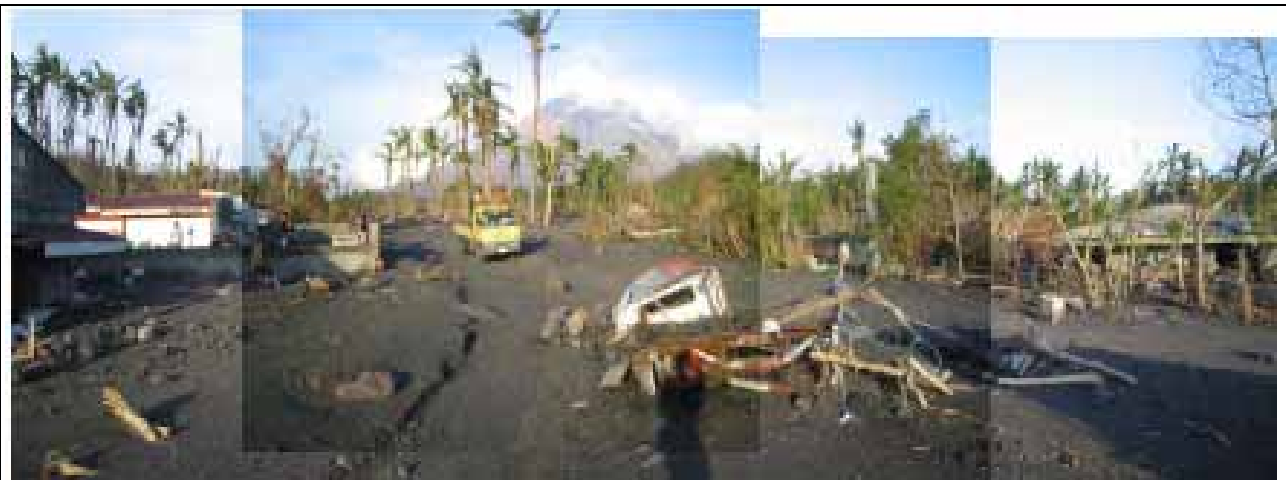
Figure11 Whole of the Brgy. Maipon was buried under debris flow.

Debris flow was deviated to Brgy. Maipon when a 50m wide and 10m deep Masarawag gully was formed during the height of typhoon Reming. The said deep gully acted as channel to the convulsive mixture of volcanic debris caused by lateral and vertical erosion. The amount of sediment transported was massive considering the changes in the gully cross section profiles.

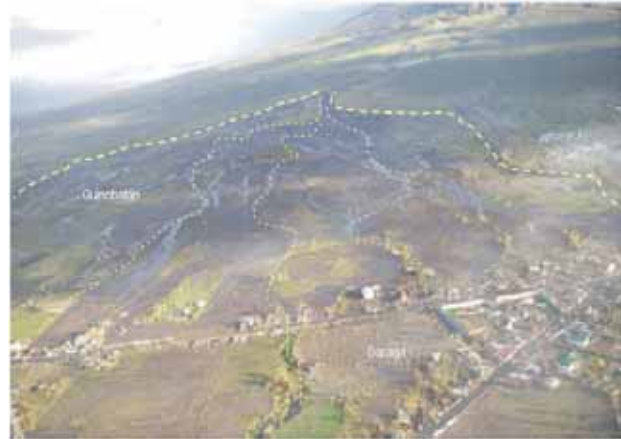
Figure12 Debris flow between the municipal boundary of Camalig and Guinobatan

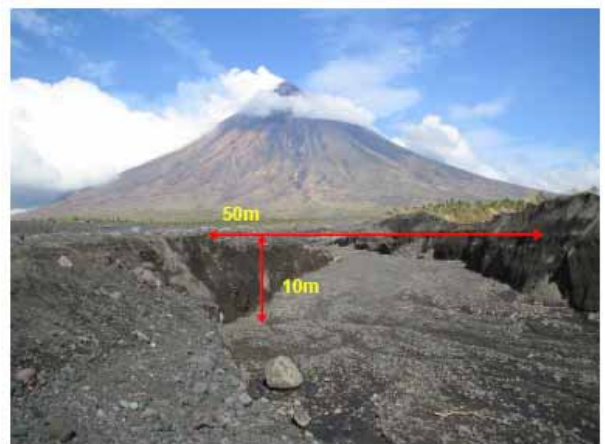
Figure13 Extensive gully formed from a small creek during the typhoon. Residents observed that this is where large debris cascaded.

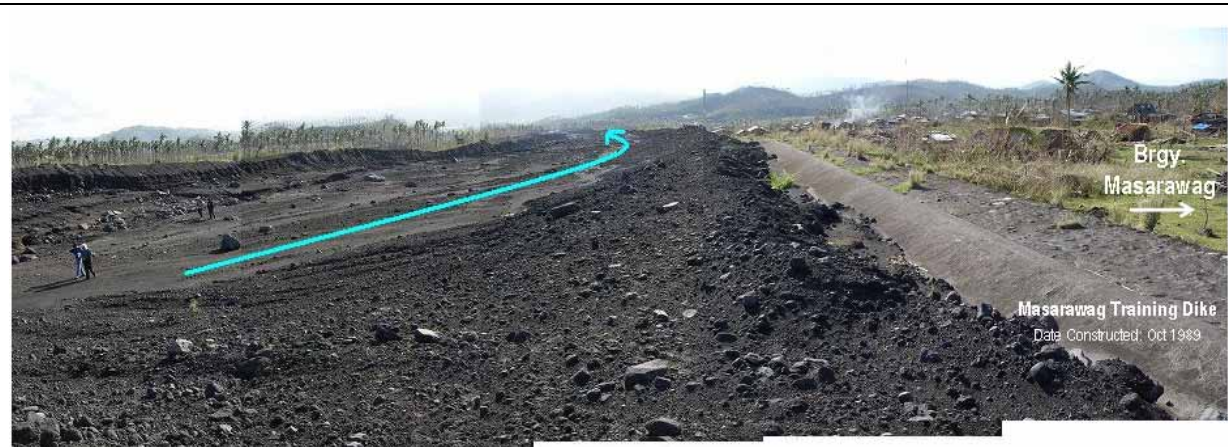
Figure14 Training dike constructed by DPWH Regional Office on October 1989 trapped debris flow from affecting adjacent barangays.

In Masarawag, where the damage to a village was greatly mitigated by the training dike, the effect of the existing training dikes was confirmed. However, as the rate of completed facilities is only 15% in terms of total budget, it is not sufficient to protect lives and properties completely. On the other hand, the condition of the area has changed severely as several catchment captures occurred. Therefore major updating of the plan is necessary based on the lessons from this disaster.

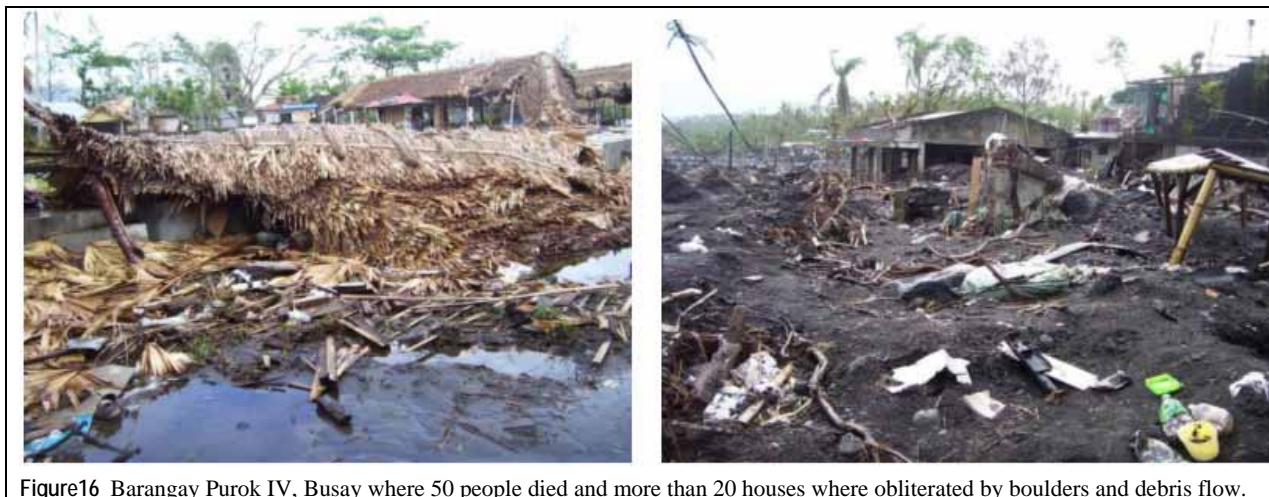
Figure16 Barangay Purok IV, Busay where 50 people died and more than 20 houses where obliterated by boulders and debris flow.

The upstream of the Busay River is the Busay gully, a deep channel running from the slopes of Mt. Mayon, which was easily scoured due to the runoff caused by excess rainfall. Using a Garmin 60 Global Positioning System (GPS), a Nikon Laser Distance Measurement Device and survey rods, the debris flow in the affected the area was measured to be 2.0 m deep, 307m wide and 314 m long. The volume of deposited debris can be calculated as 193,000 cu.m.

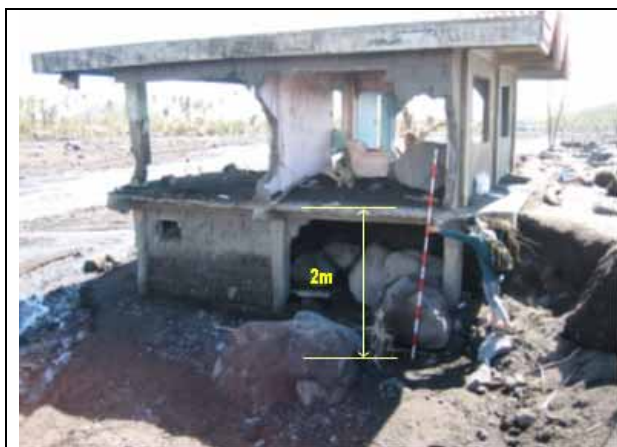
The slope of the Busay River was measured using an inclinometer to be 2°. The debris flow, with average diameter of 1.0mø primarily moved as a coherent slump consisting of volcanic materials and boulders. A fast flowing debris velocity was also suggested by eyewitnesses who stated that most residents were unlucky not to outrun the advancing flow. Similarly, the mode of debris flow movement formed as a result of rising ground water levels after deep infiltration of antecedent rainfall.

Figure17 Boulders averaging 1.0m in diameter rampage down Busay River and killed people and destroyed properties along its path.

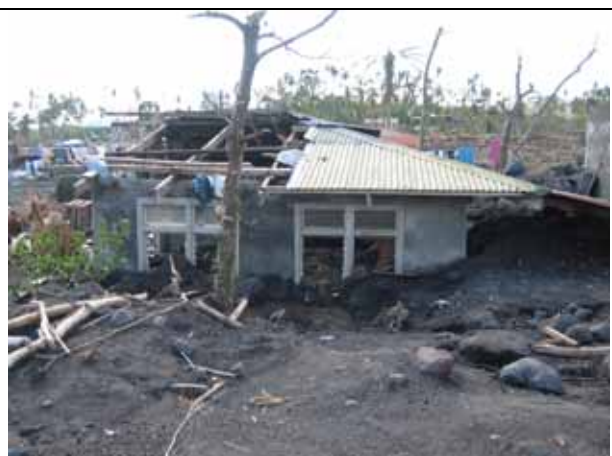
Figure18 Debris flow deposits combined with overtopping of riverbanks buried communities.

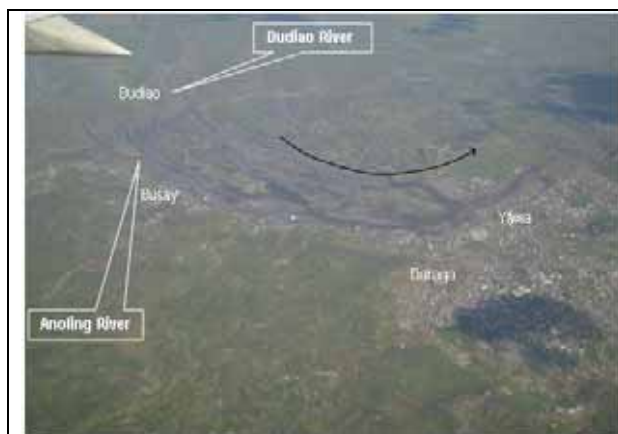
Figure20 Debris flow originating from Budiao and Anoling Rivers affecting the Municipality of Daraga and Yawa

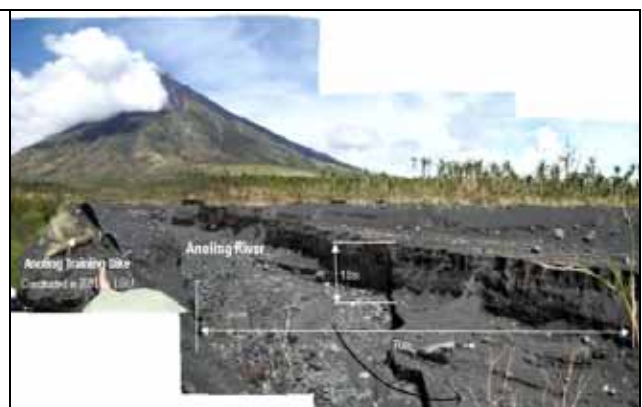
Figure21 An 18m deep gully was formed in the Anoling River where debris flow surged rapidly down Mayon

At the upstream of Anoling River, where a 50m training dike was constructed by the Daraga Municipal Government in 2001 (Location: N13.1998°, E123.63686°, Elev. 290m) a 70m wide and 18m deep gully was formed. The debris flow concentrated in these gully, redirecting away from Brgy. Anoling but acted as funnel and buried Brgys. Salvacion and Miisi. Using an inclinometer, the slope of the Anoling River is measured to be 4°.

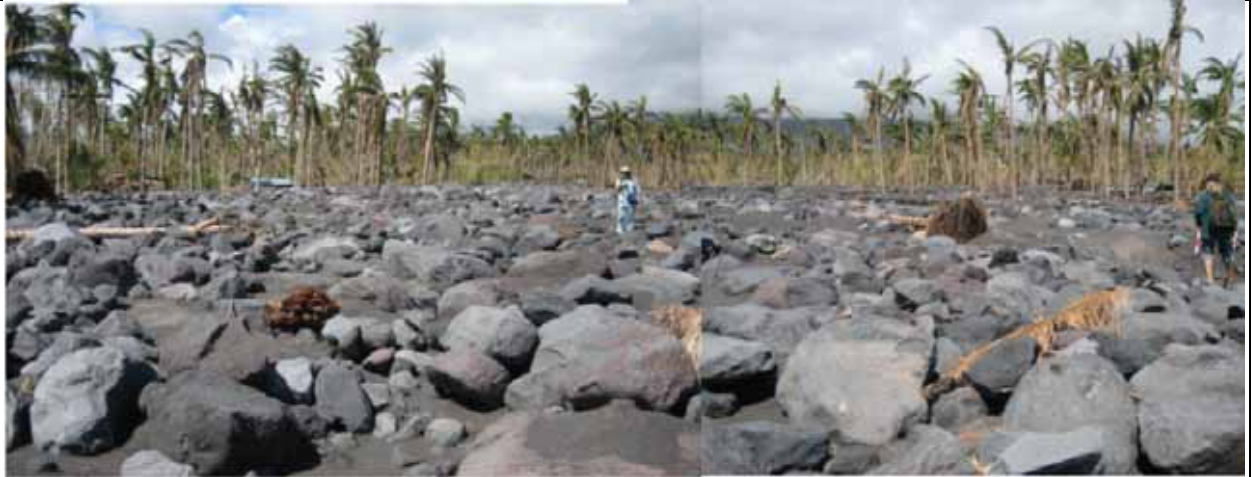
Figure 22 Wide photo of Budiao River where numerous houses were once located. Debris deposited is estimated to be 600m x 245m with boulders averaging 1.0m in diameter.

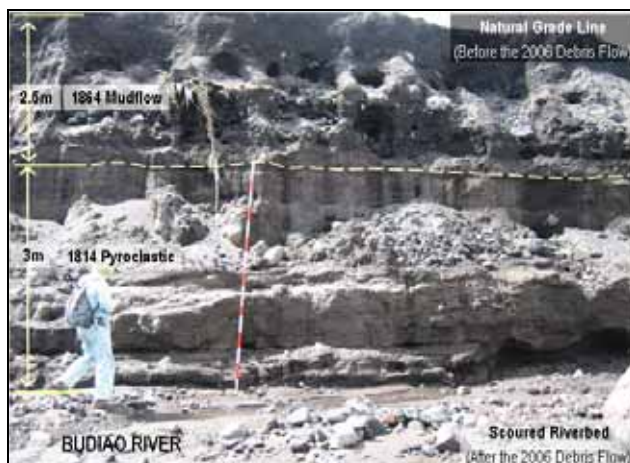
Figure 23 Section of the Budiao River in Brgy. Salvacion shows scouring depth of the riverbed and difference in lava layers as a result of volcanic activities.

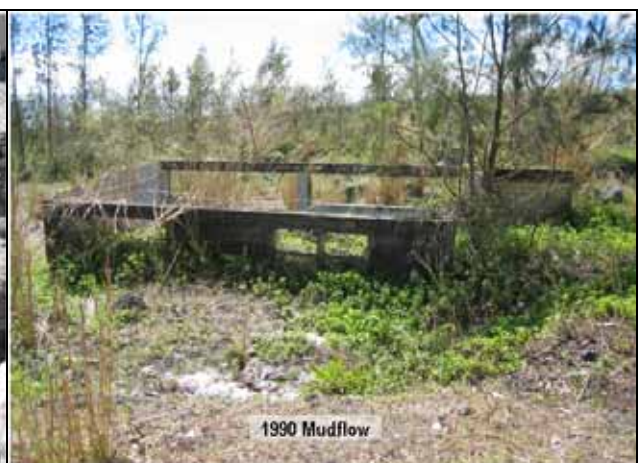
Figure 24 Brgy. Salvacion, Daraga is susceptible to debris flow, as what happened 15 years ago (1990 Debris flow) when it buried many houses.

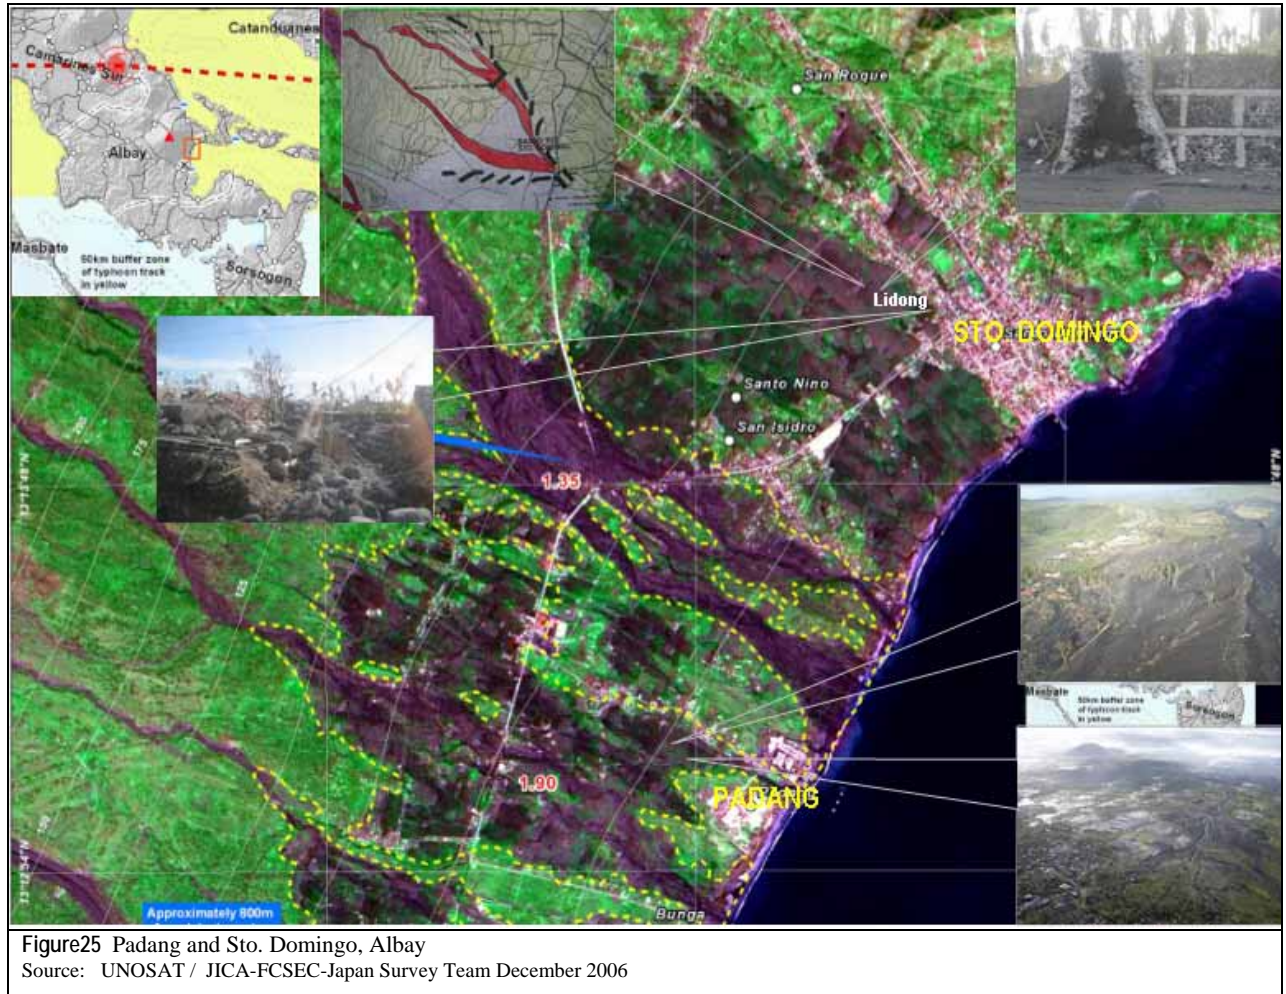
In Yawa River in Sto. Domingo, Albay, the mechanism of debris and debris flow were observed to have passed unimpeded through the breached Yawa Irrigation Dam (Width=150m), which was damaged during Typhoon Xangsane (Milenyo). The said irrigation dam is located in the southern sector of Mayon. These also affected the towns of Lidong, Sto. Niño and San Isidro.

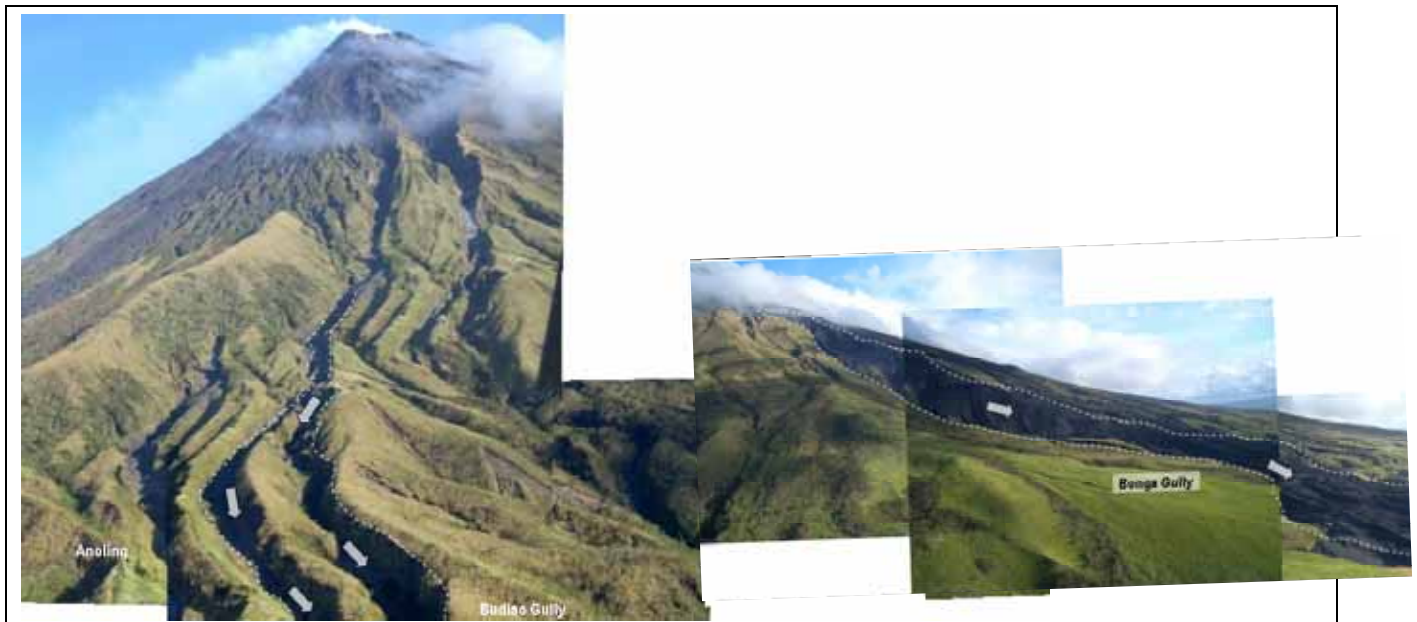
Figure26 Wide photo showing major gullies in the southeastern (SE) quadrant of Mayon where debris flow occurred, caused by high rainfall.
