FCSEC TECHNICAL REPORT

**Experiment on the Effective Arrangement of Spur
Dikes as Countermeasure Against Bank Erosion in
Agos River**

St. Bernard, Southern Leyte Landslide Field Report

Volume 2 (2nd Edition)
2007.1

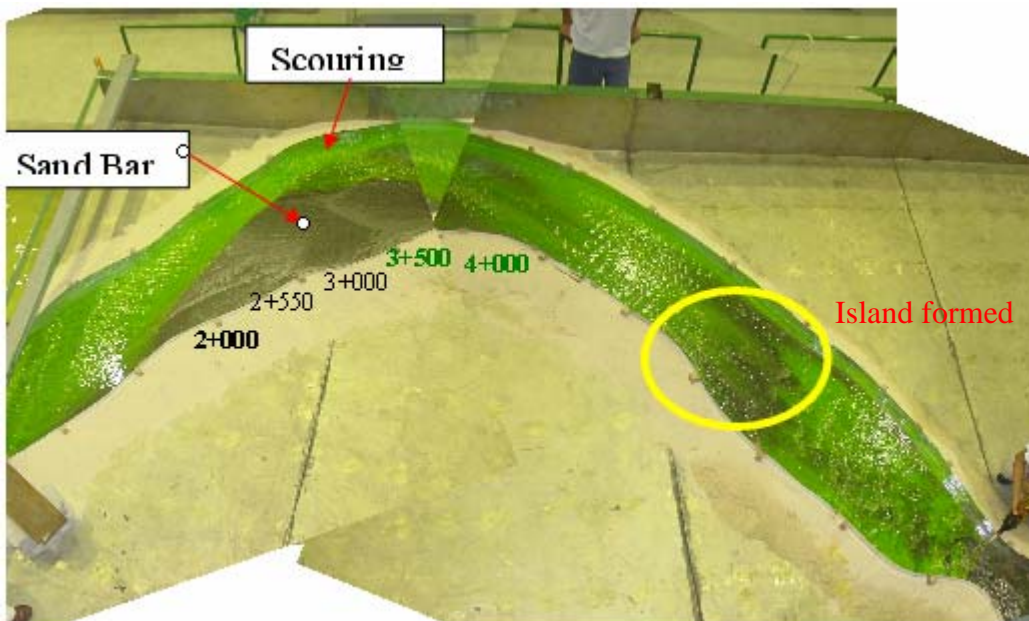
Figure 10, Preliminary Experiment

To some degree, scour and deposition pattern in the experiments replicated the prototype condition. Sand bars developed after the bridge (Sta 6+500 to 800) forming an island at the middle, see Figures 10 and 11. At stations 2+500 to 4+000, sand bars deposited at the inner bend while at the outer bend deep scour developed.

The concentration of water from sta 4+000 to sta 200 downstreamward, in green color, flowed on the outer right bank and then veered to the opposite bank. Sand bars formed on the inner bend as the outer bend scoured. Result shows similarity with the proto type bed form of Agos River, Figure 11.

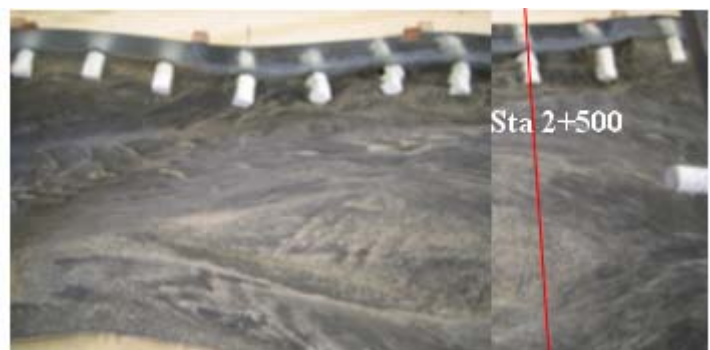
Figure 14, Deposition and Scouring Pattern Around Spur Dikes, Case 2

On the other hand, the 5 spur dikes from Sta. 3+700 to 3+000 induced sediment deposition in between them. Those upstream of sta. 4+000 were not on the high velocity flow; thus, sediment depositions were induced.

Comparing the result with case 1, the scoured portion was transferred farther downstream and the bank erosion prevention was minimal.

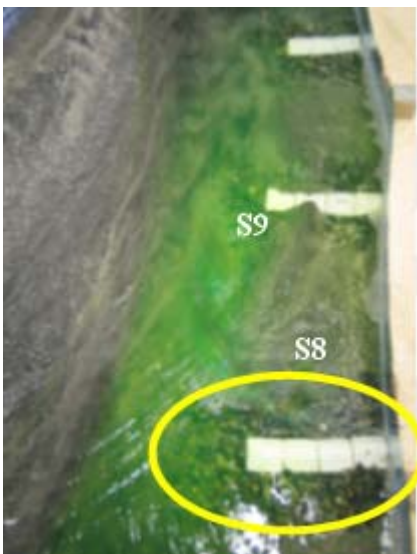
Figure 19, Effect on S8, Case 4

S8 was effective to deflect the water away from the bank; however, without added protection it was easily toppled.

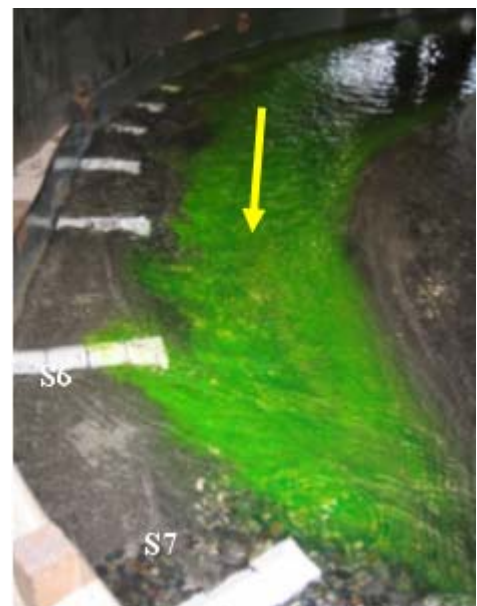
Figure 20, Flow Direction and Depositional Pattern at S6 and S8

The effect of spur dike deviated the water effectively especially from S6 to S8. Please refer to the green color on the opposite figures showing considerable distance from the river bank of the main flow.

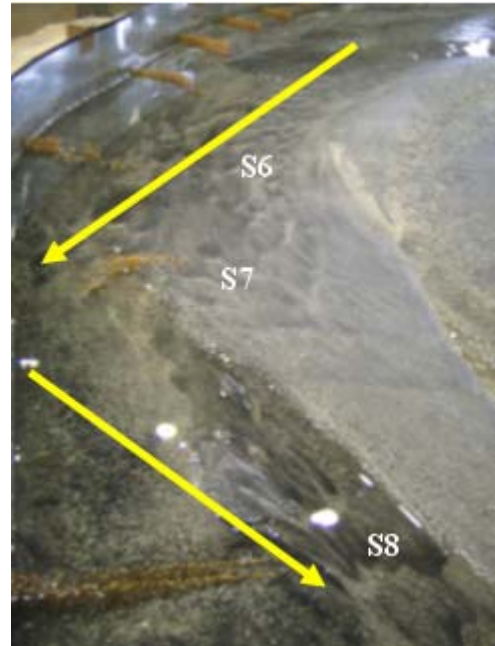
Figure 22, Effect on S6 and S7, Permeable Type Spur dike

Referring to Figure 22, in between S7 and S8, bed scour was caused by gradual removal of pile model at S7 as carried by the current. Water passed through the bigger spaces and carried the bed particles.

Given the above conditions, S8 deflected the water flow and induced sediment deposition effectively. However, the outermost piles from the bank of S8 were carried away by the flow as the bed scoured gradually until it could no longer reduce the velocity and deflect the flow. Hence, the run was terminated after 45 min.

Permeable pile spur dikes when partially damaged can lead to the damaged of the succeeding spur dikes downstream, in some cases more serious.

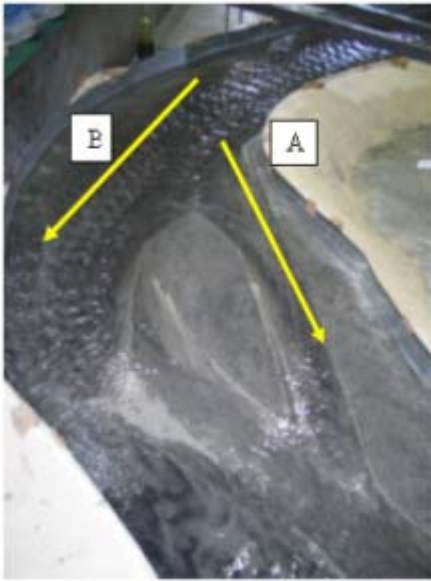
Figure 25, Flow Distribution at the Junction of Cut-off Channel

With this condition, bank erosion at the target section at the main river course could not be prevented, since volume of discharge at the cut-off channel was negligible.

The run lasted only for 40 minutes since the cut off channel became ineffective as deposition have accumulated on the bed.

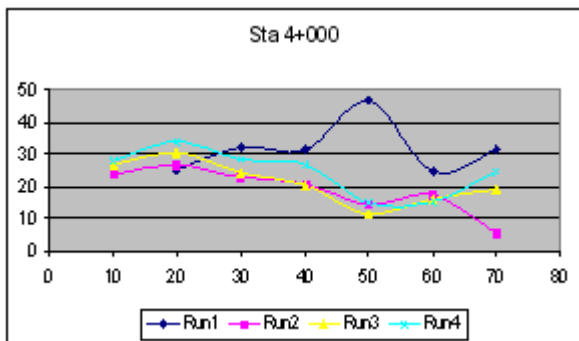
Figure 33, Velocity at Sta 4+000

Sta 4+000 was located at the beginning of the series of spur dikes. It can be noted from figure 33, that the velocity of case 1, no countermeasures case, is highest while its bed elevation is lowest at 20 cm from the right bank. The velocity from case 2 to case 4 show similar pattern, which gradually increase from 20 cm to 50 cm from the right bank.

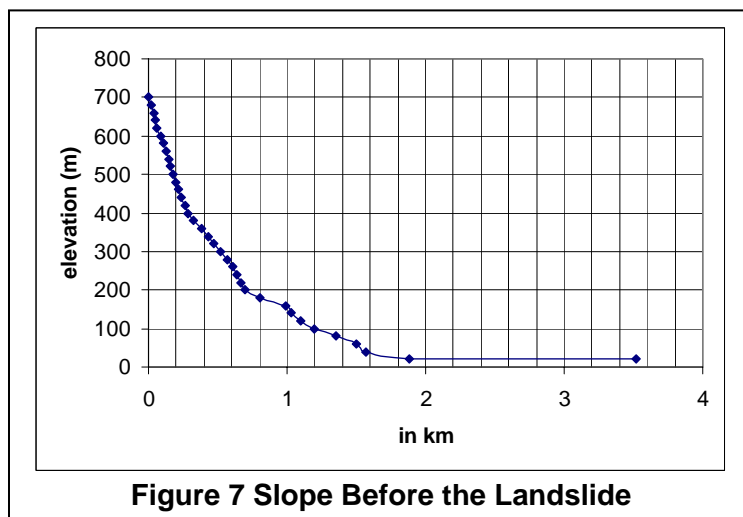
Figure 7 Slope Before the Landslide

The pre-landslide crown elevation was 700 m based on the topographic map with a

maximum slope of 45°, mostly vegetated. It consists of sedimentary rocks such as upper Miocene, Pliocene as depicted in the geological map of Mines and Geoscience Bureau. Big boulders with tuff breccia can be found in the depositional area. Collapsed soil has high fluidity which flowed down up to 3 km, horizontal distance, see .Figures 7 and 10.

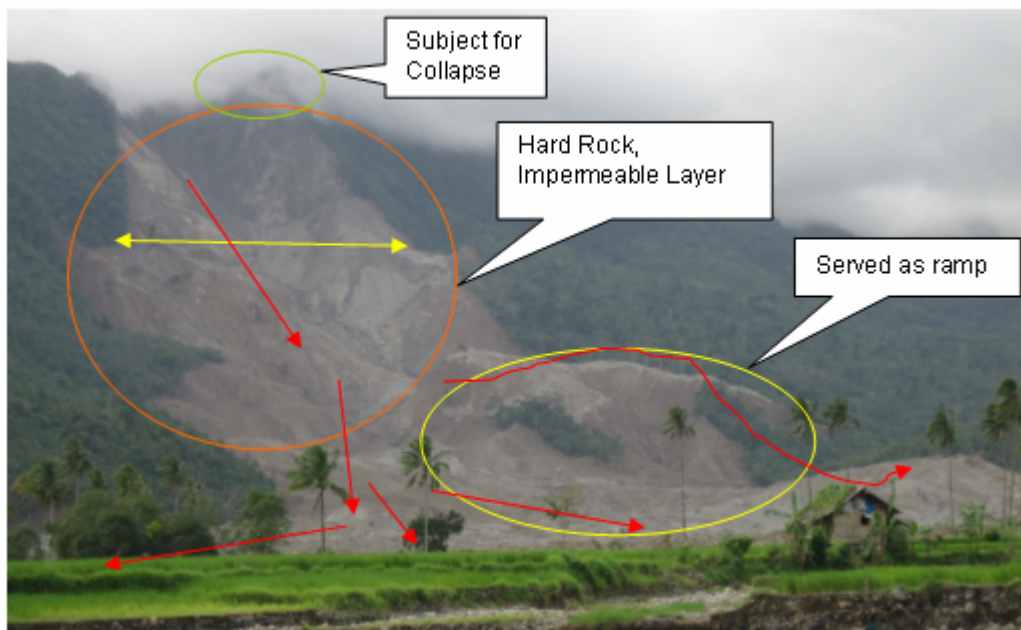
Figure 8 Aerial Perspective of the Landslide Area

Further, the distinction in land cover of the low ridge at the bottom of the mountain, please see Figure 8 in yellow circle, indicates that the collapse moved in high speed, ramped over and landed at a distance.

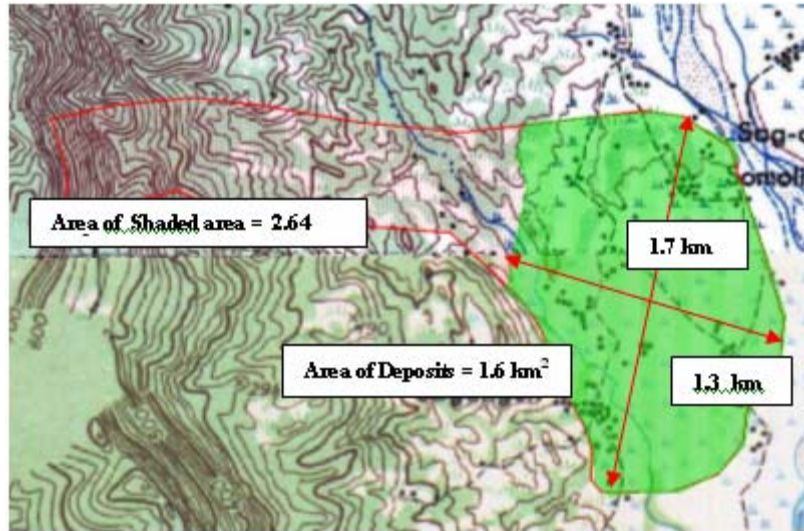
Figure 9 Overview of Sediment Deposition

The extent of slide in Figure 9, measured by handheld GPS and aerial photo from the US Army, is approximately 2.6 km², the area enclosed with red line. The depositional area, the shaded green area, is 1.6 km² reckoned from the foot of the mountain. By observation, the depth of deposition at the rim is up to 5 m, estimated from the exposed buried coconut trees and ± 10 m near the foot. If the average deposition is around 5 m, its volume is around 8 million m³ or if the average depth is as shallow as 3m, its volume is approximately 4.8 million m³, or roughly 5 million m³.

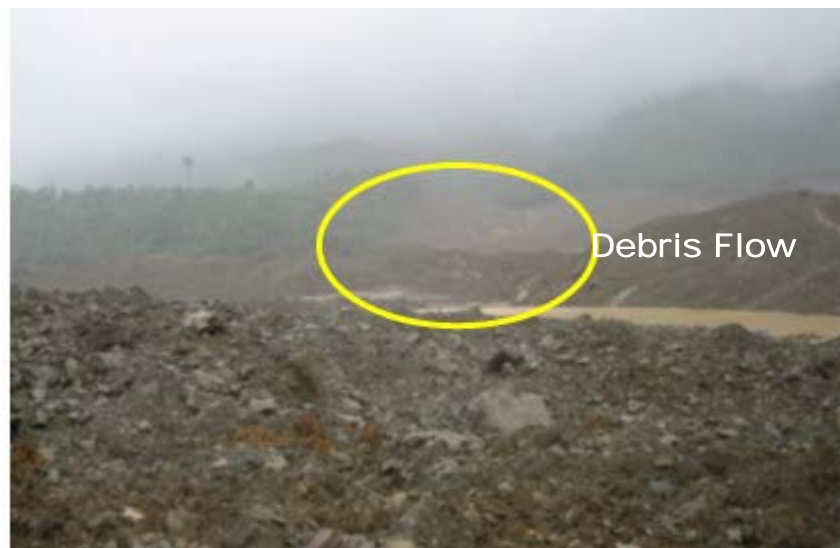
Figure 10 Surface Flow

The typical condition of the deposits was that the collapsed soil flowed down for more than a kilometer. Beyond 2 km and farther from the foot of the mountain, the slope is almost flat exhibiting high water content and high fluidity, which makes it difficult to proceed from the rim to the mid-depositional area.

Deposits are composed of fine sediment, big boulders containing gravel and tuff breccia. Near the river, materials are fractured rocks which differ from other locations.
