# GROYNE TO PREVENT RIVERBANK EROSION ON MEKONG RIVER

Hirotsada MATSUKI, Dr.Eng.

Ministry of Land, Infrastructure, Transport and Tourism (JICA Expert 1997-2000 for Laos/2013- for Vietnam)

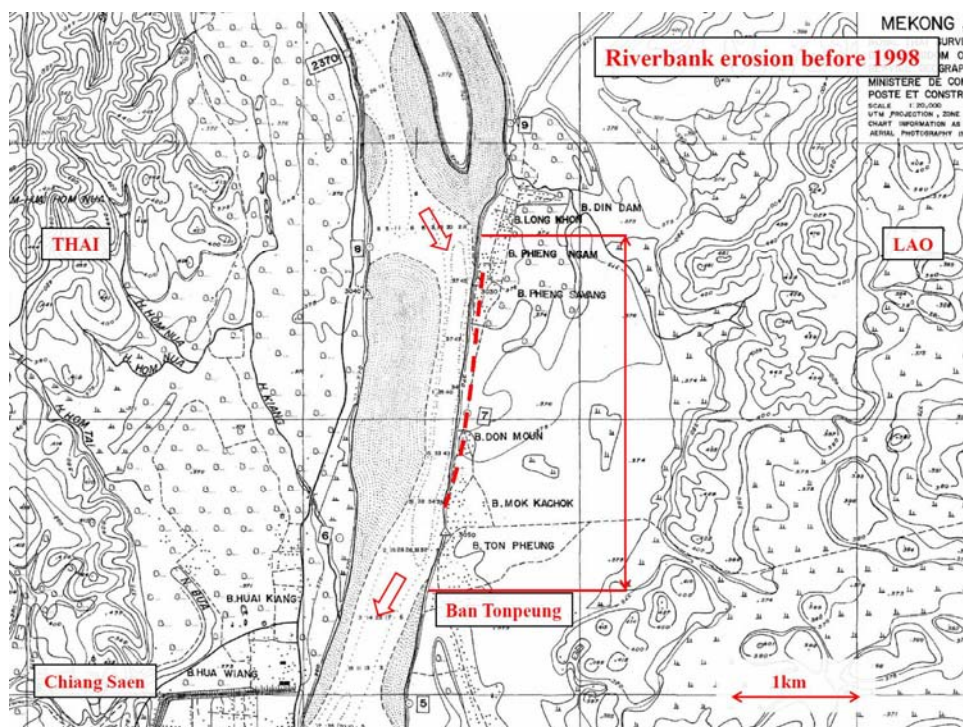
Fig.2 Erosion site in Boko province, Laos

At the opposite of the Chiang Saen, riverbank of Ban Tonpeung, Bokeo Province, Laos had been eroded severely (**Fig.2**). Lao government had a plan to open an international river port at the village, however, the riverbank was reported to step back 20 meter in 20 years. The erosion became the top-priority problem to be solved.

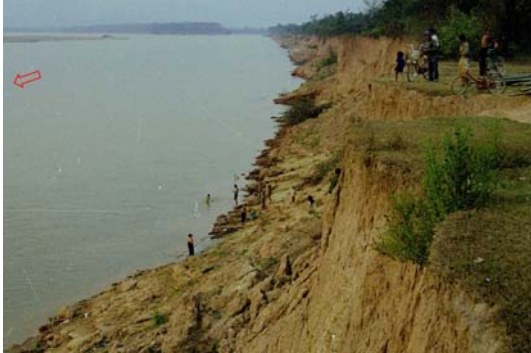
The eroded bank kept a sheer cliff of about 10 m heights with no vegetation due to half-year

submergence and soil displacement (**Photo 1**).

Photo 1 3km-long riverbank erosion (February 1998)

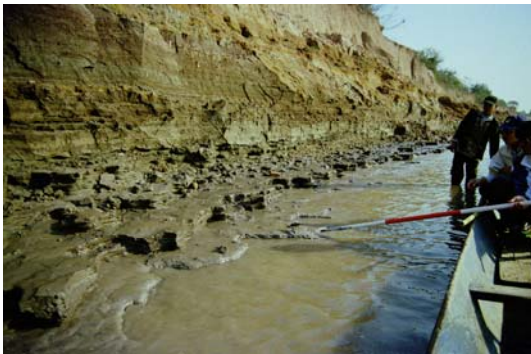
The cliff consisted of diluvial layers of laterite soil. On mudstone section, non-disturbed bedrock was not solid in wet condition enough to be scooped by a finger (**Photo 2**). Upriver cobble section was covered by 10cm diameter materials (**Photo 3**), which had come out of the diluvial layer because the tractive force is not strong to carry them form upstream. The opposite point bar of 0.1 mm fine sand covered a half of the cross section.

Photo 2 Laterized muddy rock (February 1998)

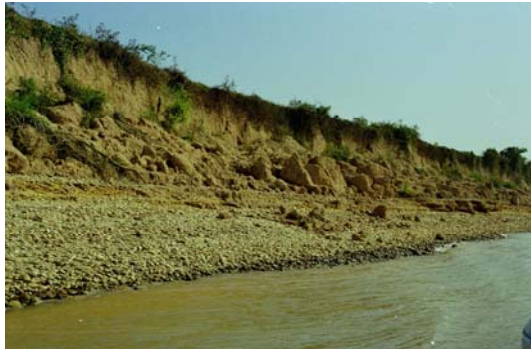
Photo 3 Cobbles on the eroded riverbank (February 1998)

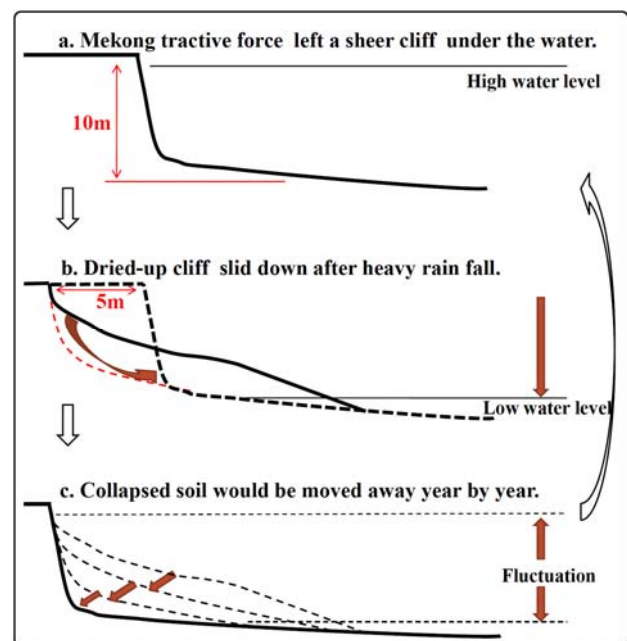
Fig. 3 Cyclic erosion in monsoonal fluctuation

The findings indicated that the progressive erosion was triggered by slip failure repeating with some return period of a couple of years. Then the author made a hypothesis of a cyclic erosion as illustrated in **Fig.3**. This could be explained as an interactive effect of the diluvial strata and dynamic fluctuation repeating the process a), b) and c).

At a concave bank of a river bend, spiraling flow washes both riverbank and riverbed. Especially in deep water of 10 meters, strong shear force removes small particles away. After repeating high-water seasons, Mekong River finally leaves a sheer 10-meter cliff of undisturbed diluvial layers under the water.

In the next low-water season, arid air dries up the cliff which keeps stability with its cohesion. In the end of the season, however, first heavy rain seeps into the cliff top and upsets the gravity balance to suddenly cause slip failures. The bank edge line steps back approximately 5 meters and collapsed bulk soil regain stability of the bank.

The bulk soil undergoes dry and wet conditions. Clumps of soil became smaller in low-water seasons and soil particles are swept away in high-water seasons. All of them are entrained little by little. After a couple of years, a 10-meter cliff will stand again at 5-meter set-back position.

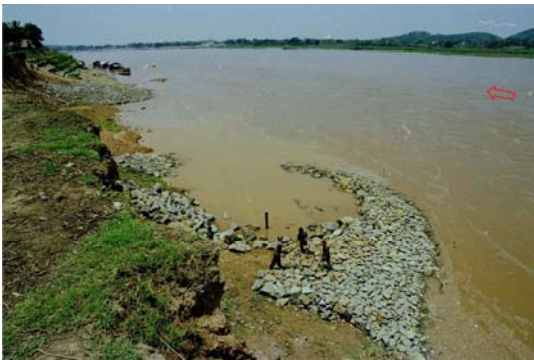
**Photo 5** No.1 and 2 masonry under construction (May 1998)

Lao government started the test construction in February 1998. The first masonry was set at 200m point from the boat stop. During the low water season, 30-70cm diameter granite transported from the hill quarry were laid out in a circle and piled up to make a 6m-high impermeable base by backhoes and workers (**Photo 5**).

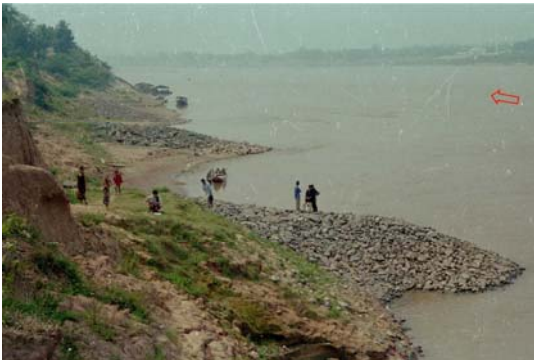
- no sinking of rock materials and no deformation on the masonry during 2 high water seasons
- initial deposition between masonries
- willow rooting naturally on the masonry No. 2
- 2-months period for 1 masonry construction
- 30,900 USD for 1 masonry, equal to 309 USD to cover 1m riverbank at an average

**Photo 6** No.1, 2, 3 and 4 masonry completed (April 2000)

4 masonries had been constructed in 3 low-water seasons by April 2000 to find following facts at the time (**Photo 6**):

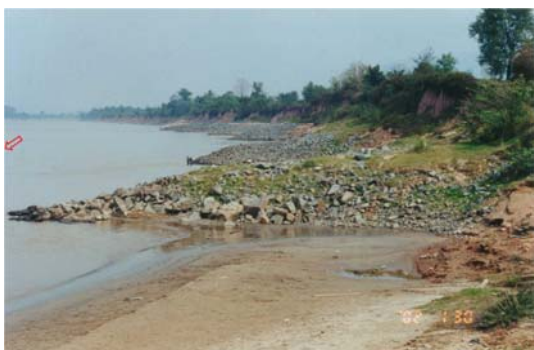
**Photo 7** Masonries and deposition (January 2002)

The result was acceptable for Lao government so that they determined to continue the groyne project. Since that, Lao engineers constructed 2-4 masonries in every low-water season (**Photo 7**) and finally 20 in 7 years. The situation in February 2010 could be checked in the satellite image (**Photo 8**).

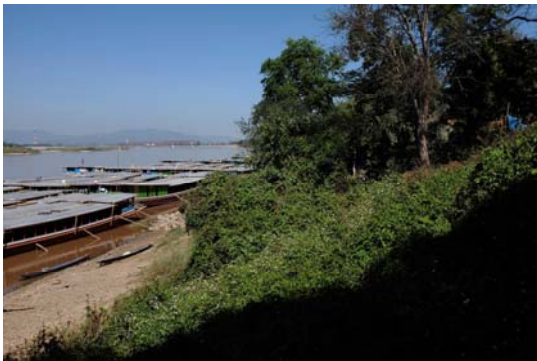
On the 20 masonries, little deformation was found and natural vegetation had been growing. No. 1 masonry, especially, was entirely veiled by green trees. The masonry was fixed by their roots and functioned as resistance of the bank (**Photo 9**). Slackwater area was created in each spacing. Thick sandy sediment covered the bank up to the

**Photo 9** No. 1 groyne concealed by vegetation (February 2014)

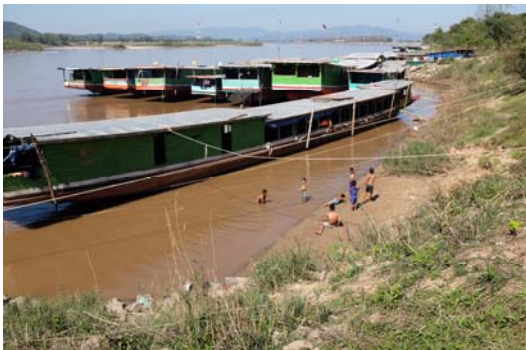
masonry's crest level and shaped a simple arc of waterline. The sediment was used in daily life of people and tips of masonries were a jetty of river boats (**Photo 10 and 11**).

**Photo 10** Deposition between No. 6-7 groynes (February 2014)

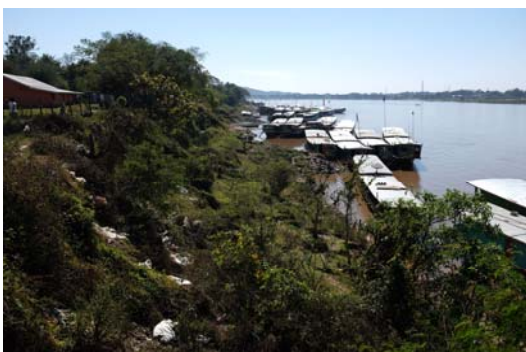
**Photo 11** Riverbank protected by groynes (February 2014)
