(Figure 1) General view of the Ajanta historic site from Viewpoint

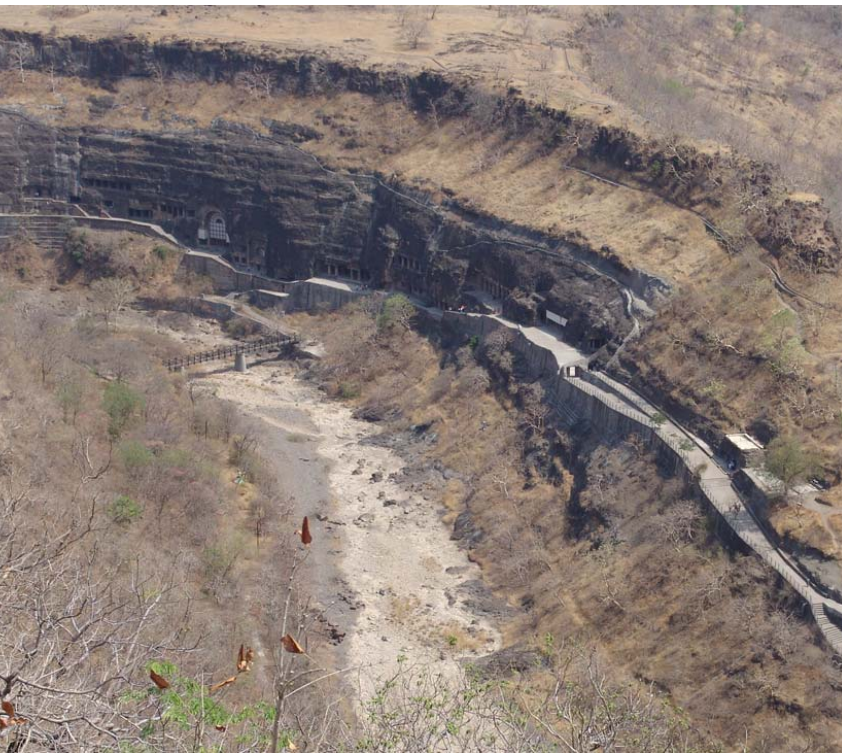
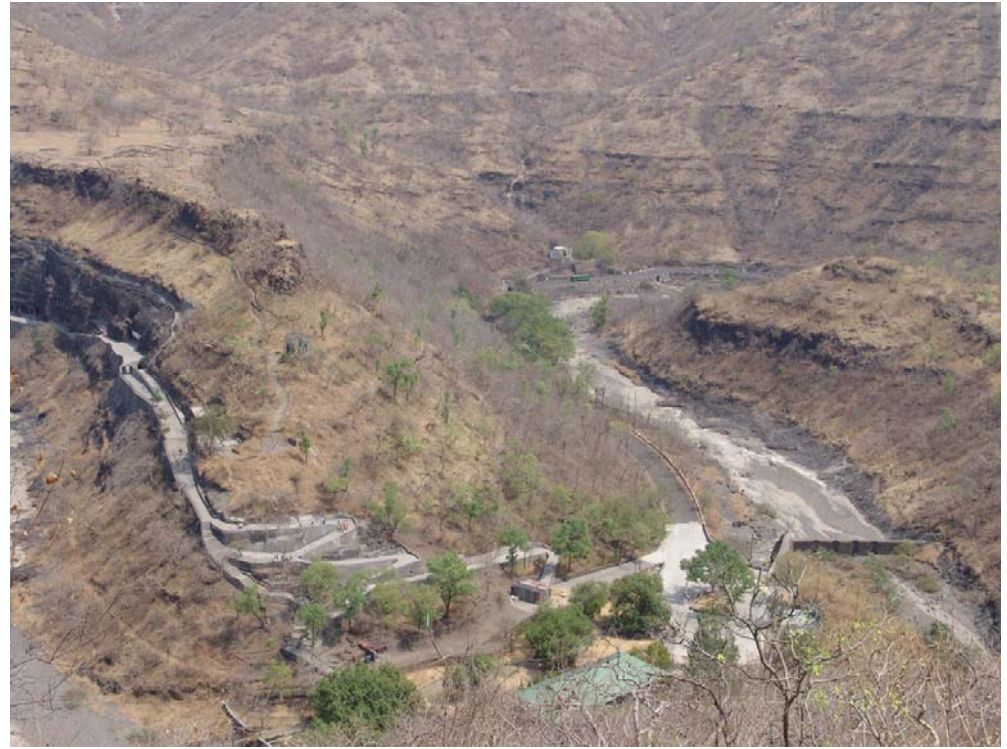
(Figure 2) Pathway construction and repair work

Ramp that was newly constructed on the slope that runs from the entrance of the historic site to the front of the caves (right) and improved and expanded pathway that runs from the top of the hill to the front of cave 7 (left)

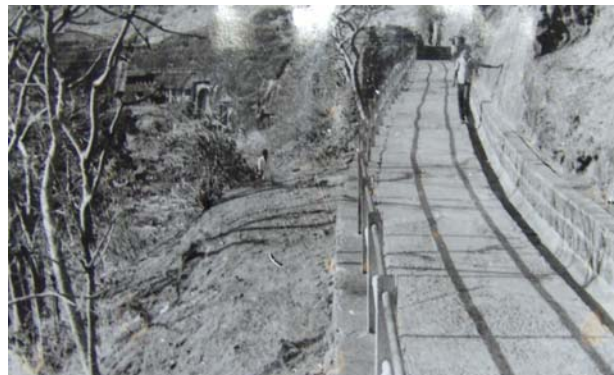
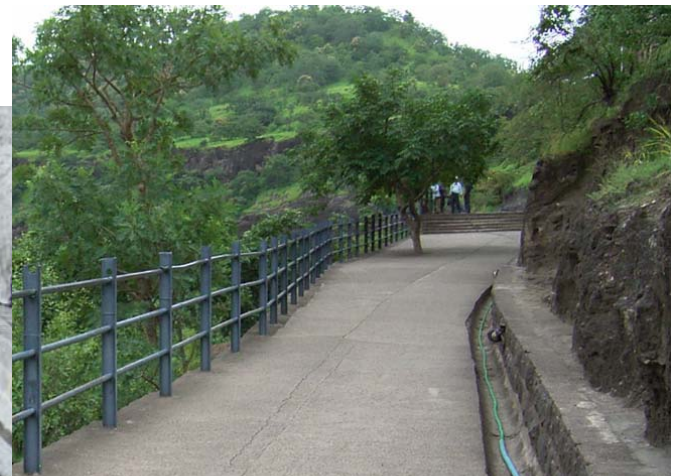
(Figure 3) Expanded pathway within the historic site (1)

Before expansion (left) and after expansion (right)

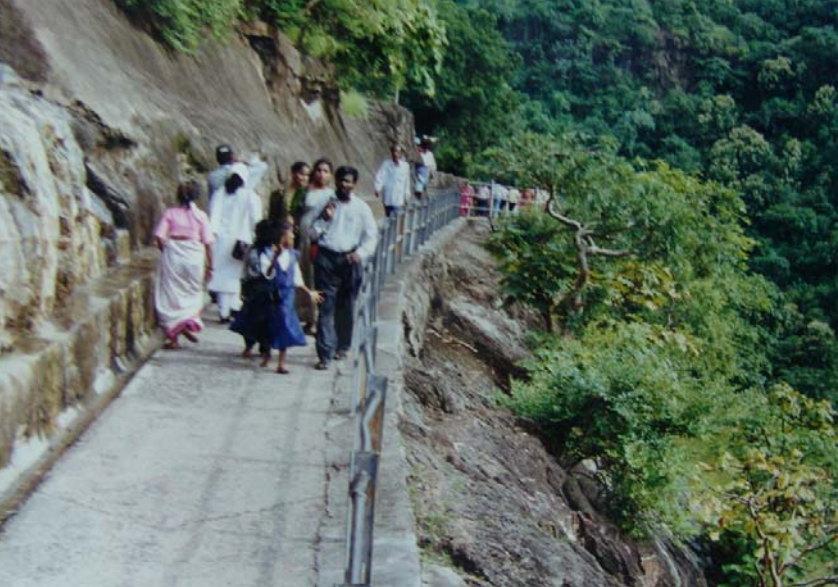
(Figure 4) Expanded pathway within the historic site (2)
Before expansion (left) and after expansion (right)

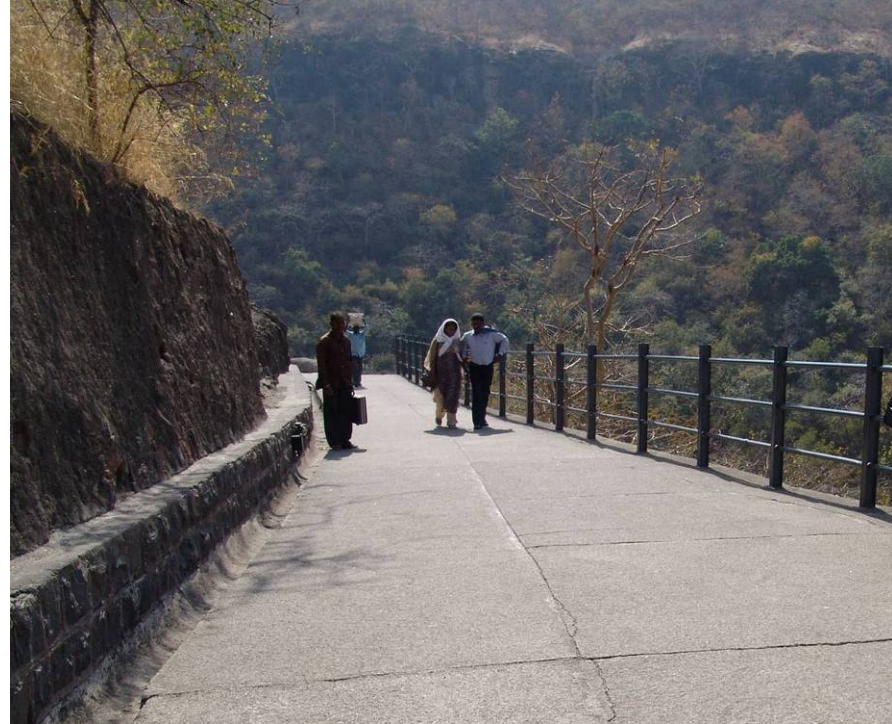
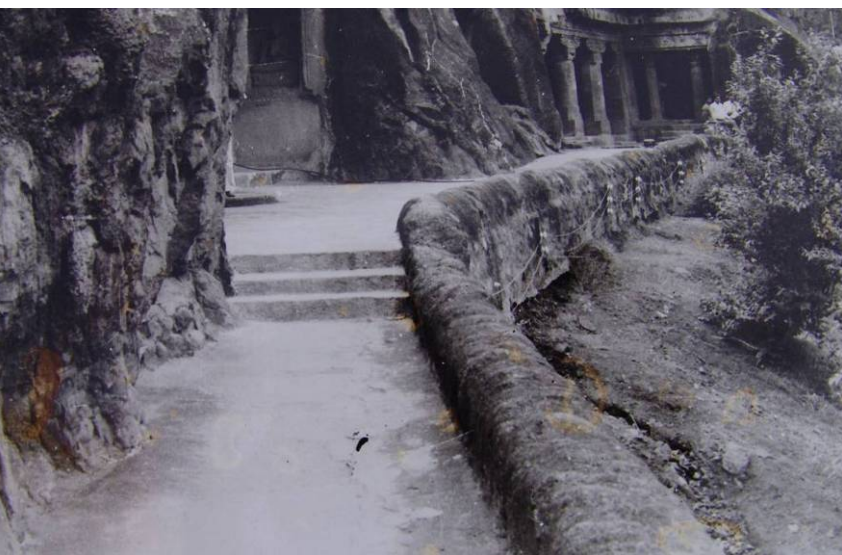
(Figure 5) Expanded pathway within the historic site (3)
Before expansion (left) and after expansion (right)
