## Session 1: Identifying the Sources of Contamination of Water Points

This session will help participants in identifying actual and potential sources of contamination of water points and provide tools for the selection of appropriate actions for avoiding water contamination at the source.

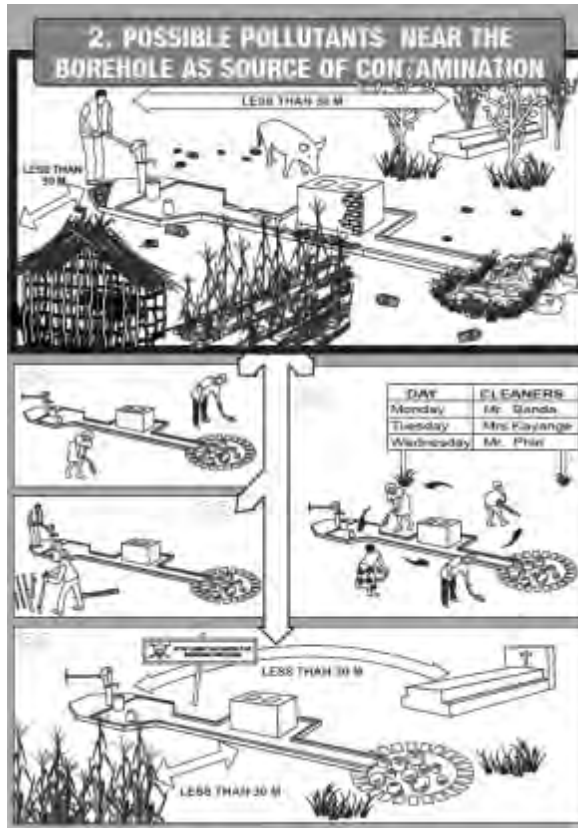
Material 2: Possible pollutants near the borehole as source of contamination

- TITLE:** Possible pollutants near the borehole as source of contamination.
- PROBLEMATIC SITUATION:** The sources of pollution (such as rubbish dumps, animal cage, feces, grazing, grave yard, cultivation) are less than 30 meters
- SOLUTION OR/AND DESIRABLE SITUATION**
  - SOLUTION 1:** Clean the rubbish dumps.
  - SOLUTION 2:** Remove animal cage, animal dung, grazing around the hand pump.
  - SOLUTION 3:** If the water points are near grave yard and cultivation is taking place, the water point should be abandoned for drinking purpose.
  - SOLUTION 4:** Make roaster among users to clean surrounding and platform.

## **Material 2: Possible pollutants near the borehole as source of contamination**

1. TITLE: Possible pollutants near the borehole as source of contamination.
2. PROBLEMATIC SITUATION: The sources of pollution (such as rubbish dumps, animal cage, feces, grazing, grave yard, cultivation) are less than 30 meters
3. SOLUTION OR/AND DESIRABLE SITUATION
  - SOLUTION 1: Clean the rubbish dumps.
  - SOLUTION 2: Remove animal cage, animal dung, grazing around the hand pump.
  - SOLUTION 3: If the water points are near grave yard and cultivation is taking place, the water point should be abandoned for drinking purpose.
  - SOLUTION 4: Make roster among users to clean surrounding and platform.

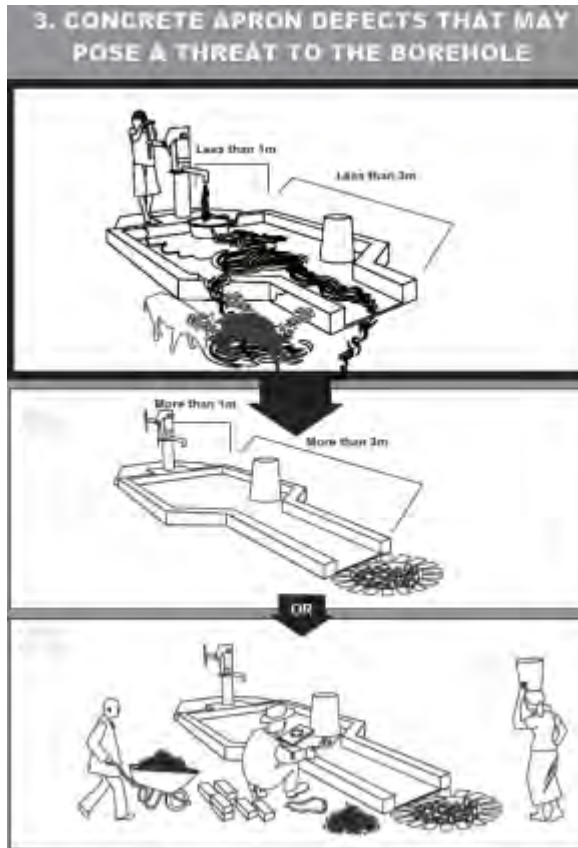
Material 3: Concrete apron defects that may pose a threat to the borehole

- TITLE:** Concrete apron defects that may pose a threat to the borehole.
- PROBLEMATIC SITUATION:** Concrete apron is less than 1 meter around the pump stand and with less than 3 meters of concrete sanitary protection with borehole or the concrete apron is broken, cracks and potholes.
- SOLUTION OR/AND DESIRABLE SITUATION**
  - SOLUTION 1:** Construct a new apron with 1 meter or more long and sanitary protection with 3 meters more long with the support of Area Mechanics and Village Builders.
  - SOLUTION 2:** Repair existing apron to remove cracks and potholes and improve slope towards drainage.

### **Material 3: Concrete apron defects that may pose a threat to the borehole**

1. TITLE: Concrete apron defects that may pose a threat to the borehole.
2. PROBLEMATIC SITUATION: Concrete apron is less than 1 meter around the pump stand and with less than 3 meters of concrete sanitary protection with borehole or the concrete apron is broken, cracks and potholes.
3. SOLUTION OR/AND DESIRABLE SITUATION
  - SOLUTION 1: Construct a new apron with 1 meter or more long and sanitary protection with 3 meters more long with the support of Area Mechanics and Village Builders.
  - SOLUTION 2: Repair existing apron to remove cracks and potholes and improve slope towards drainage.

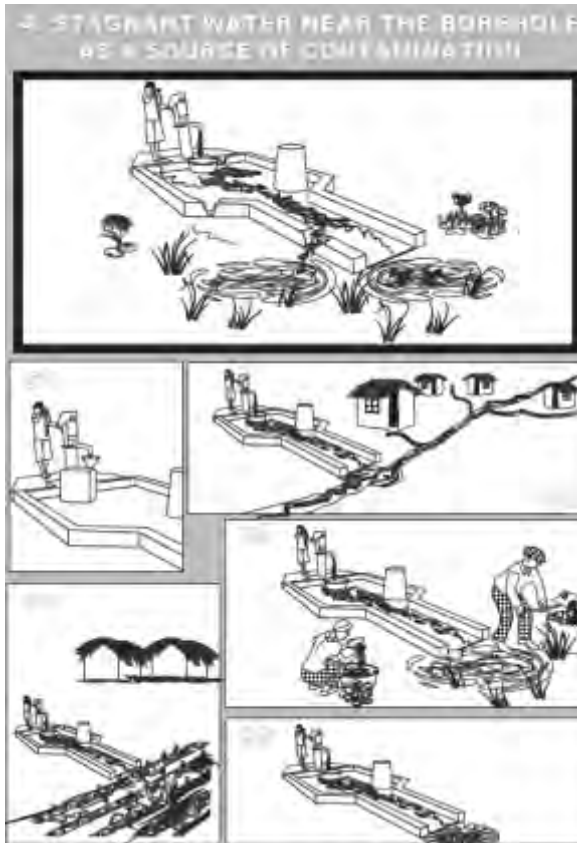
Material 4: Stagnant water near the borehole as a source of contamination

1. **TITLE:** Stagnant water near the borehole as a source of contamination.
2. **PROBLEMATIC SITUATION:** Stagnant water sources (pool of water from soak away pits, improper drainage and fish/ duck ponds) are less than 30 meters from water points.
3. **SOLUTION OR/AND DESIRABLE SITUATION**
  - **SOLUTION 1:** Use funnels when jerrycan with small mouths are being used to avoid spill over that can enhance the pool of water, waste water to be minimized.
  - **SOLUTION 2:** Improve drainage so that waste water flows into natural drainage.
  - **SOLUTION 3:** Develop vegetable garden using waste water.
  - **SOLUTION 4:** Remove litter and wash stones in a soak away pit.
  - **SOLUTION 5:** Divert the direct the direction of the soak away pit and drain off the pool of water.

#### **Material 4: Stagnant water near the borehole as a source of contamination**

1. TITLE: Stagnant water near the borehole as a source of contamination.
2. PROBLEMATIC SITUATION: Stagnant water sources (pool of water from soak away pits, improper drainage and fish/ duck ponds) are less than 30 meters from water points.
3. SOLUTION OR/AND DESIRABLE SITUATION
  - SOLUTION 1: Use funnels when jerry can with small mouths are being used to avoid spill over that can enhance the pool of water, waste water to be minimized.
  - SOLUTION 2: Improve drainage so that waste water flows into natural drainage.
  - SOLUTION 3: Develop vegetable garden using waste water.
  - SOLUTION 4: Remove litter and wash stones in a soak away pit.
  - SOLUTION 5: Divert the direction of the soak away pit and drain off the pool of water.

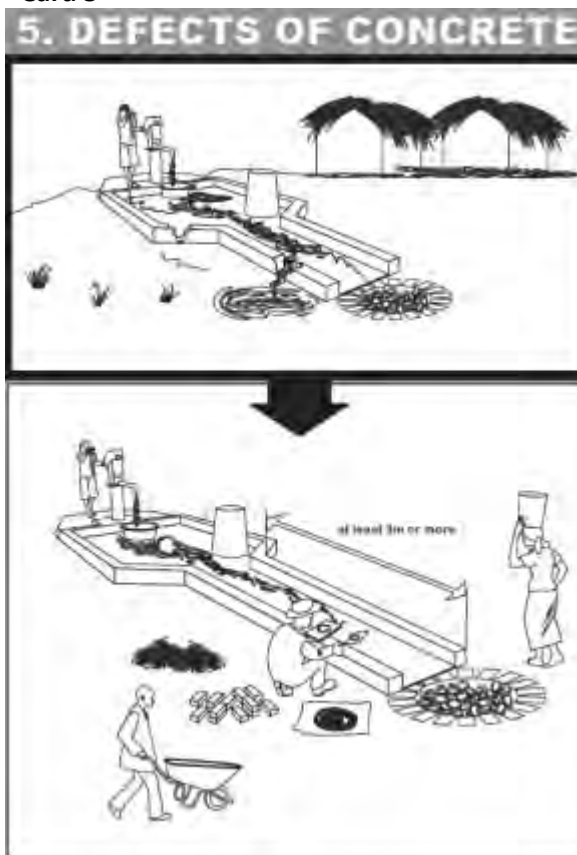
Material 5: Defects of concrete

1. **TITLE:** Defects of concrete
2. **PROBLEMATIC SITUATION:** Concrete drainage channel attached to apron is less than 3 meters long ending a soak away pit or vegetable garden.
3. **SOLUTION OR/AND DESIRABLE SITUATION**
  - **SOLUTION 1:** Improve natural drainage by lengthening it up to at least 3 meters or more or mobilize resources and extend drainage channel to at least 3 meters.

## **Material 5: Defects of concrete**

1. TITLE: Defects of concrete
2. PROBLEMATIC SITUATION: Concrete drainage channel attached to apron is less than 3 meters long ending into a soak away pit or vegetable garden.
3. SOLUTION OR/AND DESIRABLE SITUATION
  - SOLUTION 1: Improve natural drainage by lengthening it up to at least 3 meters or more or mobilize resources and extend drainage channel to at least 3 meters.

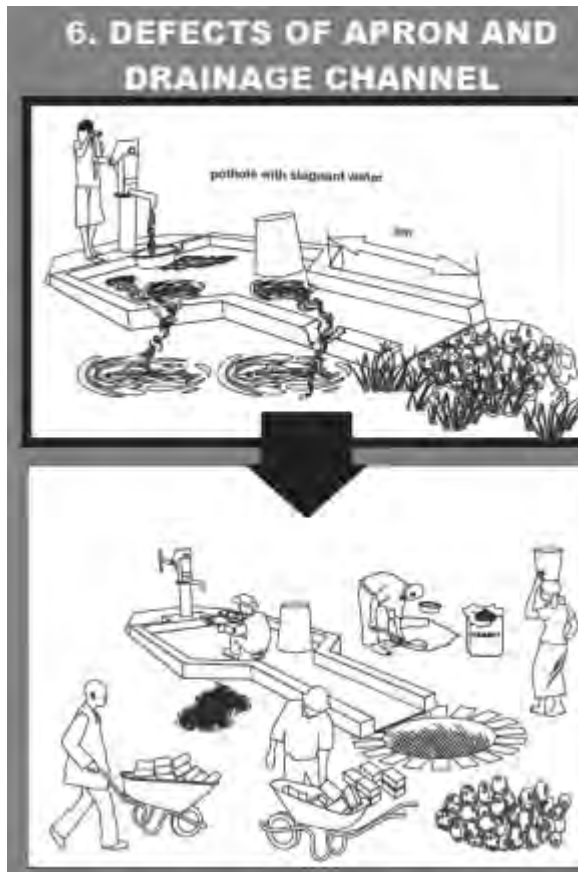
Material 6: Defects of apron and drainage channel

1. TITLE: Defects of apron and drainage channel
2. PROBLEMATIC SITUATION: Apron and 3 meters long drainage channel has cracks and pot holes with stagnant water.
3. SOLUTION OR/AND DESIRABLE SITUATION:
  - SOLUTION 1: Mobilize resources and repair the drainage and the slope of the channel.

## **Material 6: Defects of apron and drainage channel**

1. TITLE: Defects of apron and drainage channel
2. PROBLEMATIC SITUATION: Apron and 3 meters long drainage channel has cracks and pot holes with stagnant water.
3. SOLUTION OR/AND DESIRABLE SITUATION
  - SOLUTION 1: Mobilize resources and repair the drainage and the slope of the channel.

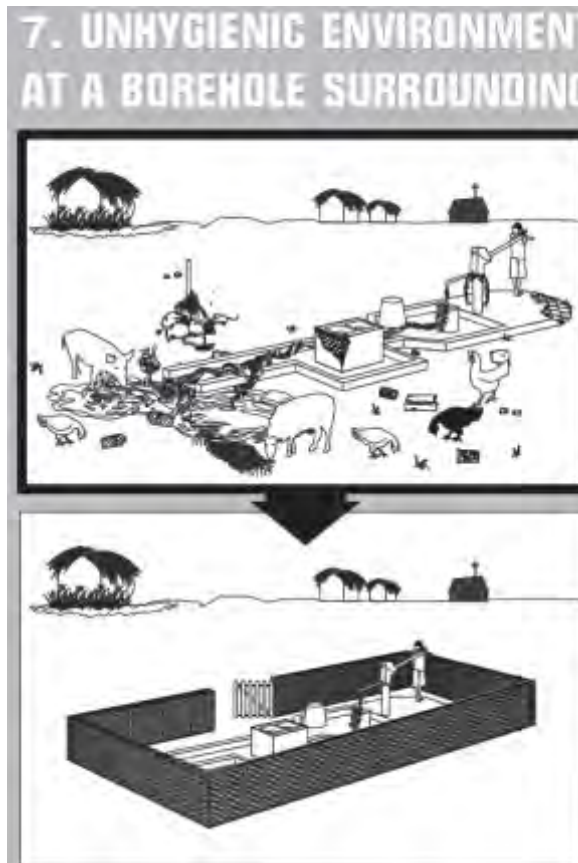
Material 7: Unhygienic environment at a borehole surrounding

1. TITLE: Unhygienic environment at a borehole surrounding
2. PROBLEMATIC SITUATION: General surrounding of a borehole is unhygienic (borehole untidy / dirty grown up grasses, shrubs/ vegetation).
3. SOLUTION OR/AND DESIRABLE SITUATION:
  - SOLUTION 1: A tidy / clean borehole surrounding.

## **Material 7: Unhygienic environment at a borehole surrounding**

1. TITLE: Unhygienic environment at a borehole surrounding
2. PROBLEMATIC SITUATION: General surrounding of a borehole is unhygienic (borehole untidy / dirty grown up grasses, shrubs/ vegetation).
3. SOLUTION OR/AND DESIRABLE SITUATION
  - SOLUTION 1: A tidy / clean borehole surrounding.

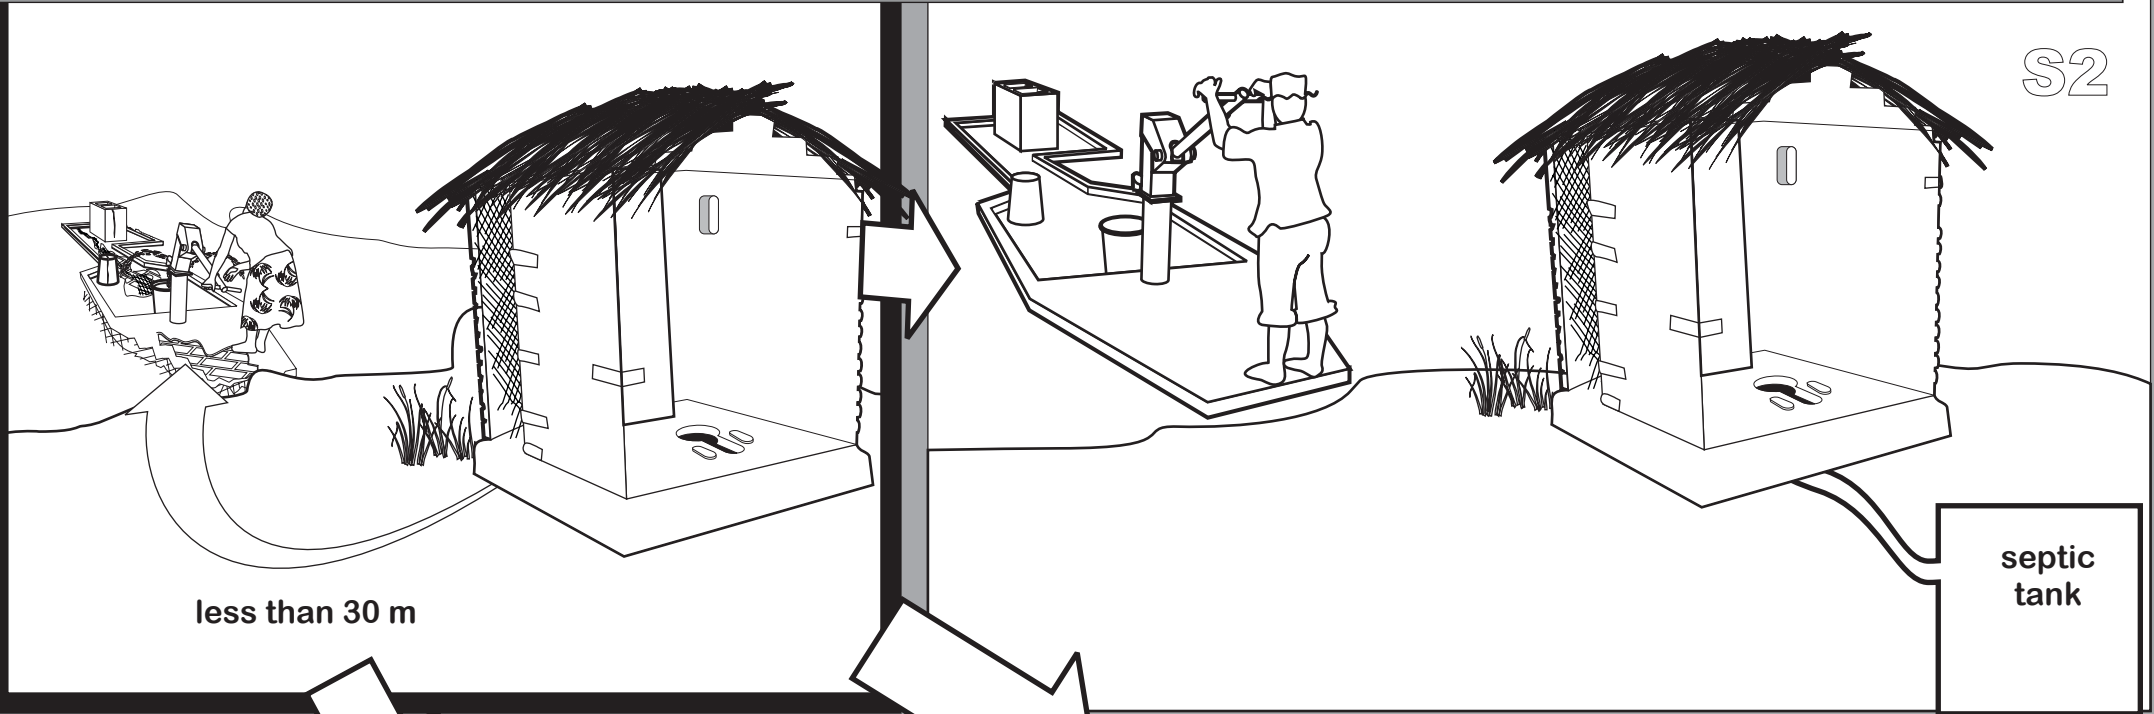
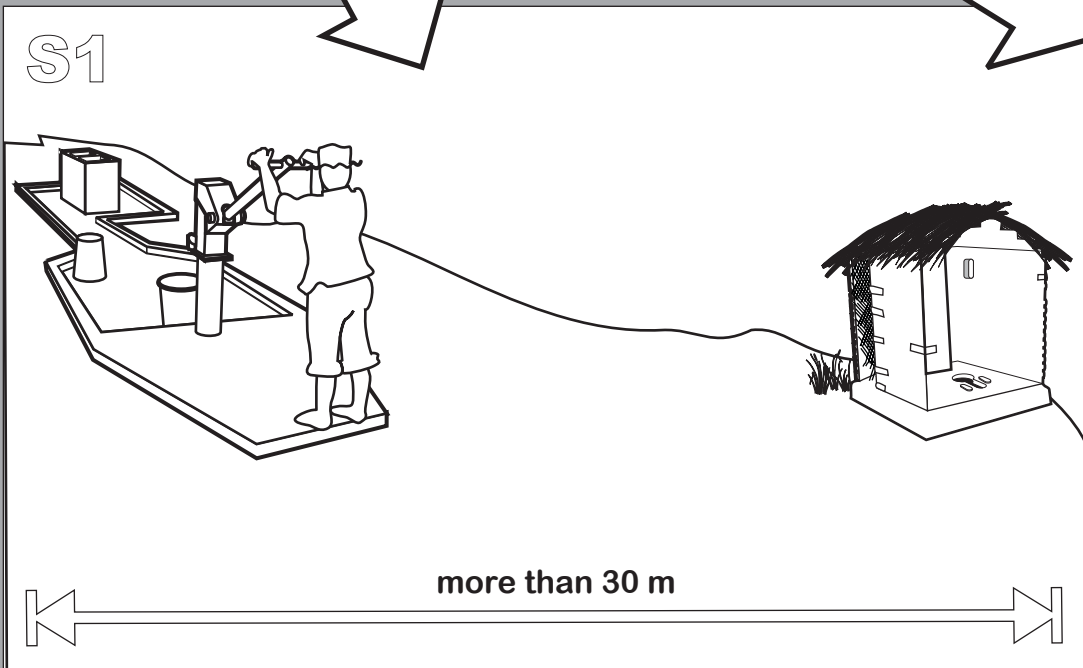
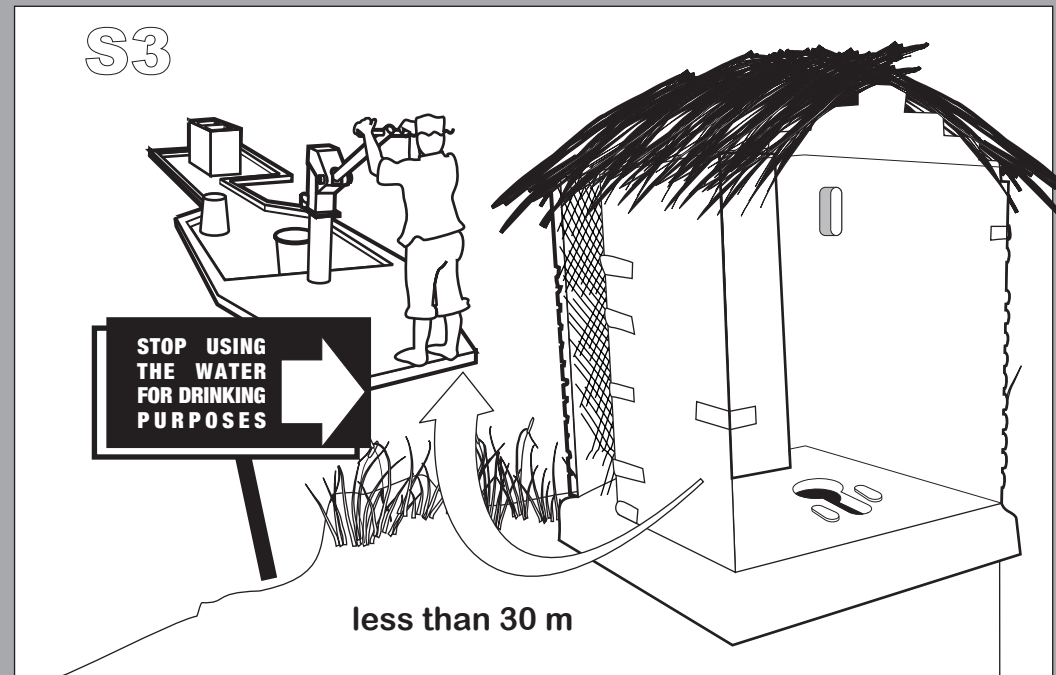
# 1. A LATRINE NEAR A BOREHOLE AS SOURCE OF CONTAMINATION

**Material 1: A latrine near a borehole as source of contamination.**

1. TITLE: A latrine near a borehole as source of contamination.
2. PROBLEMATIC SITUATION: Nearest latrine is less than 30 meters and is on higher ground than water point.
3. SOLUTION OR/AND DESIRABLE SITUATION
  - SOLUTION 1: Stop using the latrine and relocate it at a safe distance
  - SOLUTION 2: If latrine cannot be relocated, construct a latrine with a septic tank.
  - SOLUTION 3: If latrine cannot be relocated and septic tank cannot be constructed for any reason, the water point should be abandoned for drinking purpose.

Material 1: A latrine near a borehole as source of contamination.

- TITLE:** A latrine near a borehole as source of contamination.
- PROBLEMATIC SITUATION:** Nearest latrine is less than 30 meters and is on higher ground than water point.
- SOLUTION OR/AND DESIRABLE SITUATION**
  - > **SOLUTION 1:** Stop using the latrine and relocate it at a safe distance
  - > **SOLUTION 2:** If latrine cannot be relocated, construct a latrine with a septic tank.
  - > **SOLUTION 3:** If latrine cannot be relocated and septic tank cannot be constructed for any reason, the water point should be abandoned for drinking purpose.
