THE PROJECT FOR STRENGTHENING CAPACITY IN NON-REVENUE WATER REDUCTION IN PALAU

- CAPACITY DEVELOPMENT FOR ACTIVITIES AIMED AT SUSTAINABILITY AND WORK EFFICIENCY -

Japan International
Cooperation Agency

Palau Public Utilities
Corporation

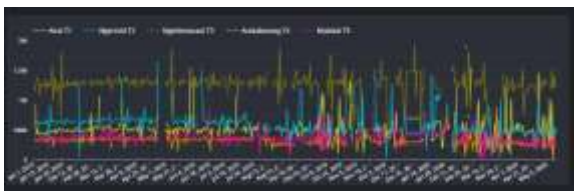
Figure 10 Flow Trend Graph with Upper and Lower Limits to eliminate Reading Errors

However, numerous errors occurred during flow rate readings, rendering them unanalyzable. To eliminate these errors, JET set upper and lower limits for each reservoir and structured the data to minimize reading errors. The results are shown in

Figure 10. Additionally, all the staff now have the ability to timely monitor the water distribution flow rate trend. Furthermore, NRW rate for the five water distribution areas has been graphed monthly by PPUC.

Following the introduction of Google Looker Studio, the PPUC staff gained the ability to swiftly identify fluctuations in water distribution flow rate. This allowed them to discern whether these fluctuations resulted from incorrect readings, water leaks, or sudden customer usage. As a result, accurate calculations for the distributed water volume can now be made by rectifying the readings. Additionally, in cases where water leaks are the cause, PPUC can promptly take action to address them.

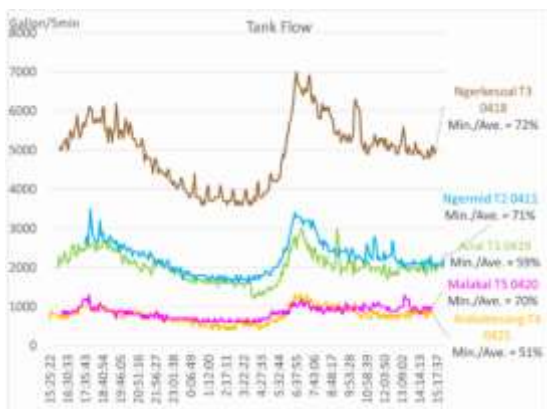
Figure 11 Rate of MNF to Water Distribution Flow

To learn the ratio of MNF to the average daily water supply flow, the Project Team used mechanical flow meters to verify daily flow rate trends in each reservoir. Figure 11 presents the recorded water distribution flow rates across all water distribution areas. The “Minimum / Average” ratio exceeds 50% (as of April 2022) in all the water distribution areas. In contrast, Japan maintains a “minimum/average” ratio of 16%. This discrepancy suggests that in Palau, substantial water flow occurs from distribution reservoirs even during MNF. The likely cause is water leakage as long as there are no high-water-consuming customers during nighttime hours.

Figure 11 reveals that the Koror-Airai water distribution system exhibits high MNF. In light of this, the Project Team discussed the potential water leakage. To gain insights into the actual water usage, the Project Team specifically focused on nighttime consumption by large customers.

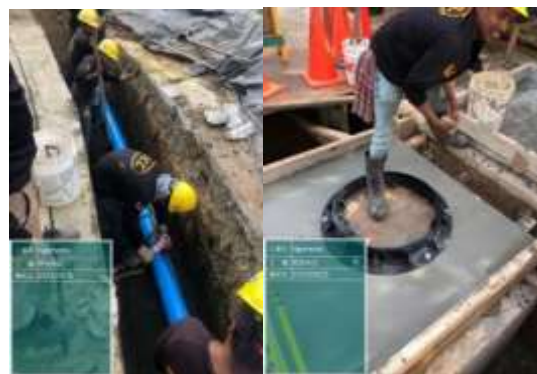
Figure 12 Pilot Construction (Pipe Renewal)

In terms of construction, approximately 140 meters of AC pipelines were replaced, and 19 out of 24 water meters which did not meet accuracy standards, were also replaced (see Figure 12).

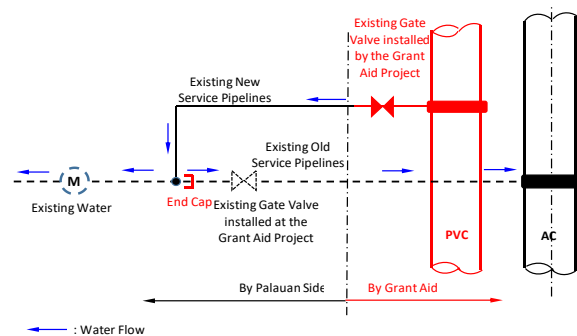
Figure 14 Back-flow

A field survey was carried out to assess the progress of pipeline switching work. The findings revealed that one of the contributing factors to the persistent NRW in the Koror-Airai water distribution area is the occurrence of backflow. Despite pipeline renewal, there are specific locations where water flows from the new pipeline back into the old pipeline. This issue was identified during the survey (see Figure 14). Subsequently, the Project Team discussed to develop a systematic approach for preventing backflow.

To prevent backflow from the new pipe to the old pipe, which could contribute to an increase in NRW, PPUC has undergone training on reliable pipe switching techniques, as illustrated in Figure 20. By understanding the precise locations where valves should be opened and closed on the water supply pipes, PPUC was able to verify and take necessary action along routes where pipelines have been updated. It is anticipated that performing reliable switching over will steadily highlight the effects of renewing water distribution pipelines.

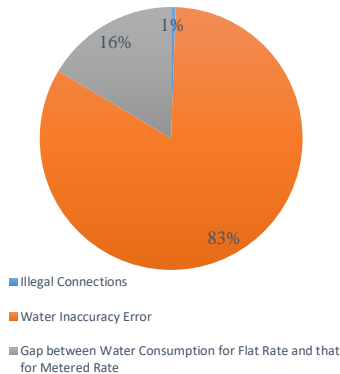
Figure 16 Breakdown of Commercial Loss

The Project Team conducted a survey on illegal connections, metering errors, and commercial losses resulting from the flat-rate tariff system in the Koror-Airai water distribution system. The findings are presented in Figures 16. Metering errors made up about 80% of total commercial loss.

Ratio of commercial loss to daily average water distribution flow was less than 10 %.

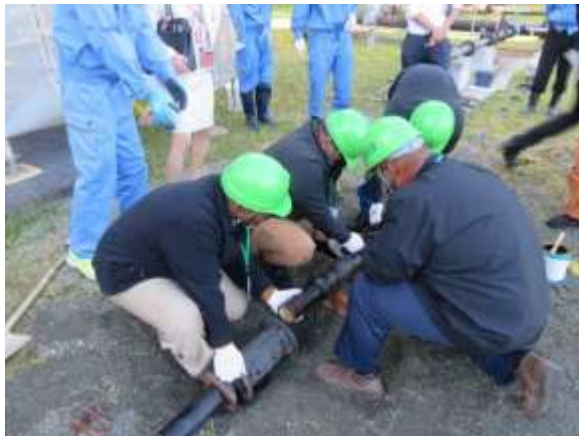
Figure 18 Artificial Leak Occurrence by pressurized Water and Plumbing at Takano Water Treatment Plan, Mie Prefecture

In addition to training focused on water leak detection, pipeline renewal, addressing commercial losses, and various construction experiences in Palau (see Figure 18), trainees also gained knowledge related to general NRW reduction measures and water supply service operations in Japan. A training session aimed at providing useful insights on future NRW reduction operation was conducted for the five PPUC staff from October

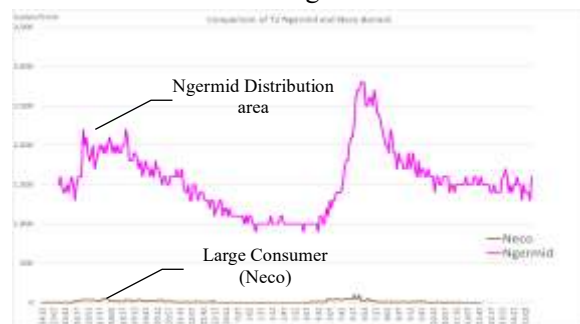
Figure 19 Daily Water Distribution Flow and Water Consumption of Large Consumer

Figure 19 illustrates the water distribution flow in the Ngermid water distribution area, alongside the MNF for a major customer (Neco). Notably, the MNF associated with large customers is remarkably low, suggesting that their impact on the overall MNF is minimal. However, this also raises the possibility of water leakage. From this aspect, PPUC officials are committed to further survey, including assessing water use by other large customers and scrutinizing MNF within the water

distribution area and to pinpoint the root cause of the leak.

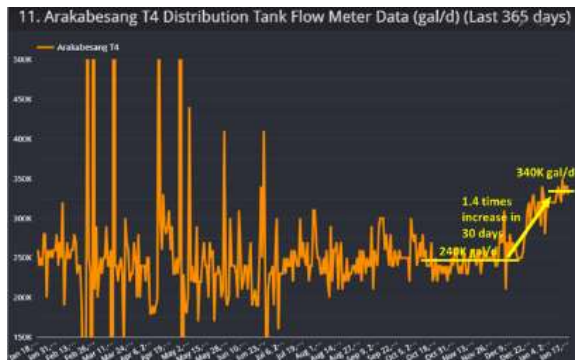
Figure 22 Annual Distributed Water at Arakabesang Service Tank

Notably, a sudden surge occurred, with the water distribution flow rate reaching approximately 1.4 times the usual level within a month as highlighted in yellow line in Figure 22.

Subsequently, PPUC conducted a MNF survey, revealing an increase in the MNF compared to previous MNF measurements and identified the leak location through leak detection and promptly repaired it. These proactive measures significantly contributed to the reduction of NRW.

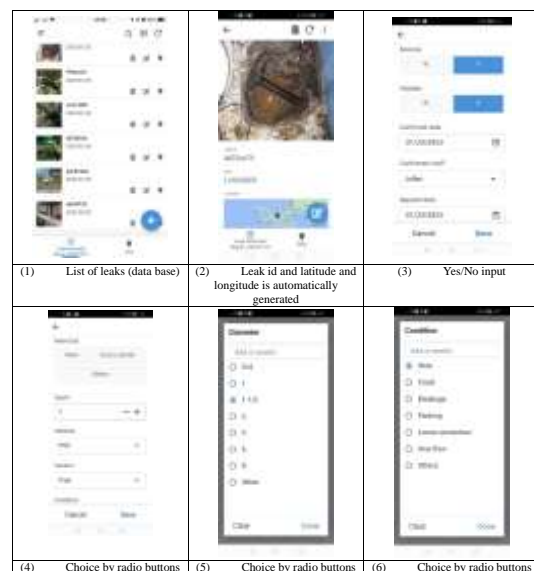
Figure 24 Input Display of Google Appsheet

Furthermore, to ensure the efficiency and sustainability of water leak detection activities, the water leak detection manual mandates the use of Google AppSheet for developing a database of water leak records. This step further strengthened the water leak detection capabilities (see Figure 24).
