Environmental Equipment Project for Power Plants

Report Date: September 2002
Field Survey: June 2001

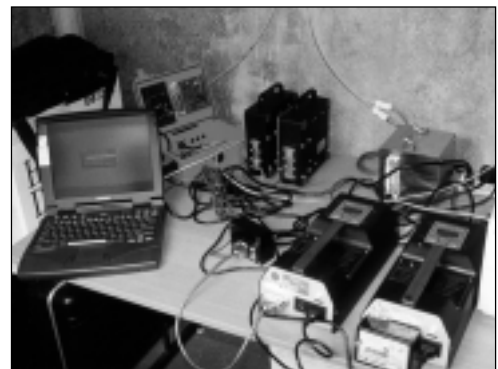
Figure-1: Ambient H₂S Monitoring System

Under the project, 6 sets of ambient H₂S monitoring systems were procured for the Bac- Man, Tongonan and Palinpinon geothermal power stations (2 sets each). Originally, NPC intended to procure continuous-type equipment to comply with DENR's requirement. As mentioned before, however, non-continuous-type equipment was procured owing to the high actual tender price. As of now, all H₂S analyzers are in good operational condition. On the other hand, of 6 attached data loggers, 3 units are out of order. Thus, monitoring results are recorded manually.

Problems regarding maintenance also exist in the calibration of equipment. An ambient H₂S analyzer requires calibration every six months to maintain the accuracy of monitoring results. Since special equipment is needed, NPC has to send the equipment requiring adjustment to a branch of the supplier in

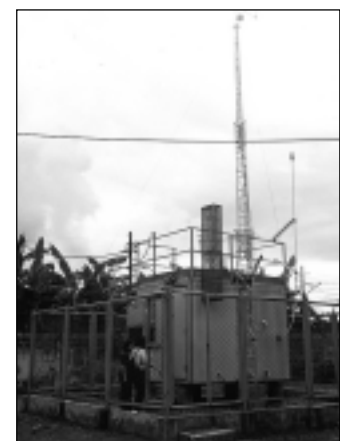
Figure-2: MET Instrument

Under the project, 10 sets of meteorological monitoring instruments (MET instruments) were procured. Nine of the sets were installed within the sites of NPC-owned power stations. Each instrument is equipped with a

wind speed/ direction sensor, a temperature/ humidity sensor, a solar radiation sensor and a barometric pressure gauge. All meteorological data being monitored are recorded in the computerized data logger and illustrated in a diagrammed display.

One set, procured for NPC's hydrology service department, has not been utilized. Instead, it is stored in NPC's warehouse, because the department has curtailed its activities (details will be provided in a subsequent section). The remaining 9 sets were installed in thermal/ geothermal power stations. From the start, the equipment had many problems. NPC-EMD asked the local office of the original supplier to repair the problematic equipment^{*6} whenever there was a problem. As of February 2002, all the equipment was working satisfactorily.

⁶ For example, two of METs (meteorological monitoring instruments) installed in geothermal power stations were partially corroded owing to acid gas, which was naturally produced from the field, and two were damaged because of extreme high temperature, occasionally reached 50 degrees Celsius in a housing unit resulting from an air conditioner outage. During the warranty period (within one year after installation), all problems were fixed by original supplier for free

*NPC has repaired problematic facilities with the help of the original suppliers. To illustrate, regarding METs, all of these equipments were successfully repaired by the original supplier by February 2002.

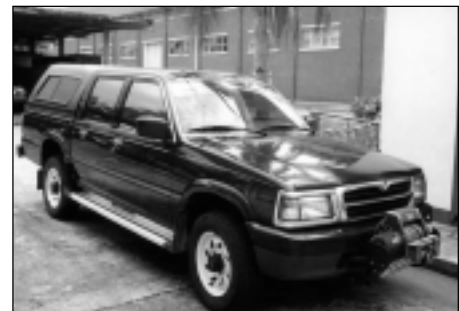
Figure-3: Field Monitoring Vehicle

Under the project, 6 cars were procured for conveying monitoring equipment to the monitoring sites. The cars are usually parked at one of five locations: the Northern Luzon Regional Center, the Southern Luzon Regional Center, the Visayas Regional Center, NPC head office (EMD) and the Bataan thermal power station. As the need arises, the cars convey removable-type monitoring equipment -- including stack sampling equipment, noise level meter and water quality monitors -- to existing power stations or to the proposed site of a power station. At the time of site survey, one car, not being used because of engine trouble, was awaiting repair. That exception aside, the procured cars have successfully contributed to monitoring activities and have suffered no mechanical difficulties.
