# THE PROJECT FOR STRENGTHENING ADDIS ABABA WATER AND SEWERAGE AUTHORITY'S MANAGEMENT CAPACITY OF NON-REVENUE WATER REDUCTION IN FEDERAL DEMOCRATIC REPUBLIC OF ETHIOPIA

February 2023

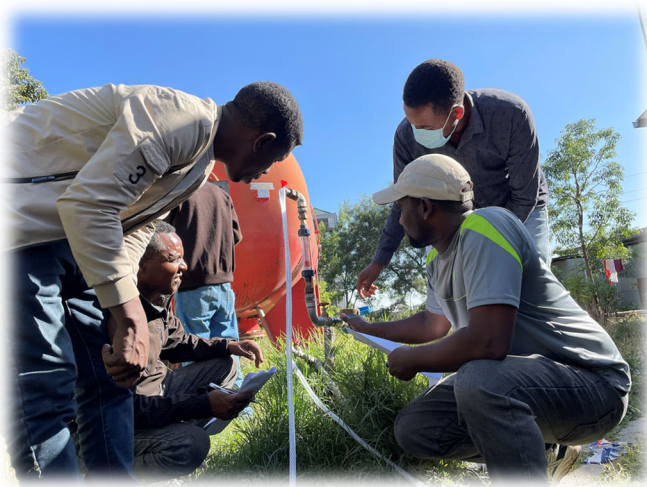
Training on the Use of Meter Instrument Error Test Equipment.

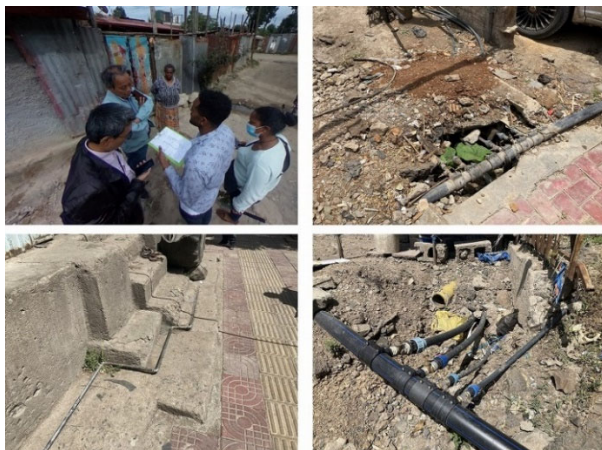
**Photo 1 Situation of exposed piping and spaghetti pipes**

As shown in Photo 1, exposed and sbageti pipes were found, and the situation was identified to have many issues.

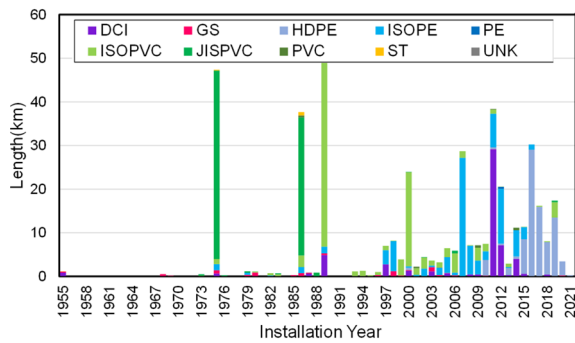
**Figure 8 Length of pipeline by installation year and pipe Material (Kirkos area)**

- Although the length of GS pipes installed is small in the data, it is considered that many GS pipes are actually installed, because the data for pipelines of 40 mm or less are not managed in the pipeline drawing.
- While it is easy to understand objectively from the collected data that GS pipes have many leaks, there are no such information management, and this is an issue to be addressed in the future.

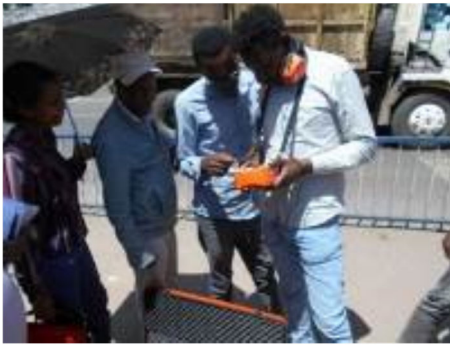
**Photo 3 Confirmation of Correlative Leak Detector Handling Status**

At first, implementation of normal operations were confirmed in order to check the technical skills of the onsite staff.

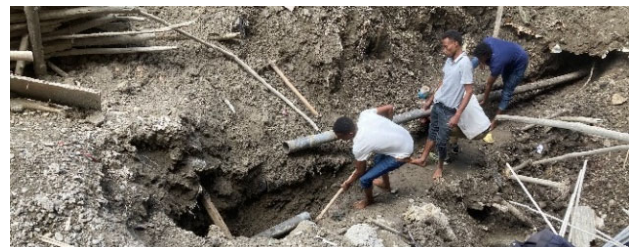
**Photo 4 Pipe repair work**

The following issues regarding pipe jointing technology were identified from the capacity assessment and current situation confirmation.

- Basic knowledge and techniques need to be improved for general pipeline works such as pipe installation, pipe repair, and service pipe installation.
- There are no manuals that indicate work procedures for pipeline construction, and techniques are shared only through on-site communication among staff members, which may

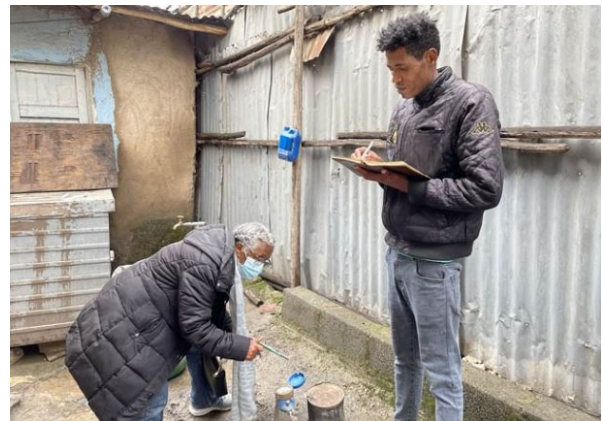
**Photo 5 Situation of household survey**

Although the survey is still under progress, following are the main issues identified from the household survey:

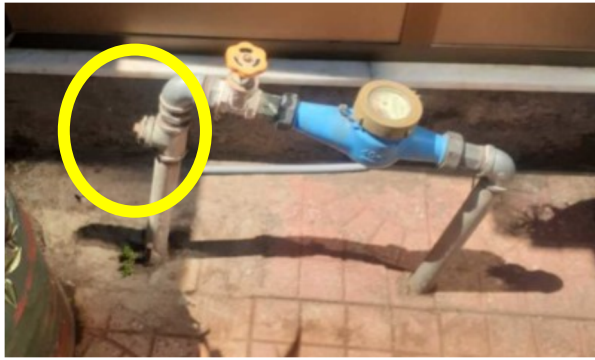
**Photo 6 Example of a branch installed upstream of a water meter**

- There are cases where there are records on the water billing system, but no water meter is installed on site or the contract was terminated several years ago on the customer file.
- Many water meters are not installed according to installation standards.
- There were cases where customers may have modified the pipelines around the water meters.
- There were several water meters facing risk for illegal connection (see Photo 6).
