India

Western Yamuna Canal Hydroelectric Project (ID-P7)

Evaluator: Akihiro Nakagome, Hiromi Suzuki, S.

Field Survey: October 2006/February 2007

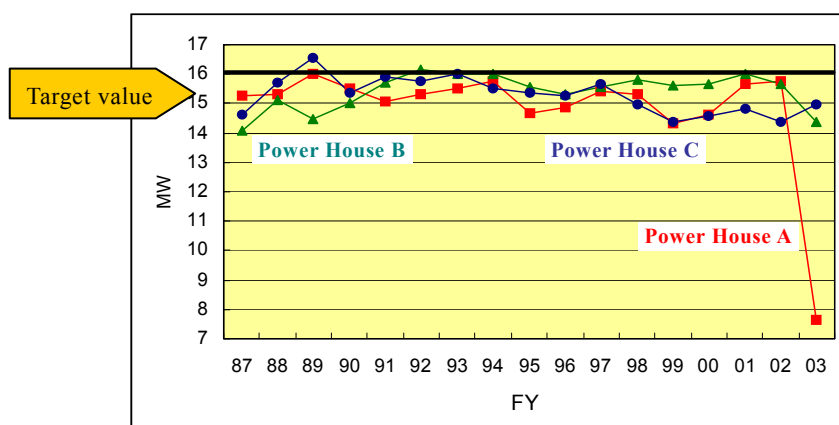
Figure 4: Stage 1 Maximum Output

The maximum output was, in the case of Stage 1, 16 MW × 3 (Power Houses A, B and C) = 48 MW; in the case of Stage 2, 7.2 MW × 2 = 14.4 MW. For the 16 years for which data on Stage 1 (Power Houses A, B and C) was available, the target value was achieved only in a very small number of years. In Stage 2 (Power House D), the target value was never once reached. However, except for Power House A in FY2005, all power houses achieved more than 80% of their target.

In addition, the main reason why the power houses cannot achieve 100% of their target value is the recent reduction in the discharge of the Yamuna Canal.¹² On the other hand, the main reason why the maximum output was so low in FY2003 is that the silt ejector at Power House A Unit 1 broke down, and a month and a half later, the front gate could not be opened due to silt, ultimately causing a shutdown of the channel. The operation of Unit 1 was stopped for a period of one year. A new silt ejector has been procured from a local manufacturer, so the problem has already been solved.

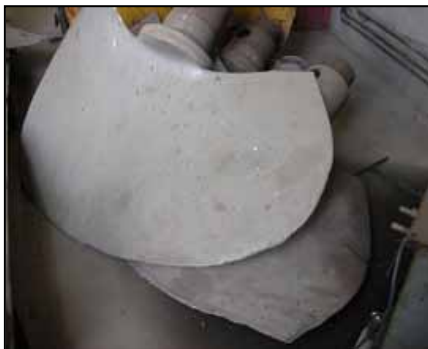
Figure 5: Turbine damaged by quartz silt

Problems that should be addressed immediately include (1) the damage to the parts of the turbine that are under water caused by the increase in the amount of quartz silt especially during the monsoon season; and (2) the damage to the electronic control panel in the control room in all power houses caused by the air conditioning system’s failure to

run properly. Most of these problems had to do with the problem of replacements parts (these parts are old designs or their production has been discontinued, there is no technology for the production of spare parts, etc.) and the lack of awareness of the importance of operation and maintenance.

¹⁹ As of 2007, the problem concerning the under water part of the turbine was in the process of being solved by repairing the runner blade and the discharge ring and by replacing the carbon ring. As for air conditioning, a new system is scheduled to be procured this fiscal year. In respect of safety and hygiene, while it was confirmed that rubber boots and cotton work gloves were provided, helmets continued to be unavailable, and there was no plan to procure them. Outsourcing the cleanup services for the power houses is now being considered.
