OJT and Monitoring in New Target Provinces

JICA Expert conducted OJT on the construction of simple weirs and monitoring of simple weir schemes in new target provinces (Copperbelt, North-Western and Central Provinces) in July and August 2019. This article shares the result of those.

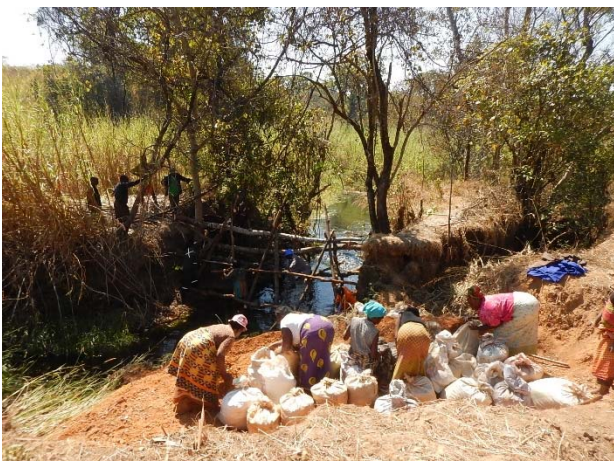
The team inspected a trigonal type weir in Kalulushi District, which had been constructed under supervision of MoA-TSB officers. Because of terrain, water level should be raised very high, the structure was made very strong. 17 farmers (7 males and 10 females) participated in the construction. The water source is very rich and large area will be irrigated.

While the male farmers fabricate the frame of trigonal weir, female farmers prepare sandbags which are put in front of the weir. London Irrigation Scheme in Chilambe Camp, Kalulushi District, Copperbelt

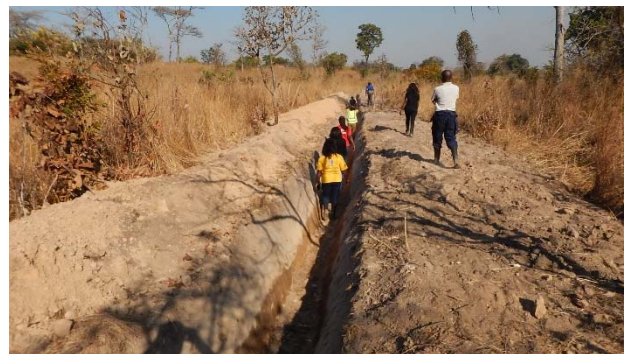
The monitoring team traveled to Mufulila District finally and inspected two sites. In one site, a constructed weir had a lot of leakages and it seemed that it was difficult to raise up the water level. The farmers were advised to dry up the weir once and then excavate and backfill the leakage point. In the other site, the canal was excavated to higher part of land and it was very deep. The farmers were advised to use line level to determine the alignment of the canal.

The depth of canal which farmers dug so far is very deep because Farmers tend to choose routes of canal that allows irrigation water to reach the beneficiary area from weir point as quickly as possible without considering heavy labor forth required. Mutundu North, Mutundu Camp, Mufulila District, Copperbelt Province

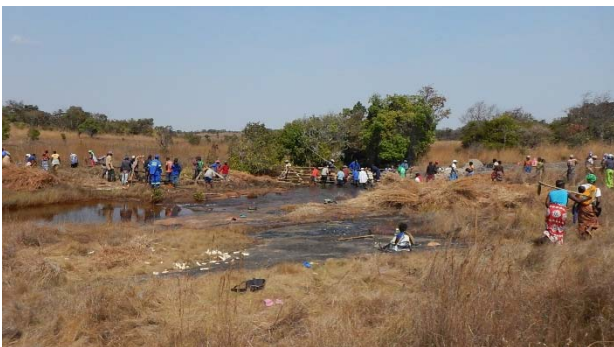
In Serenje district, large number of farmers (34 males and 55 females) participated in construction of a trigonal type weir with 15 m width. It took about 4.5 hours. The stream is rich of water. It is expected that many farmers will be benefitted by irrigated agriculture.

Weir construction works were shared. Male farmers fabricated the frame of trigonal weir and female farmers prepared grass and ishinde. Chiefteness Serenje Camp, Serenje District, Central Province

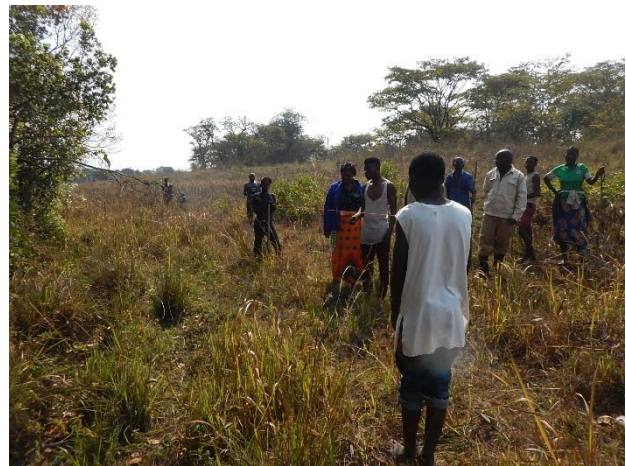
A completed single weir was inspected in Mwinilunga district. The weir had a lot of leakage and the farmers were planning to improve it by changing it to double line type. Alignment of the canal was improper and they were planning to realign it. In Kawiko camp, combined type weir of incline and single line was constructed by 15 farmers (9 males and 6 females). The farmers struggled to complete the construction. It took 4.5 hours to complete because the weir has 20 m width. After construction of the weir, alignment of the canal was determined using line-level method. In order for aligning 200 m, the farmers took only 1 hour since the technique is very easy for them.

Determination of alignment of the canal using line level. Kawiko Camp, Mwinilunga District, North-Western Province
