Condition of Permanent Weirs Constructed by COBSI Study and T-COBSI was monitored by TSB and CEOs in FU provinces

Implementation of the Survey on the permanent weirs constructed by COBSI study and T-COBSI

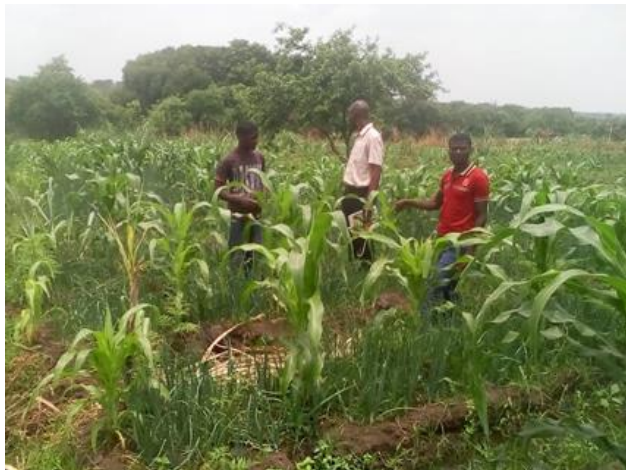
Mpela Irrigation Site in Lunte District, Northern province, constructed by T-COBSI. Maize is always intercropped with all the crop. A picture shows intercropping of maize and onion.

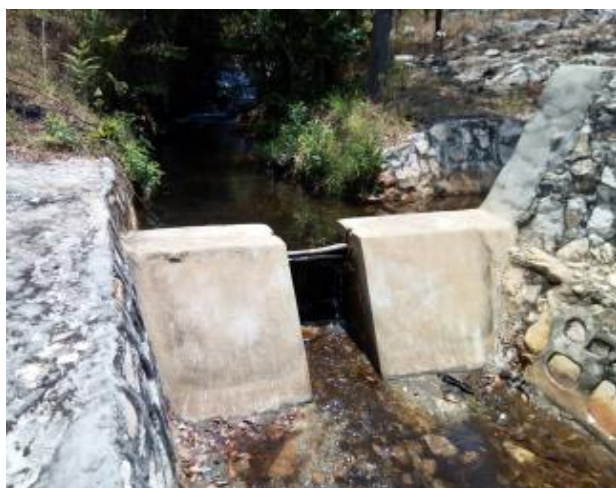
Musanda Irrigation Site in Kasama District, Northern Province, constructed by T-COBSI. Condition of the permanent weir is good, and this site is selected as E-COBSI District Model Site.

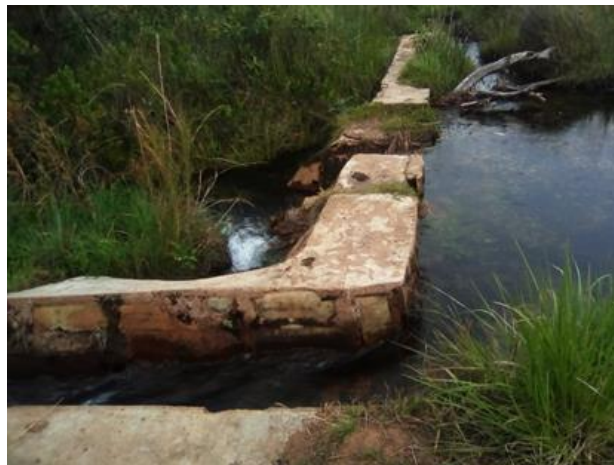
On the other hand, most of the COBSI study sites have partially damaged on the weirs and require repairing of the weirs using cement because ten years have passed since they were constructed from 2010.

Chilala Irrigation Site in Mporokoso District, Northern Province constructed by COBSI-study. Although the weir is partially damaged, farmers can still take water from the front site furrow.

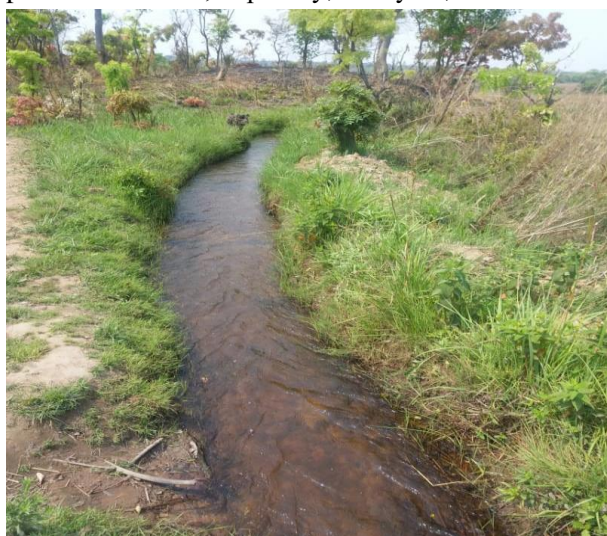
Nseluka Irrigation Site in Mungwi District, Northern Province constructed by COBSI-study. The picture shows main furrow at upper part of the site. Farmers monthly conduct O&M of furrow and the condition is good. Volume of the water is high in the furrow.
