# Smart Pavement Inspection

25th Feb. 2021

Pavement Roughness Measurement  
Smartphone Application

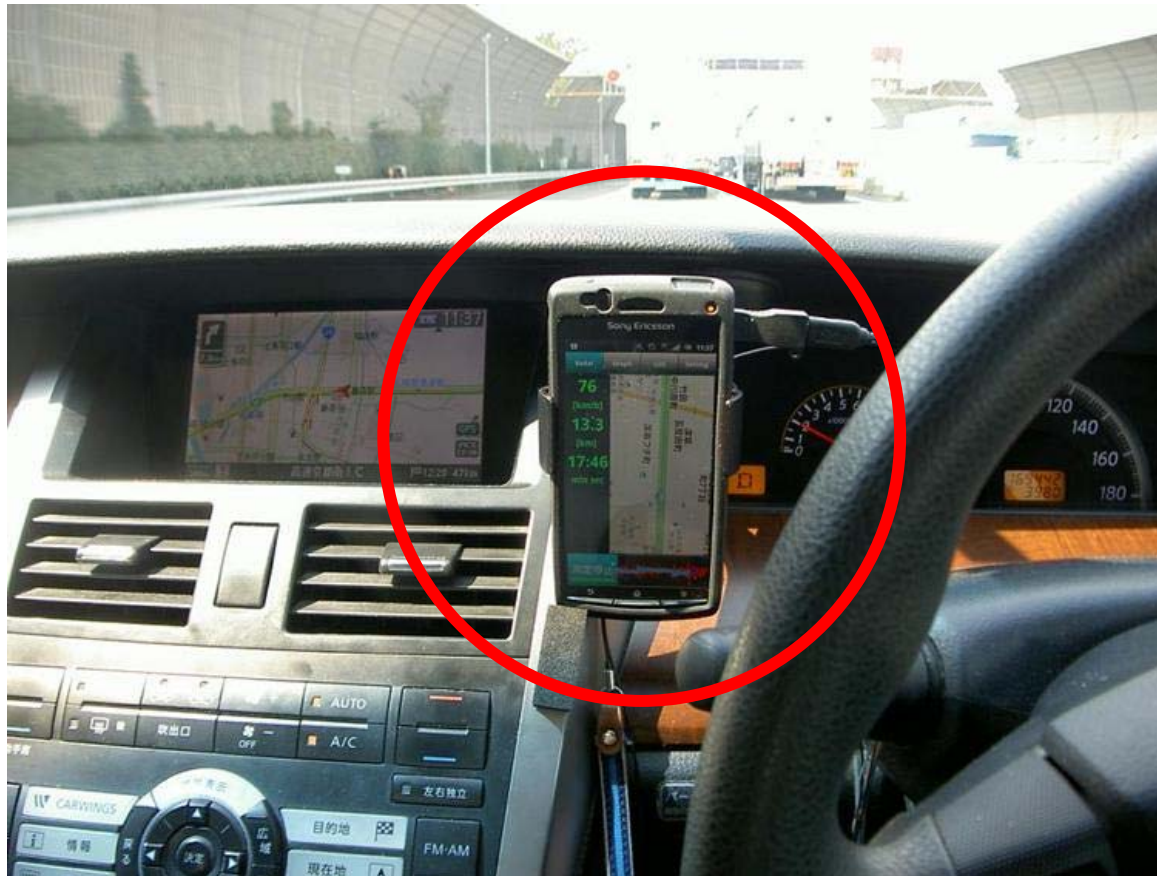
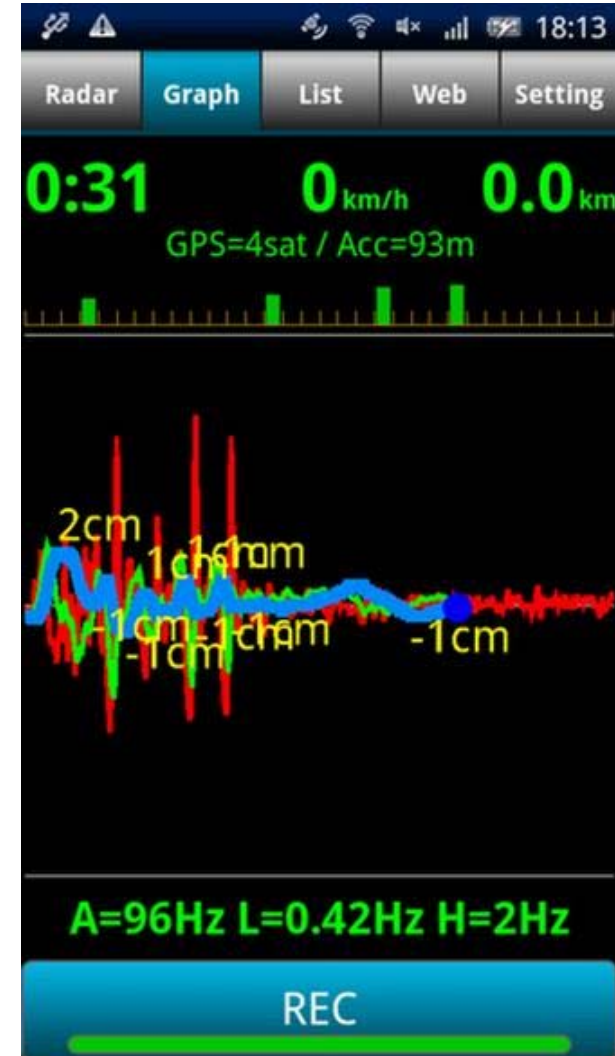
Vibration data is collected under the driving by Smartphone App.

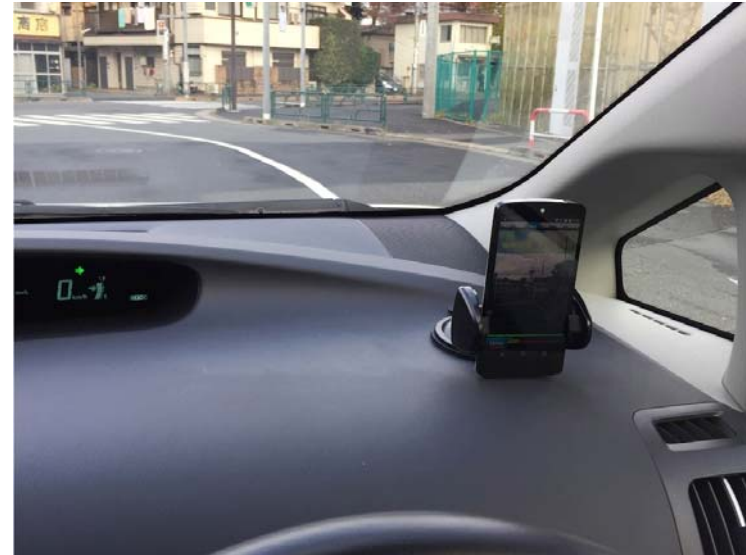
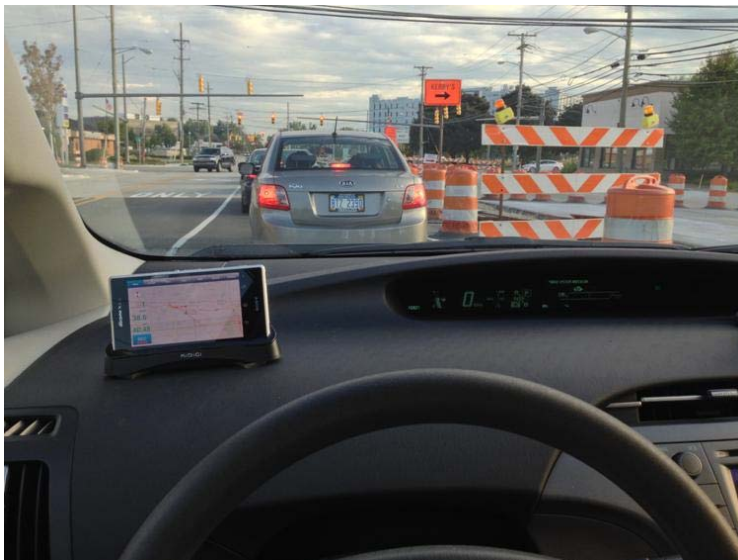
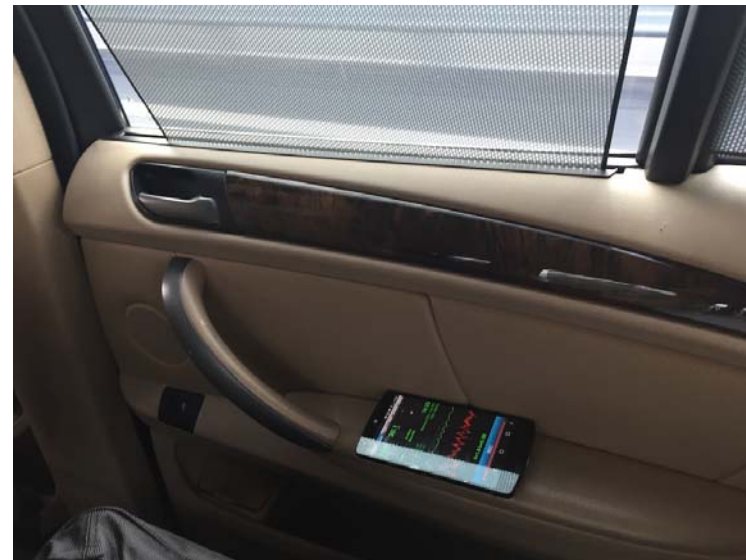
Smartphone is placed on hard surface tightly, like dashboard, arm rest.

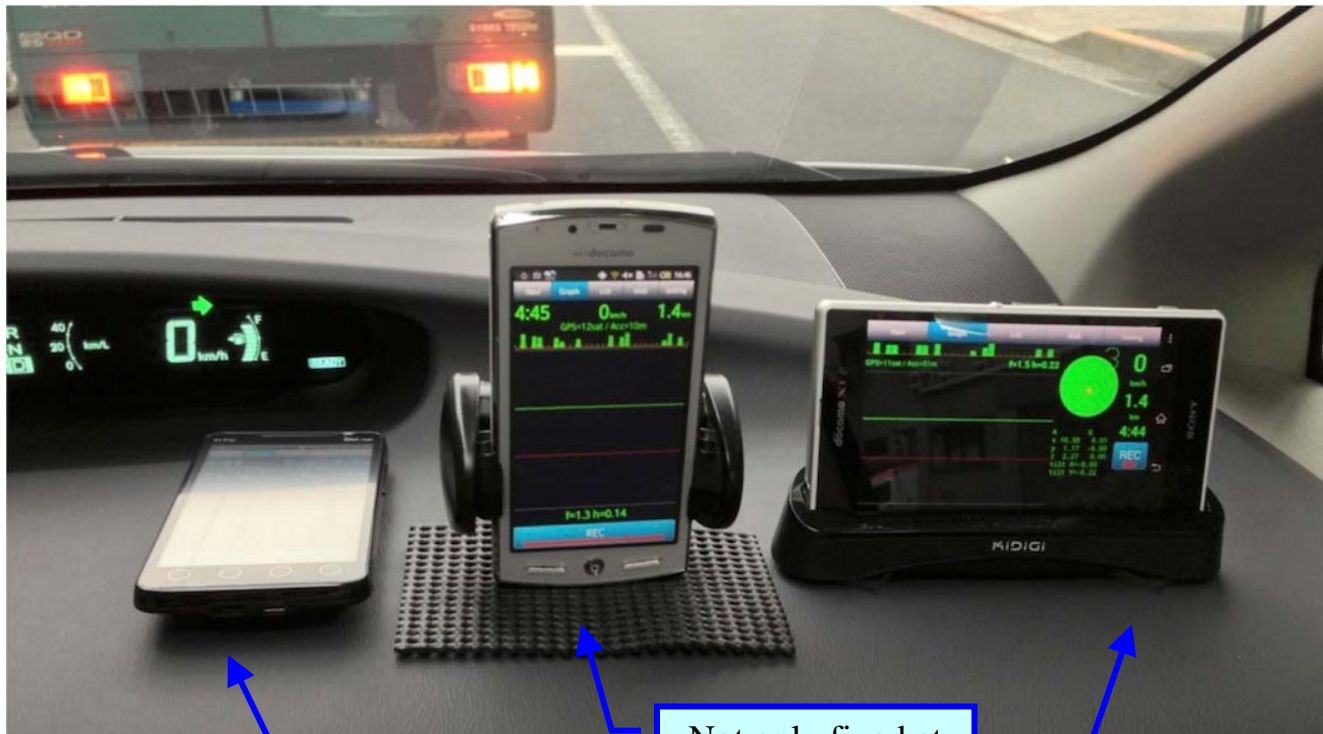
Any tilt angle is okay, but must placed tightly NOT recommend

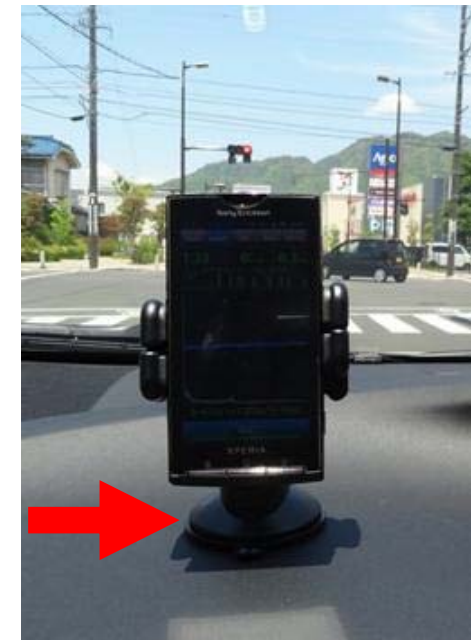
Not only fixed at left and right, but also bottom side.

It use sticky sheet on the bottom side.

It is easy vibrate itself

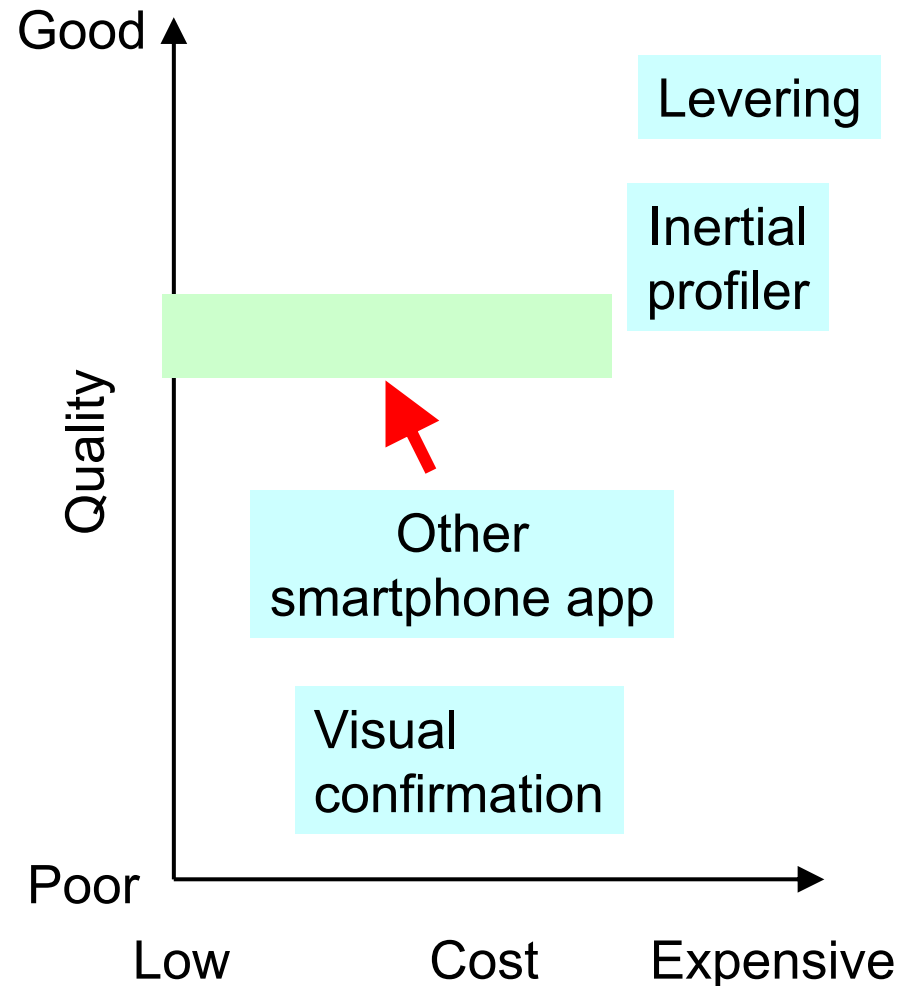
is more precise and lower cost for IRI measurement.

Class 1 Precise Static method	Profilometric QC simulation
Class 2 Other method	
Class 3 Correlation equations	No QC simulation
Class 4 Subjective ratings	No verifiable

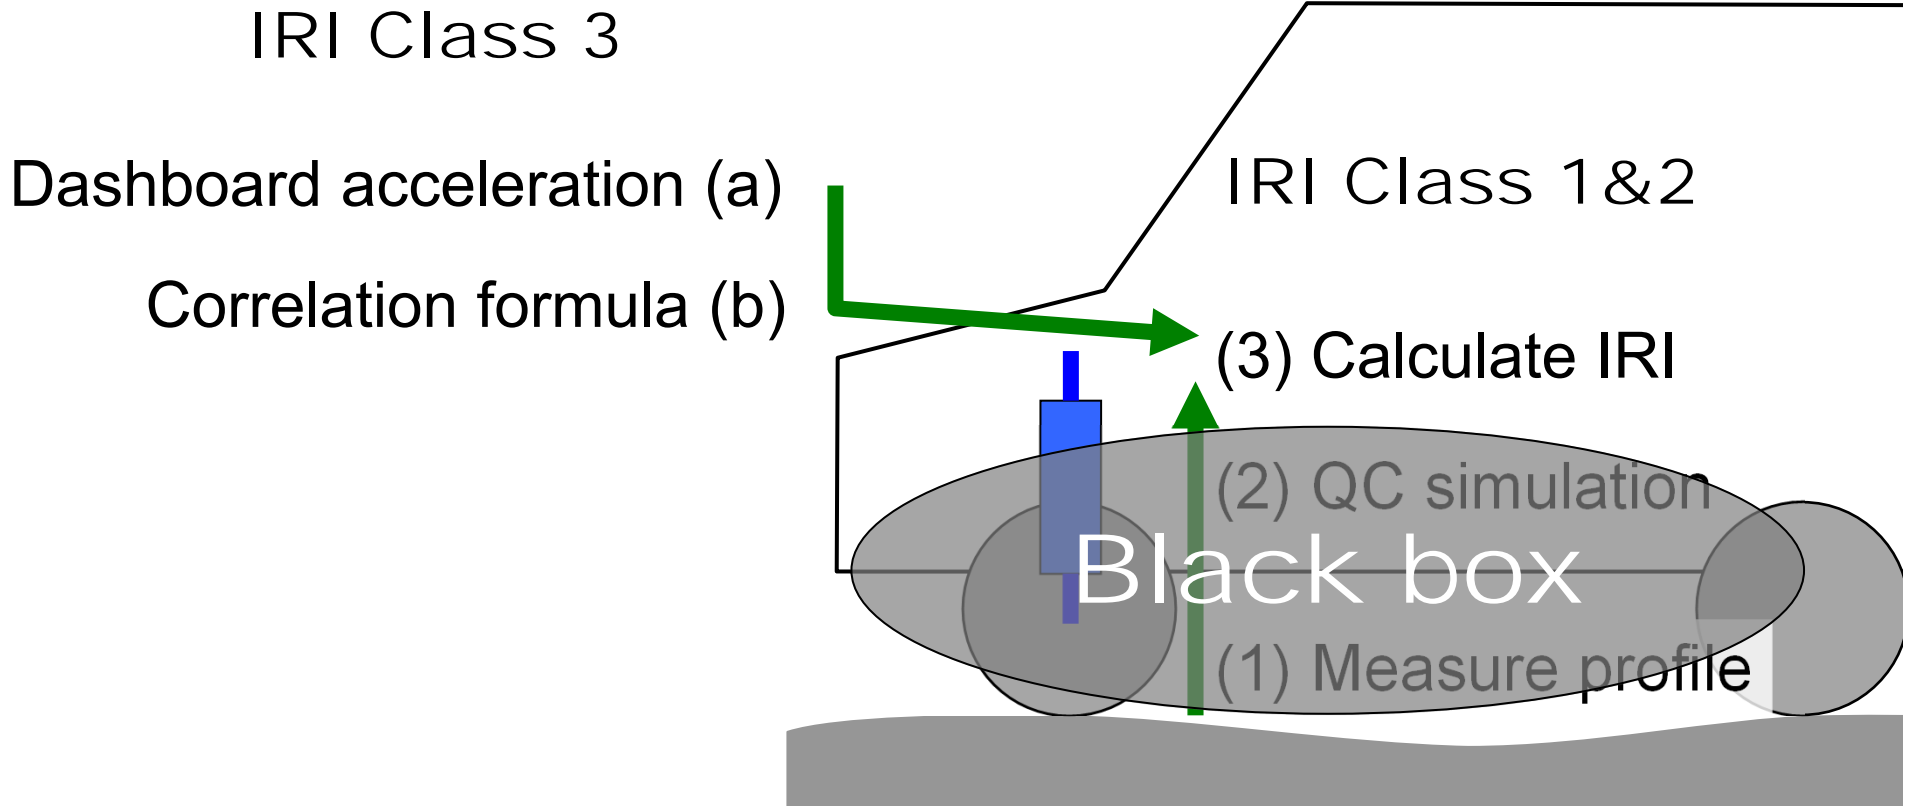
Calibration driving is needed.  
Low repeatability.

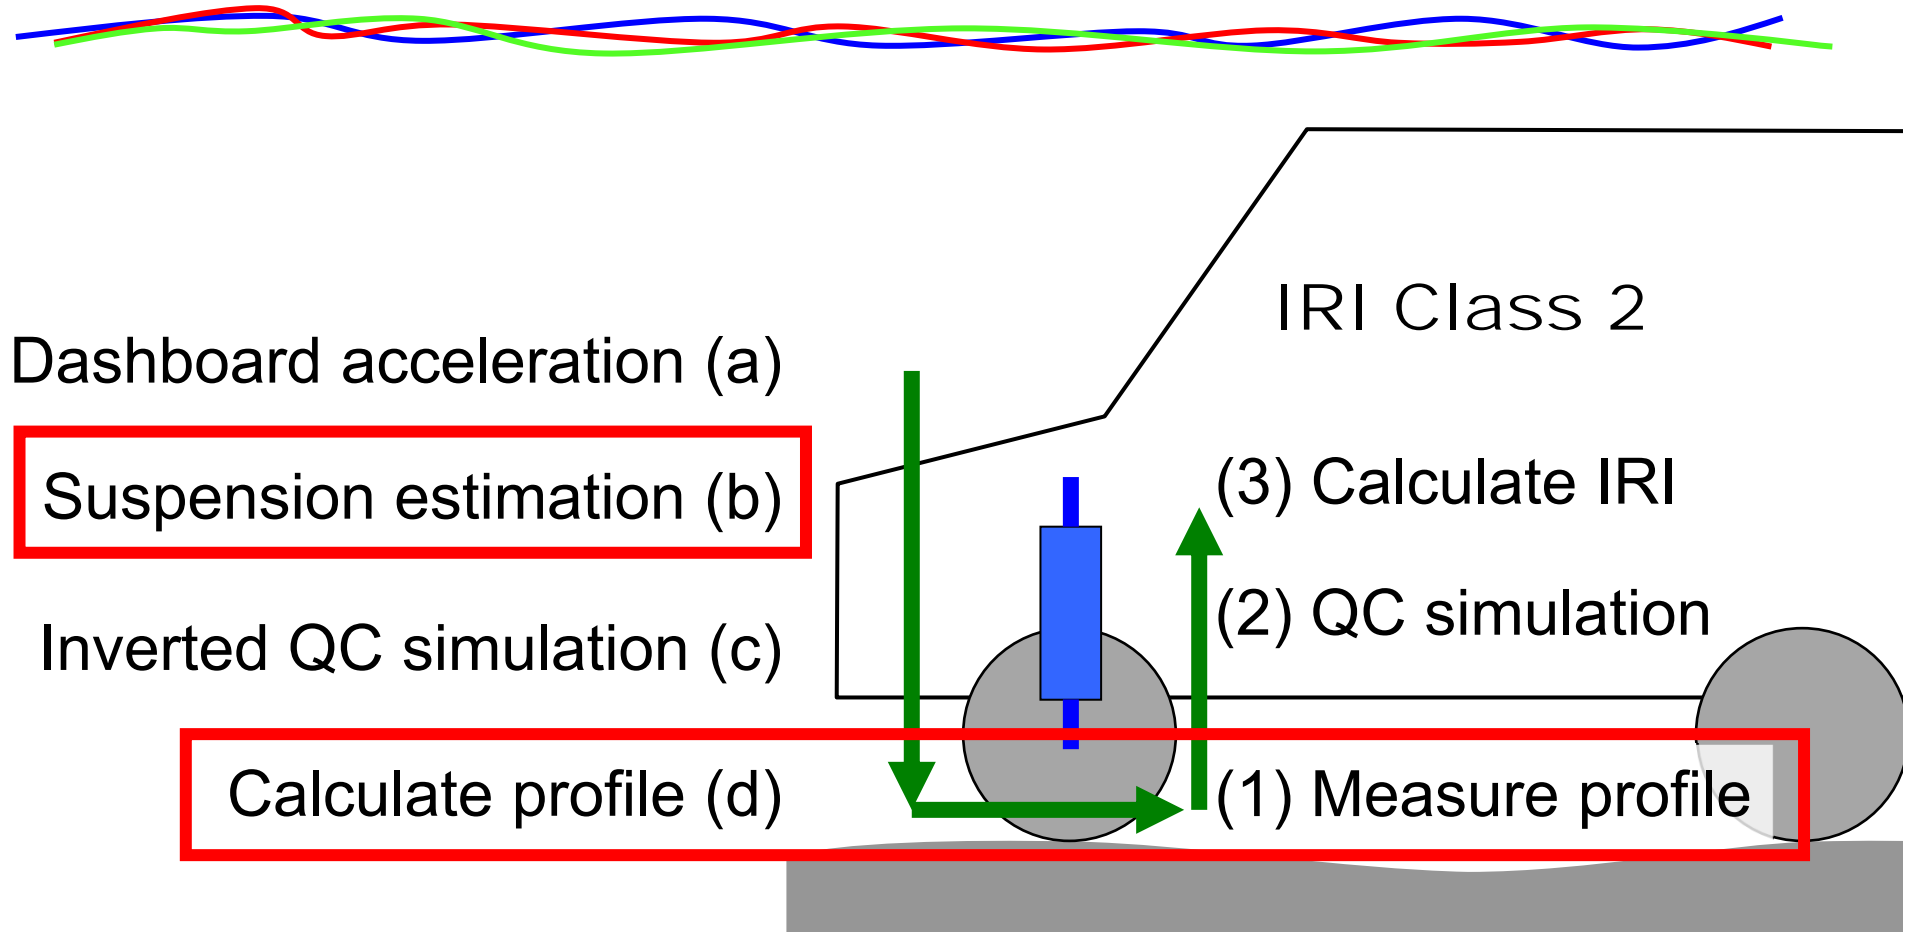
Auto calibration is done during measurement driving.  
Good repeatability.

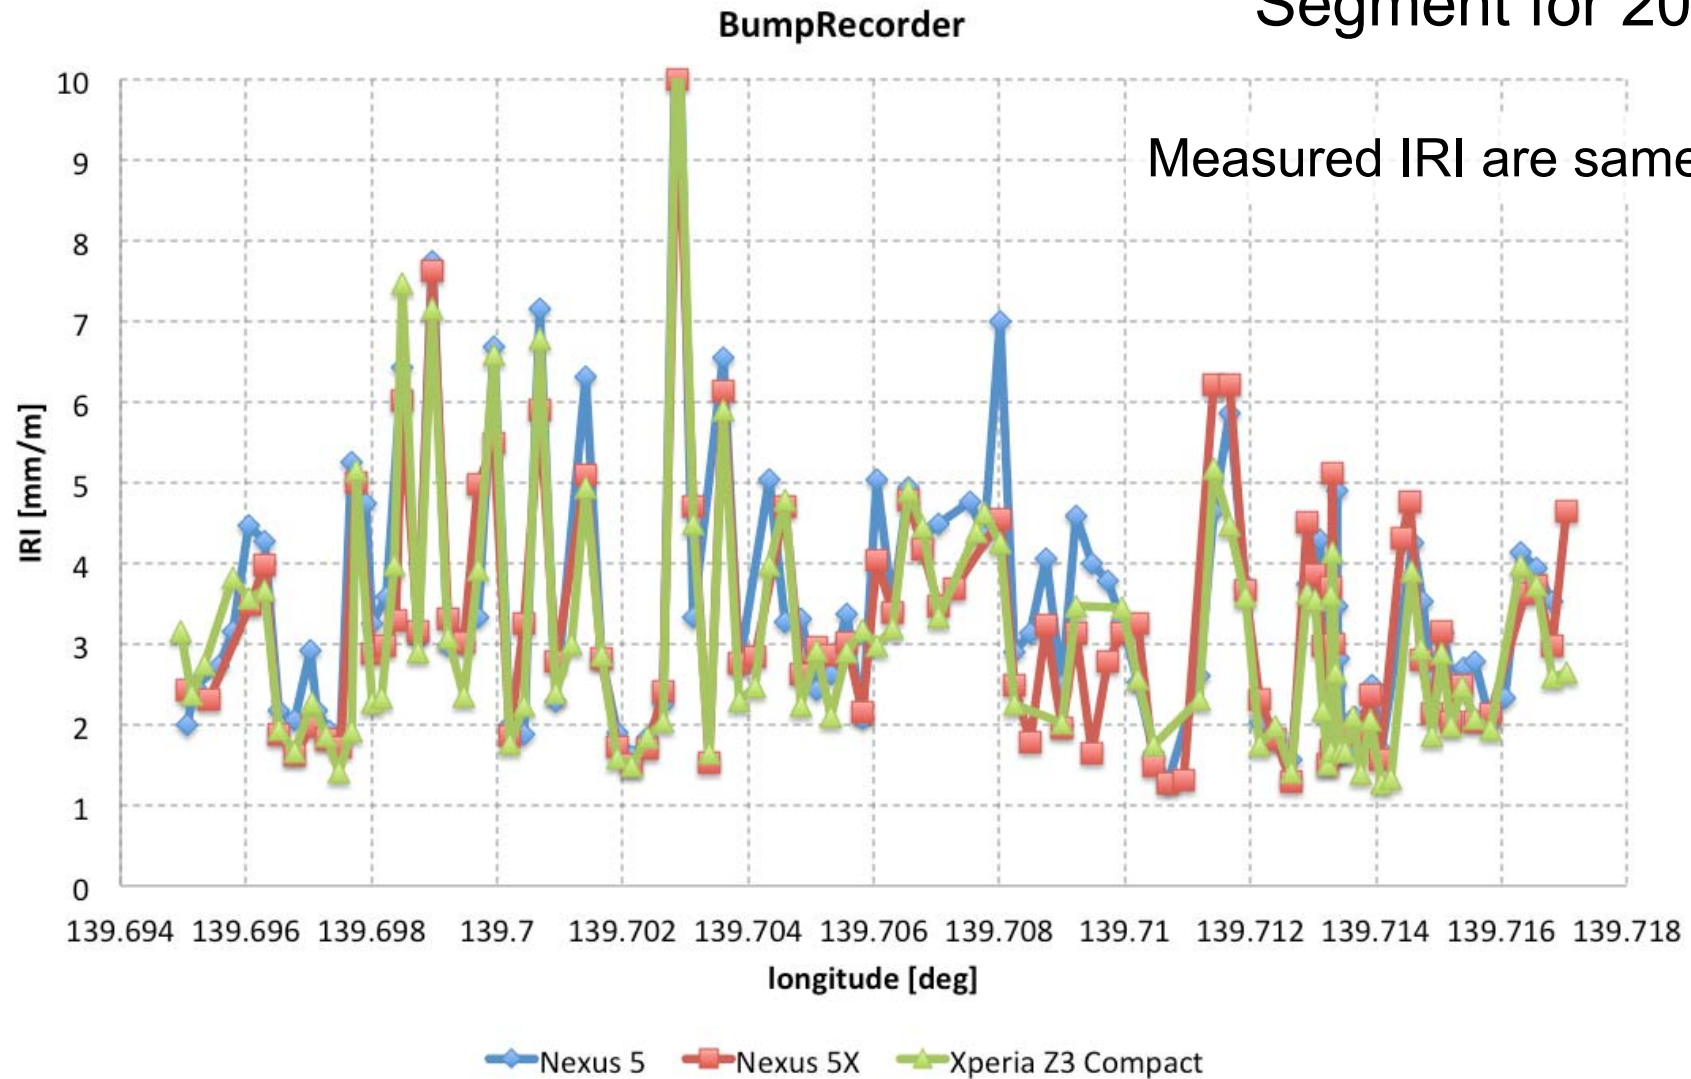
# Using different smartphone model

Segment for 20m

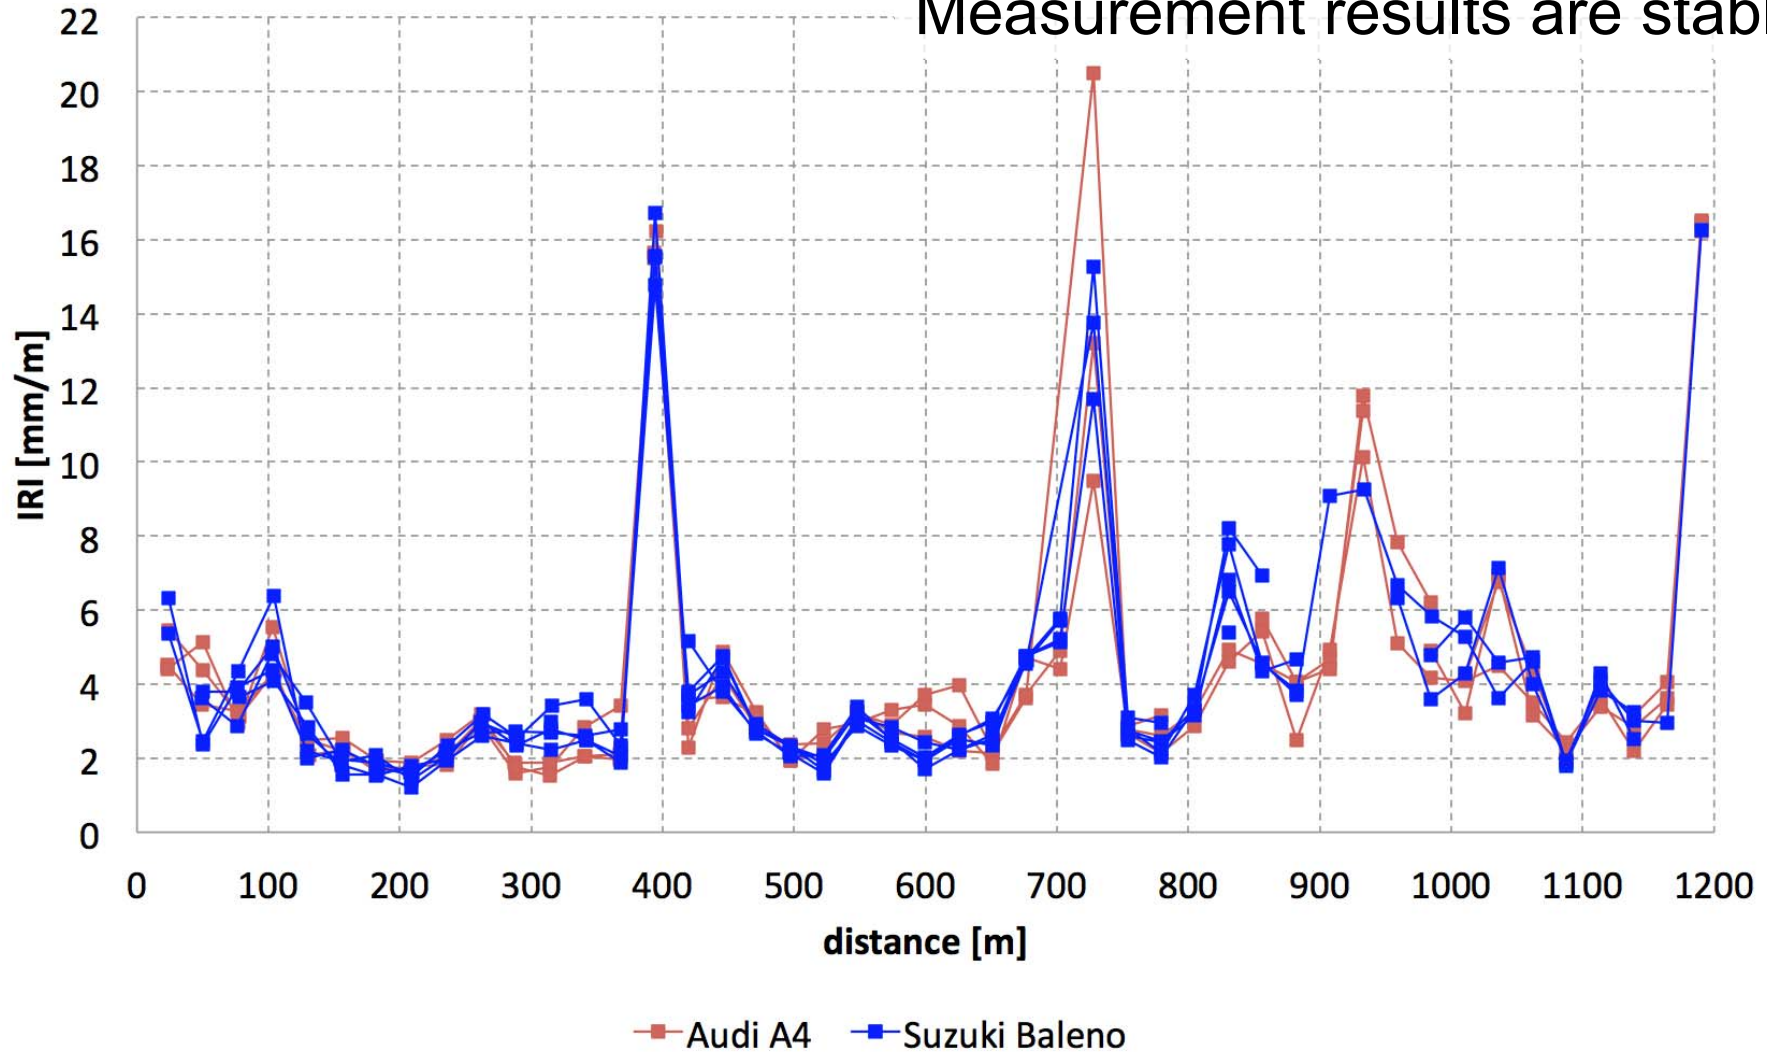
# Using different vehicle type

It measured 3 times

Measurement results are stable

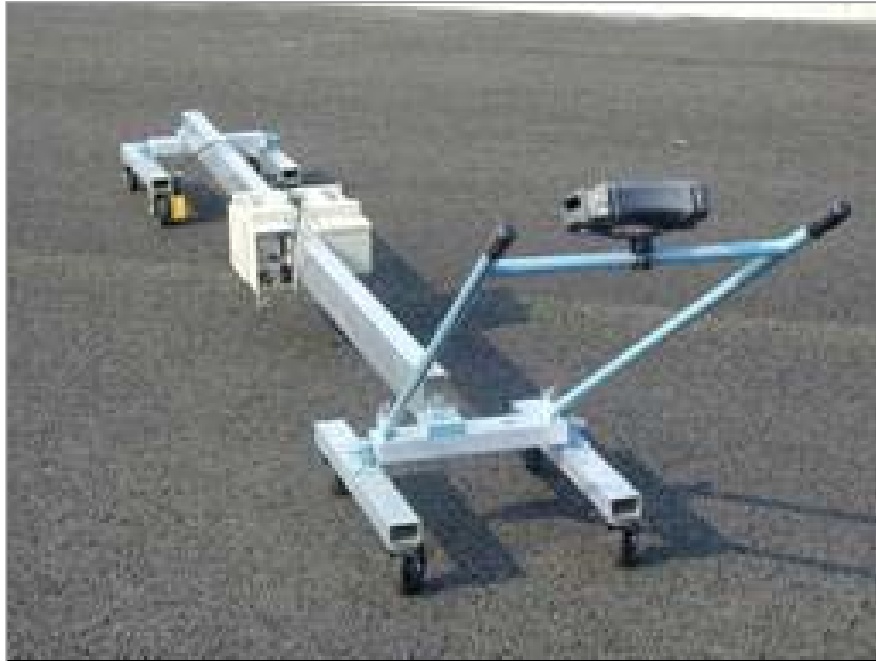
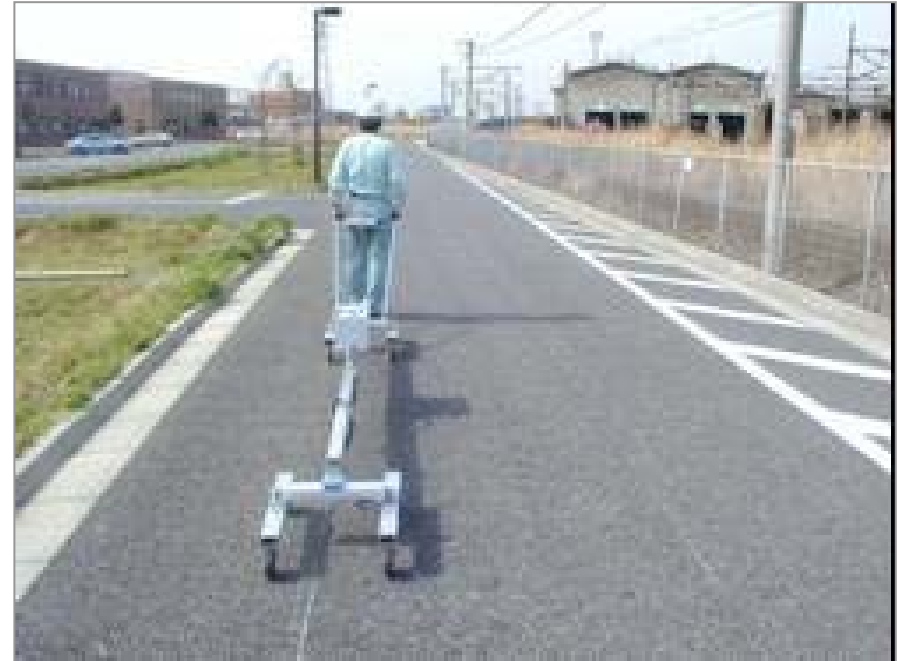
# Comparison with KUMATAKA MRP-3000

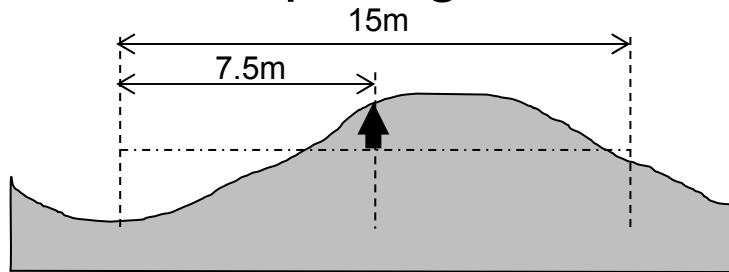
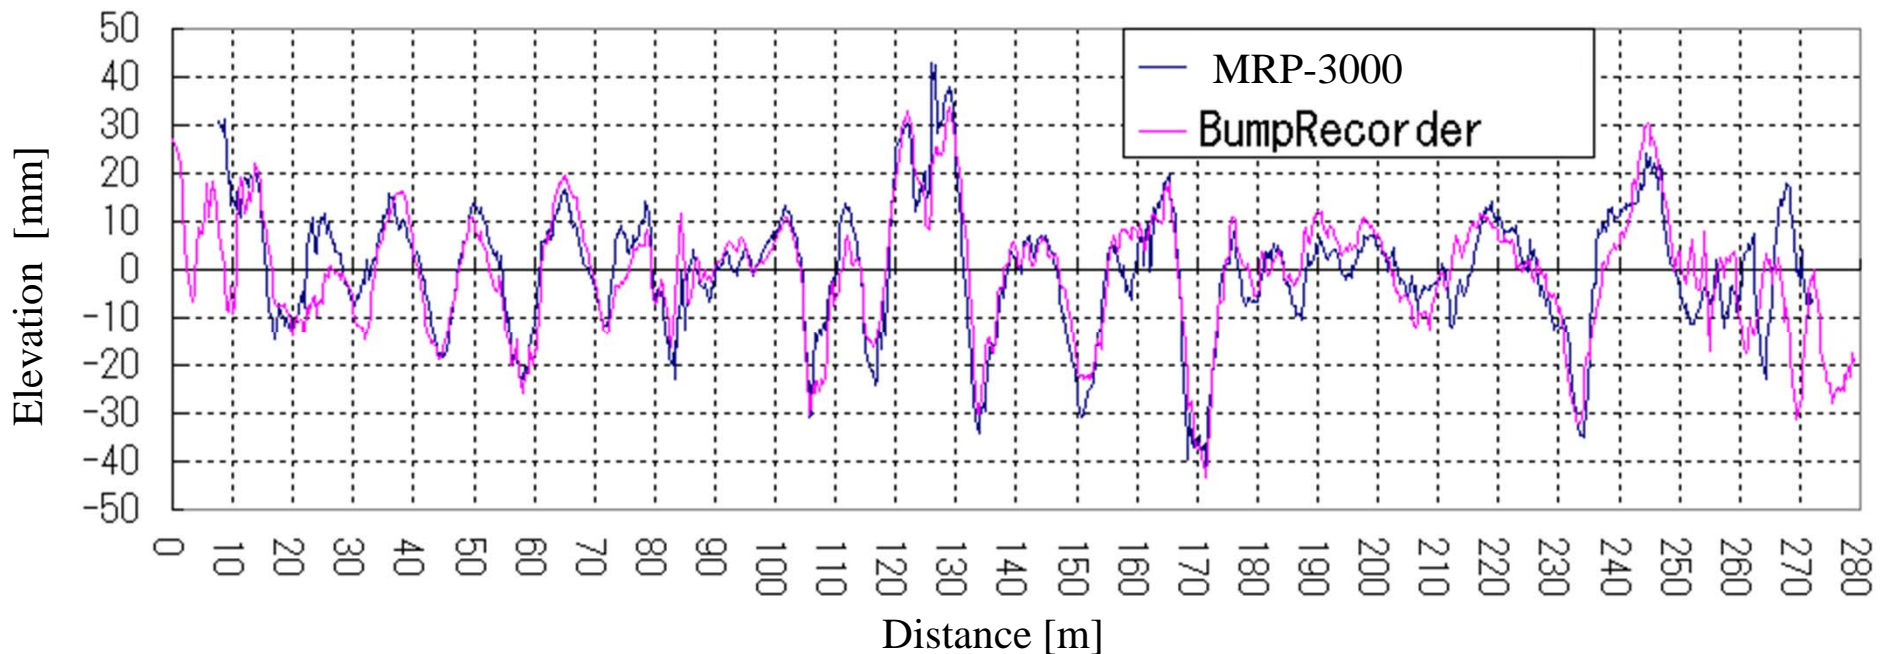
Calculating relative height in 15[m] long for MRP-3000 and BumpRecorder. Then comparing this two values.

Trend was consistent.  
Position gap was not so large.

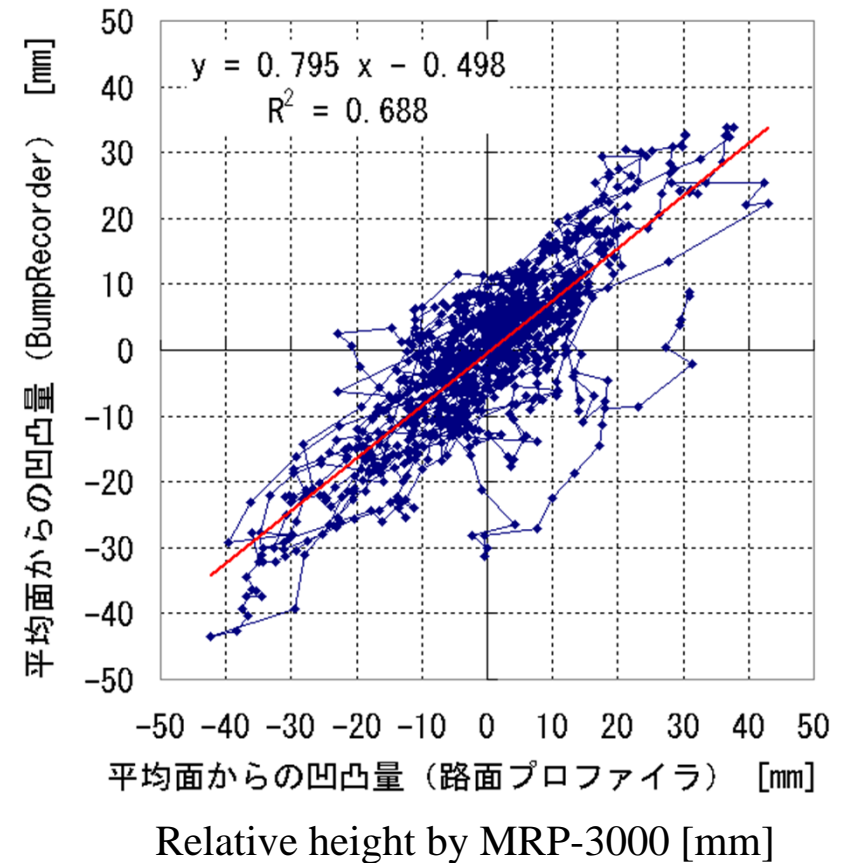
Liner regression was done,  
by using result of MRP-3000  
and BumpRecorder

- Contribution Ratio : 0.688  
= **Correlation coefficient : 0.829**

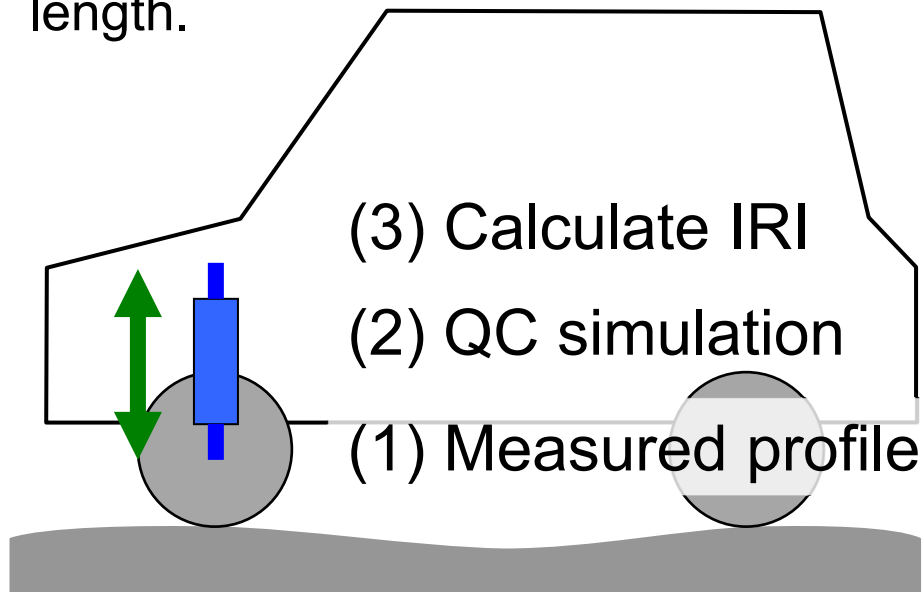
IRI - International Roughness Index  
 Average of suspension expansion & compression under 80km/h driving situation. It includes longer wave length.

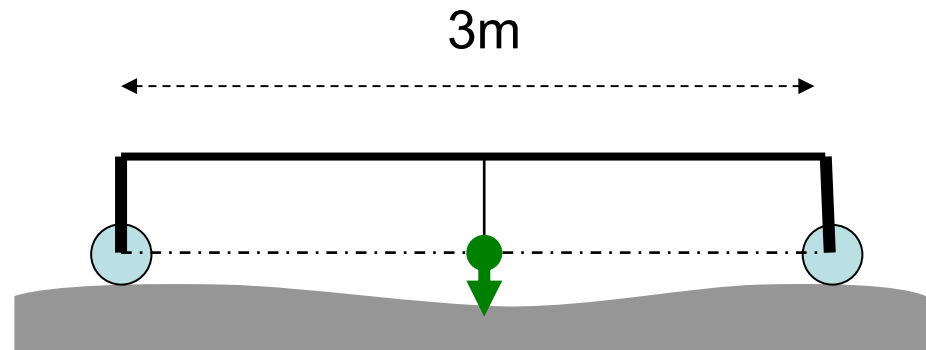
JRI - Japanese Roughness Index  
 Standard deviation of 3m  
 profilometer measurement value. It  
 indicate shorter wave length situation.

Similar to PI : Profile Index

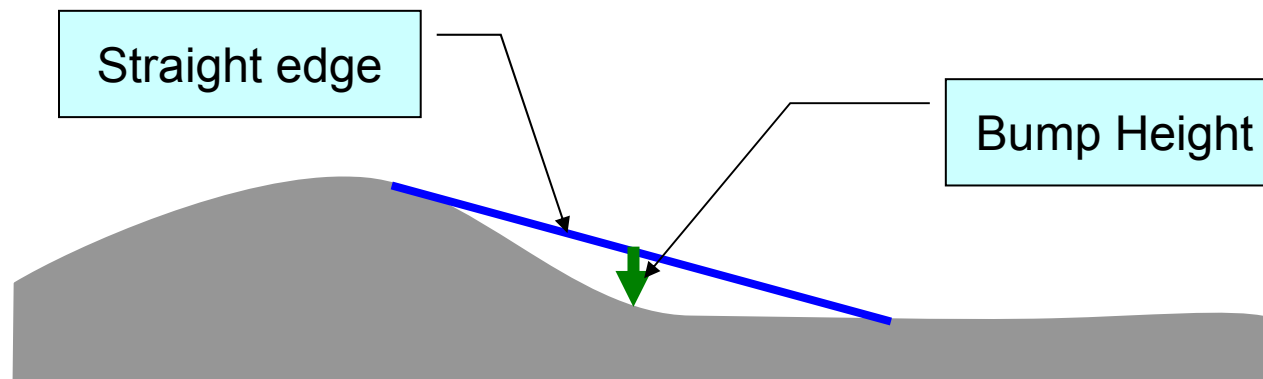
BBI - Boeing Bump Index

**Point** information of the bump size and location.

2m/10m/15m straight edge is used,

and deepest depth is defined Bump Height.

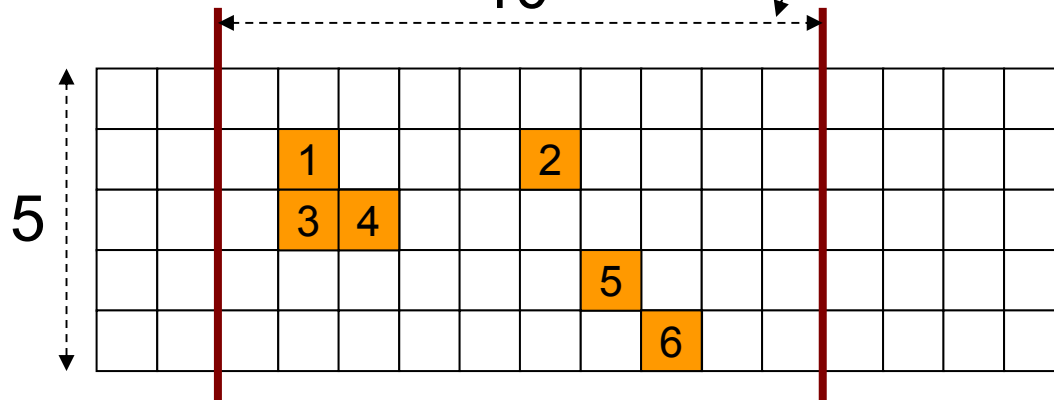
Surface cracking rate  
10

Square measure rate between road surface and cracking area

$$\frac{6}{10 \times 5} = 12\%$$

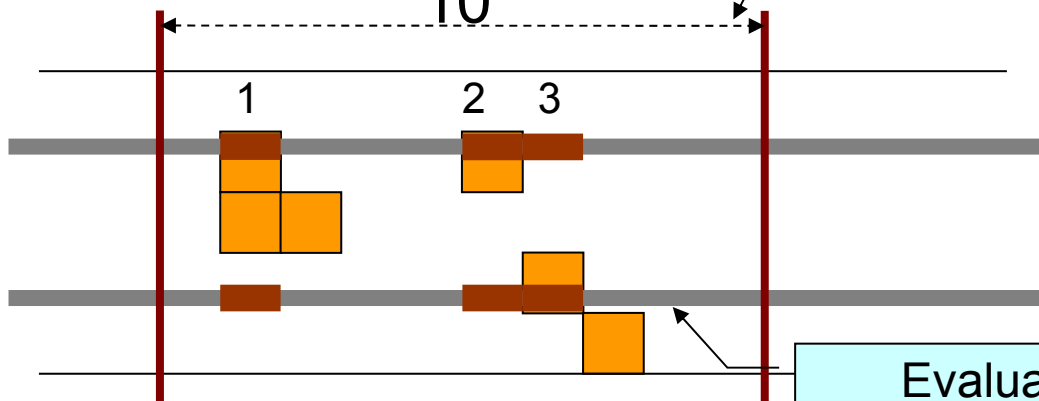
Wheel path cracking rate  
10

Distance rate between running distance and cracking distance

$$\frac{3}{10} = 30\%$$

Evaluate on wheel path  
(not include other surface)

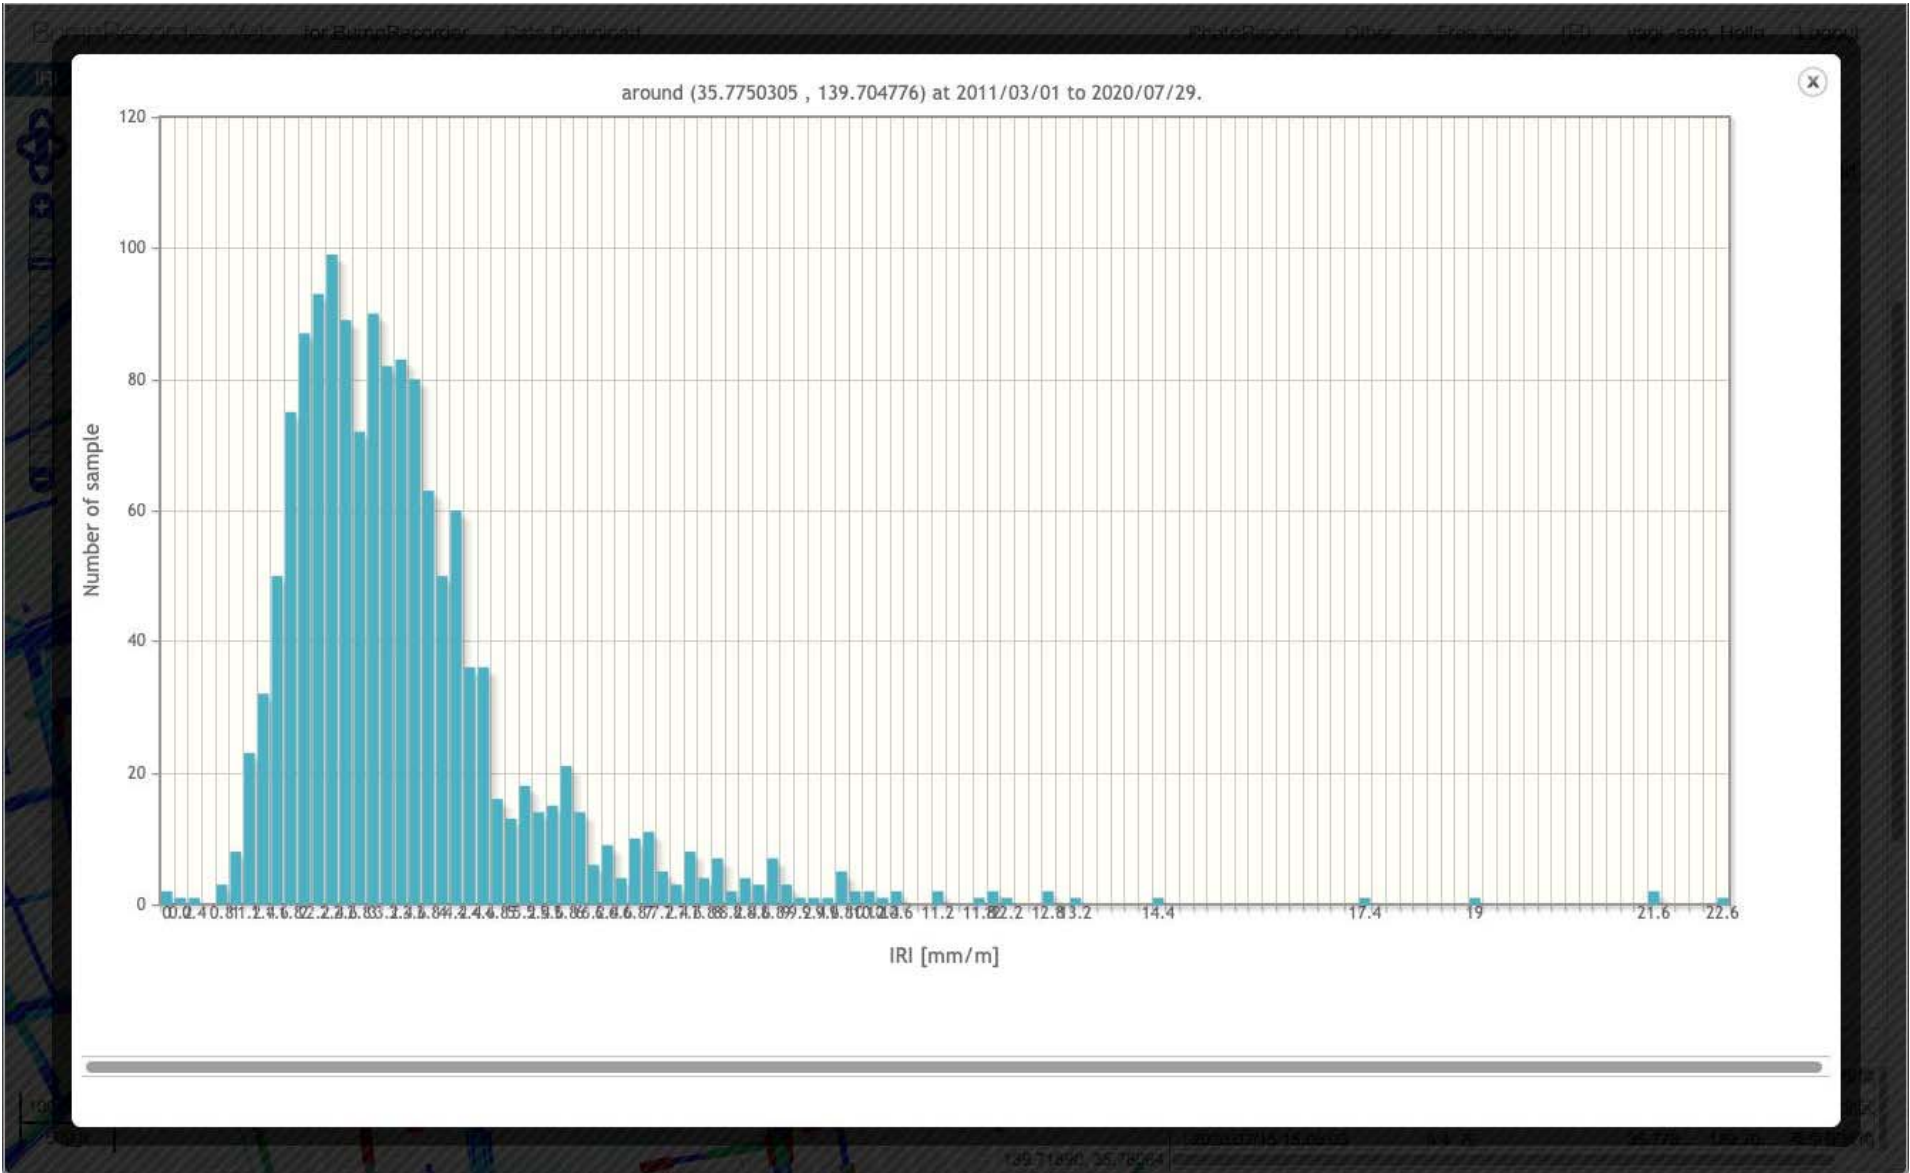
# Histogram

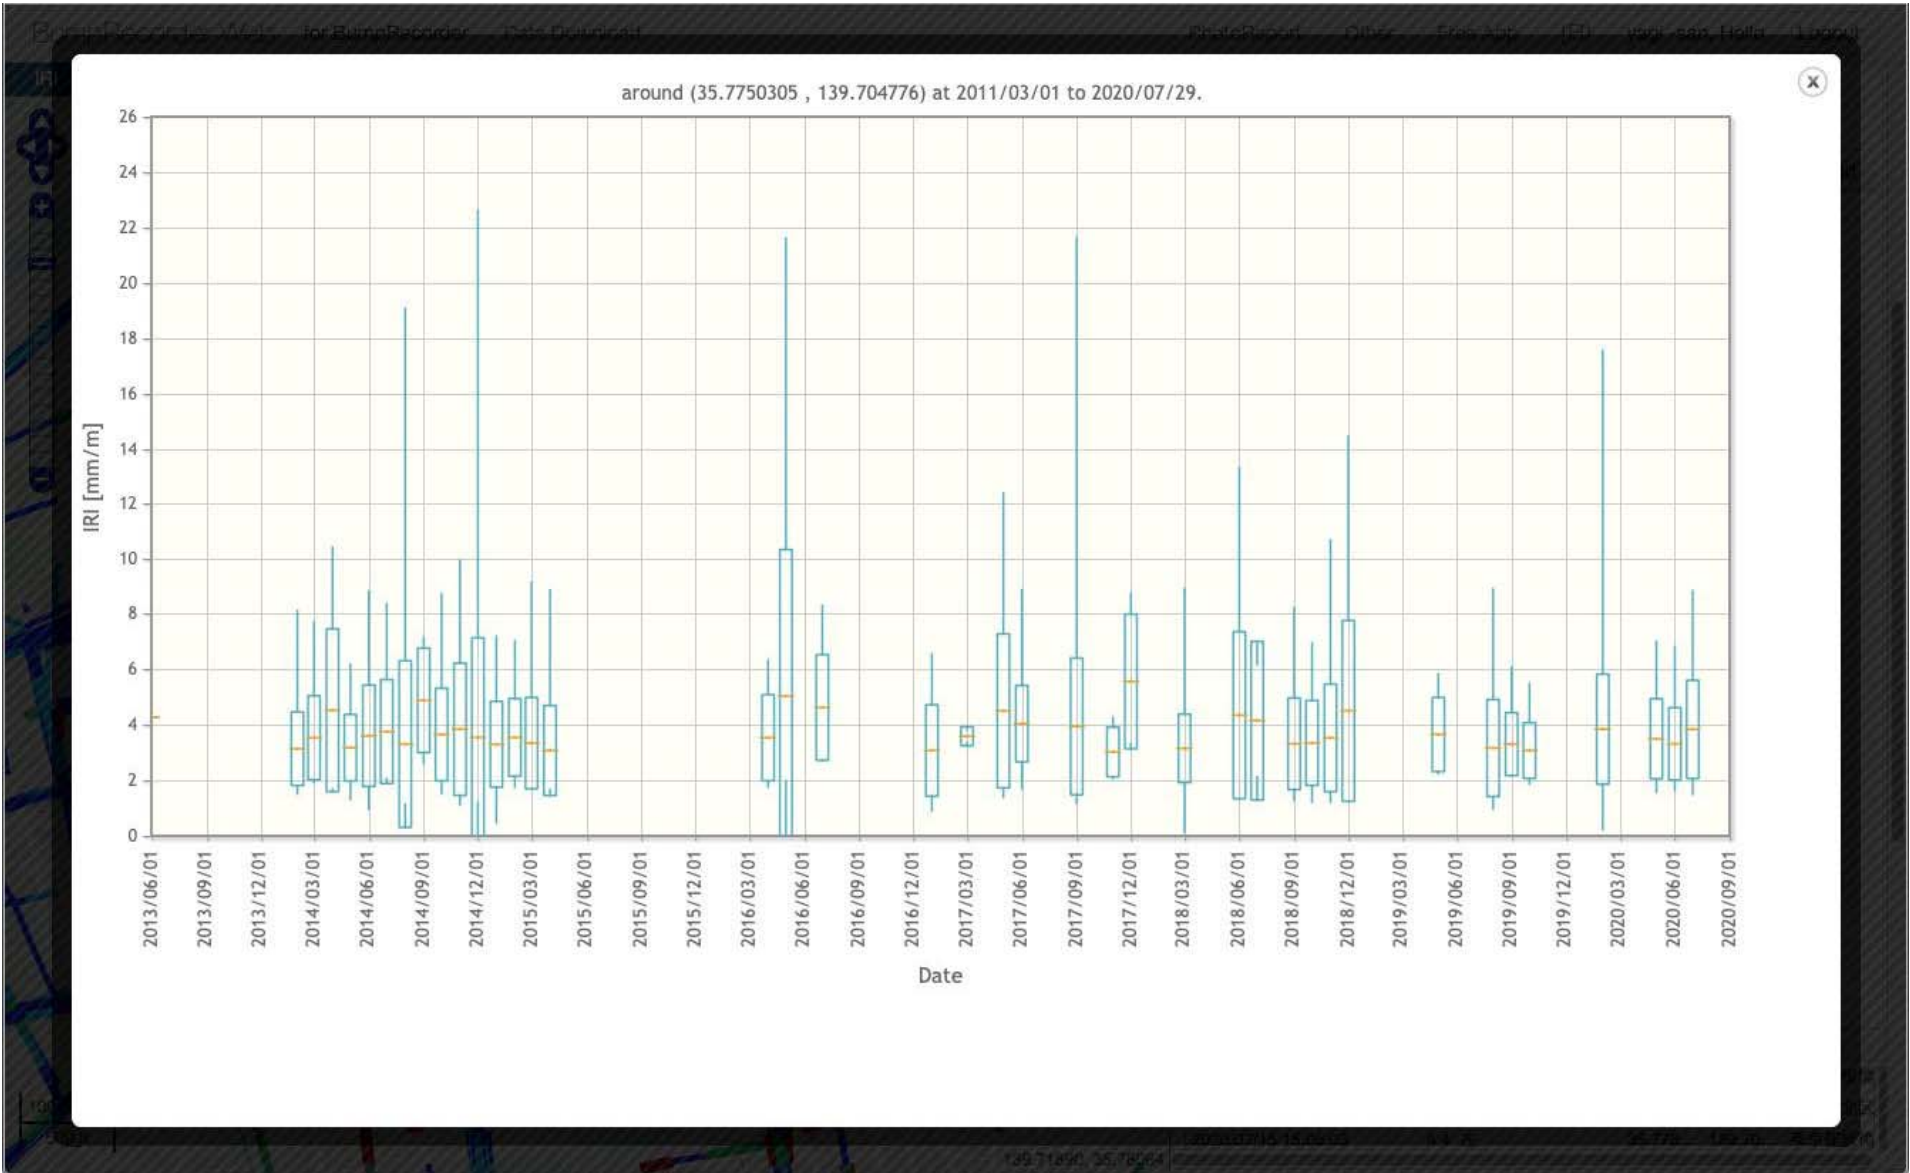
# Time series

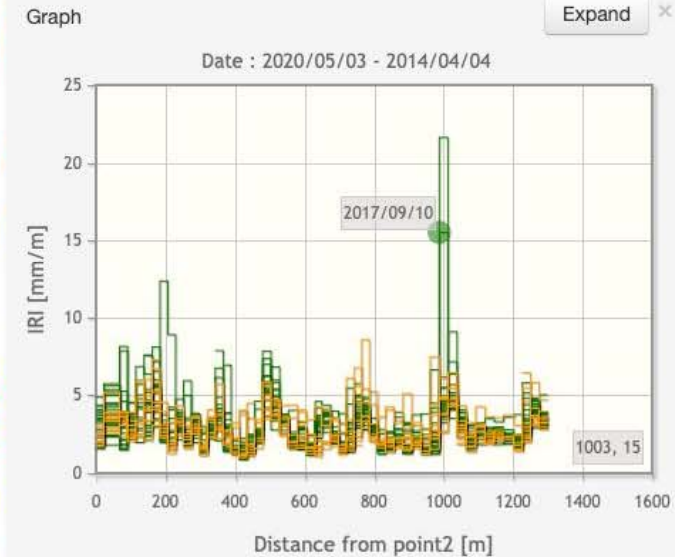
# Distance base

Analyze Type Distance based graph between select Analyze
