THE PROJECT FOR SEWERAGE SYSTEM DEVELOPMENT

JAPAN'S GRANT AID PROJECT

ENVIRONMENTAL MONITORING REPORT No.1

August 2021

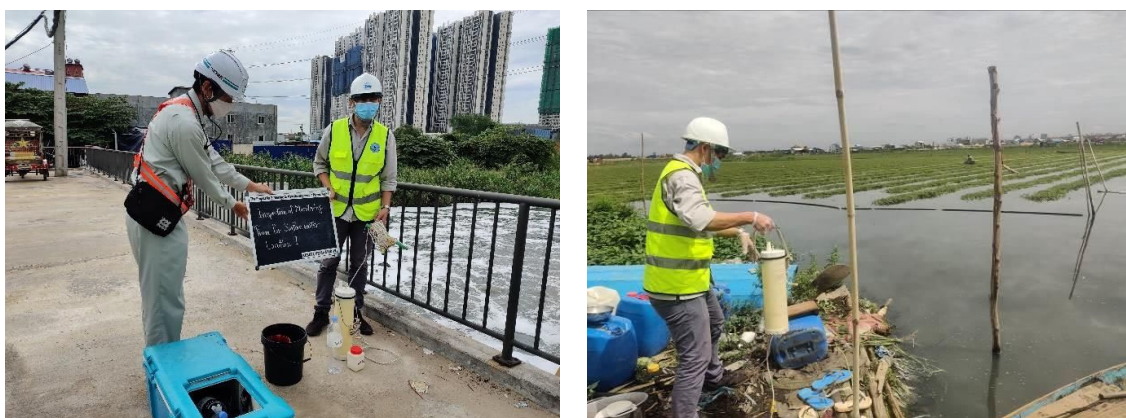
Figure 1 Water quality sampling tools and equipment

The samples would keep in the cool box quickly after taking, and at the same day were sent to MoE Lab in Phnom Penh for analyzing the parameters as required by the Water Quality Survey.

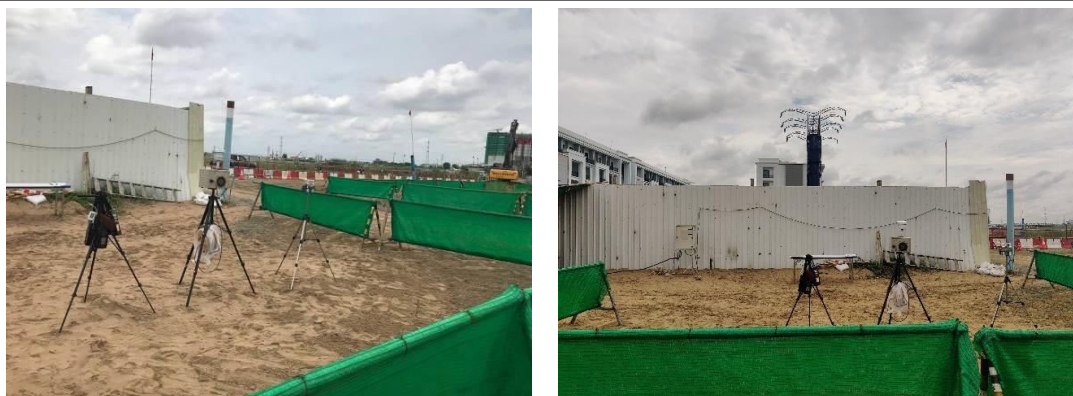
Figure 2 Air quality sampling tools and equipment

Air quality sampling was conducted on-site in the proposed project. The sampling equipment were installed at a height of 1.2 to 1.5 meters above the ground, and air quality parameters were carried out within 1 hour, 8 hours, 24 hours according to each parameter method. Air quality parameters were analyzed in the laboratory of the MOE.

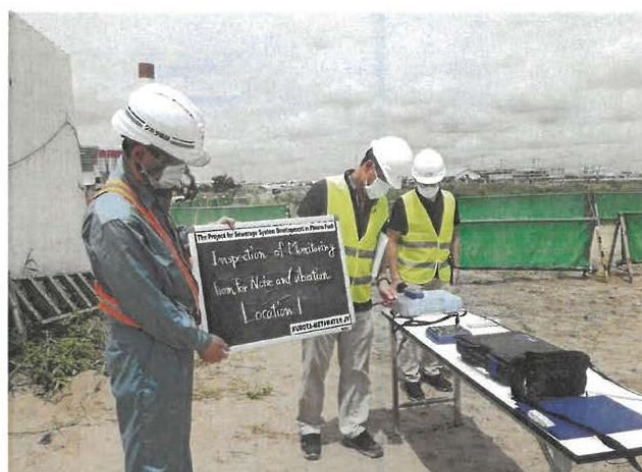
Location1

The noise and vibration was monitored from the material transportation, the operation of any machinery, generator and vehicle.

Monitoring form for Noise and Vibration

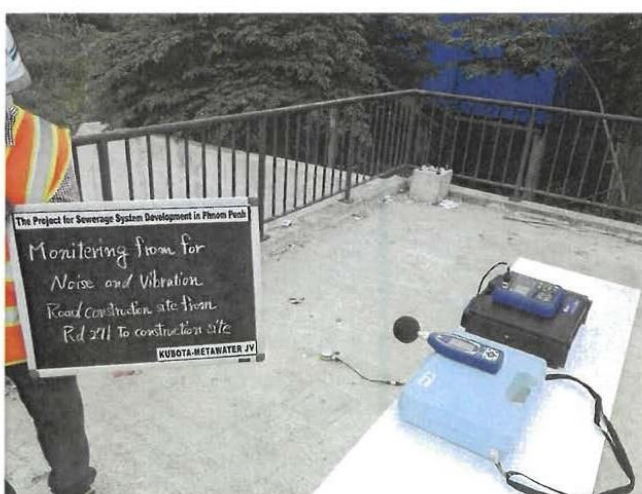
Location3

Monitoring form for Noise and Vibration

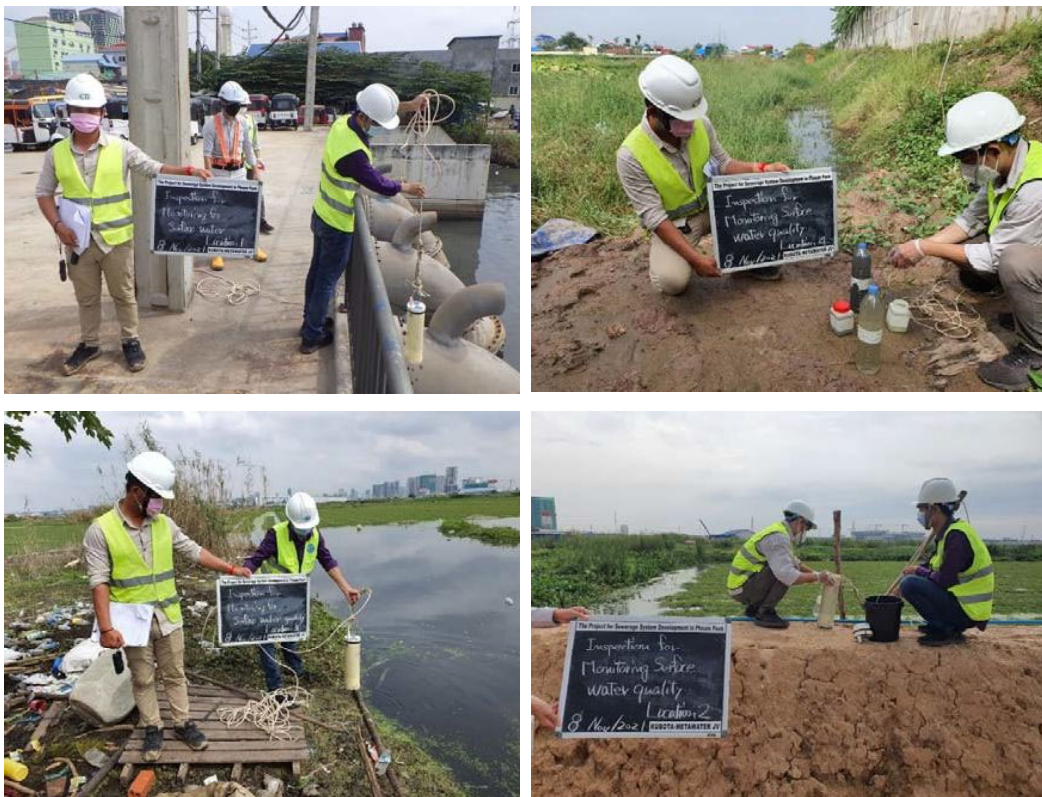
Figure 2 Water quality sampling tools and equipment

The samples would keep in the cool box quickly after taking, and at the same day were sent to MoE Lab in Phnom Penh for analyzing the parameters as required by the Water Quality Survey.

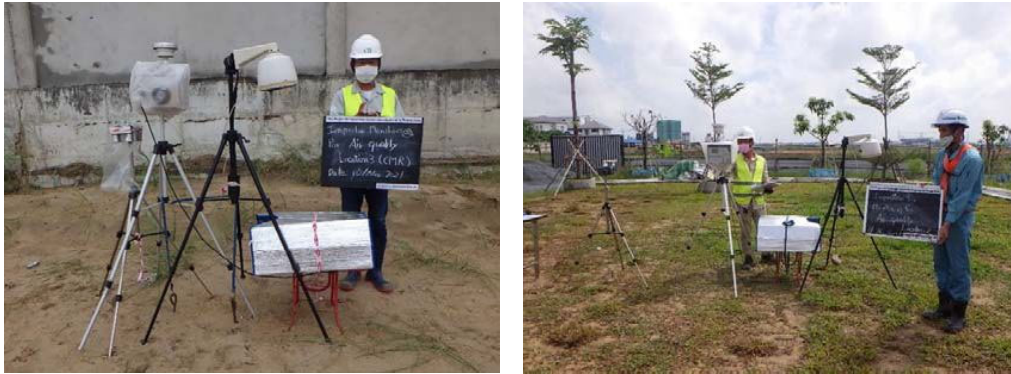
Figure 3 Air quality sampling tools and equipment

Air quality sampling was conducted on-site in the proposed project. The sampling equipment were installed at a height of 1.2 to 1.5 meters above the ground, and air quality parameters were carried out within 1 hour, 8 hours, 24 hours according to each parameter method. Air quality parameters were analyzed in the laboratory of the MOE.

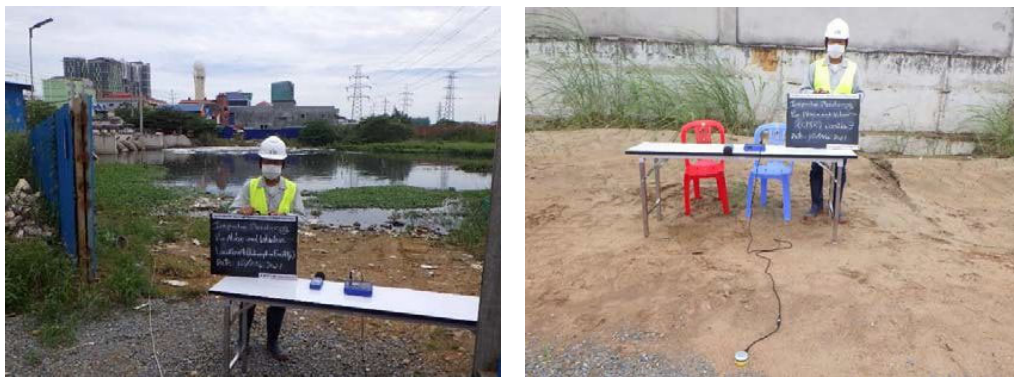
Figure 4 Noise and Vibration sampling tools and equipment

The noise and vibration was monitored from the material transportation, the operation of any machinery, generator and vehicle.

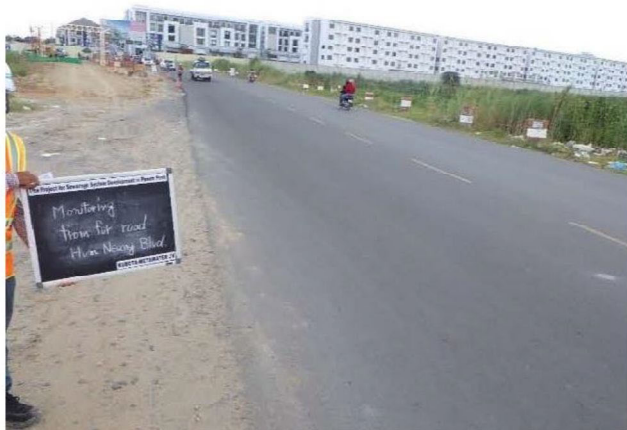
Road
Hun Neang Road
1-Jun-21

| | | <p>The repair of damaged road by the project</p> <p>Location :Channel Maintenance Road</p> <p>Detail : Cheak the Hun Neang Road</p> <p>※Illegal parking near the site is not observed. Satisfactory/ Unsatisfactory</p> |

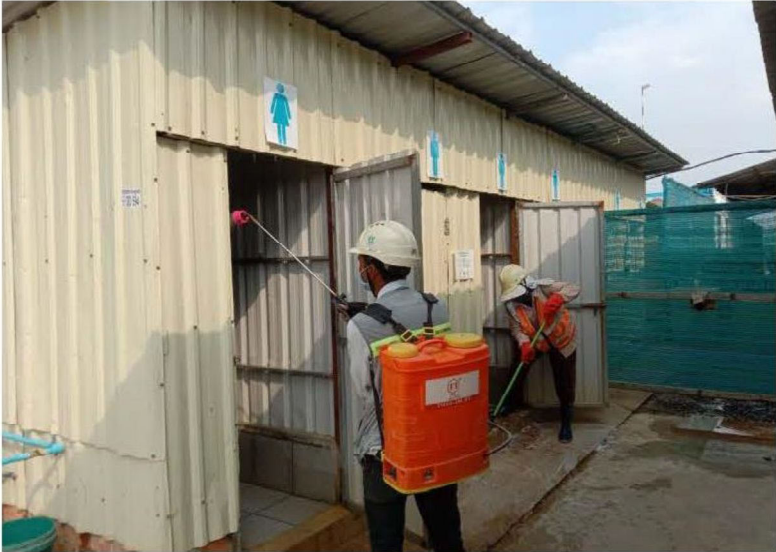
| | <p>Public Health and Safety</p> <p>Disinfecting toilets</p> <p>Sewerage Treatment Plant</p> <p>---</p> <p>---</p> <p>---</p> <p>---</p> <p>---</p> |

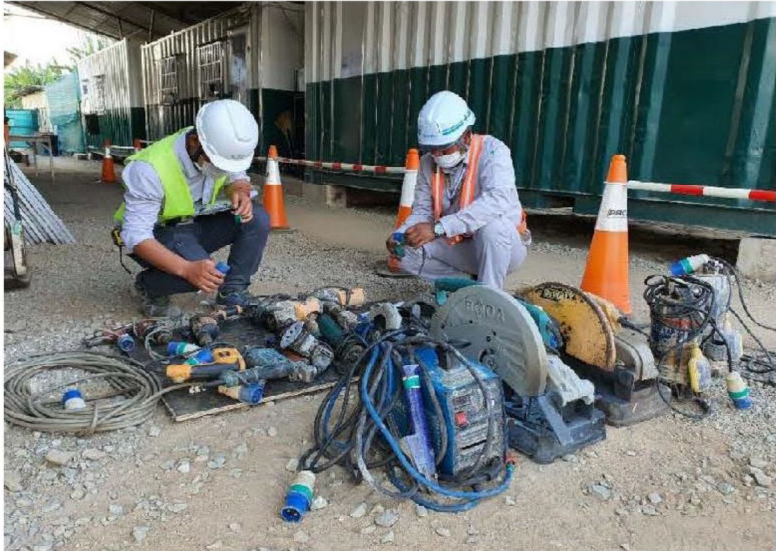
| | <p>Public Health and Safety</p> <p>Public Health and Safety</p> <p>Inspection tool</p> <p>Sewerage Treatment Plant</p> <p>---</p> <p>---</p> <p>---</p> <p>---</p> <p>---</p> |

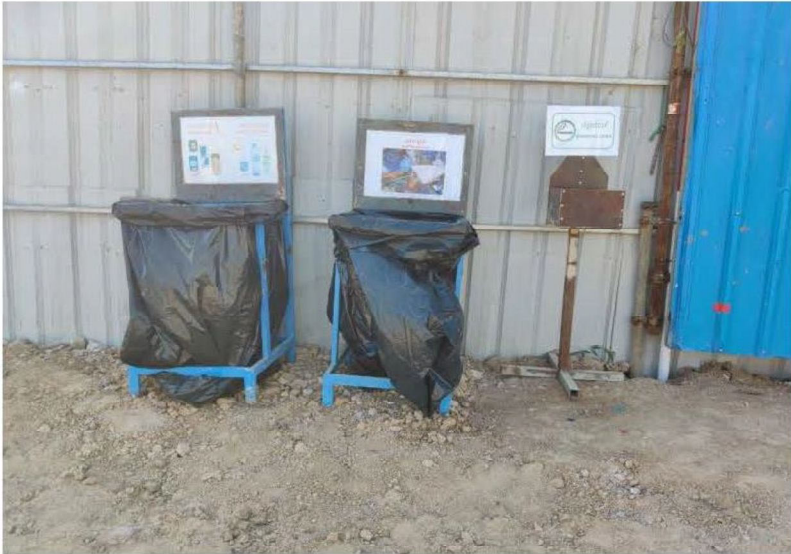
| | <p>Public Health and Safety</p> <p>The rubbish bins are installed and separate properly in the construction site Interception Facility</p> |

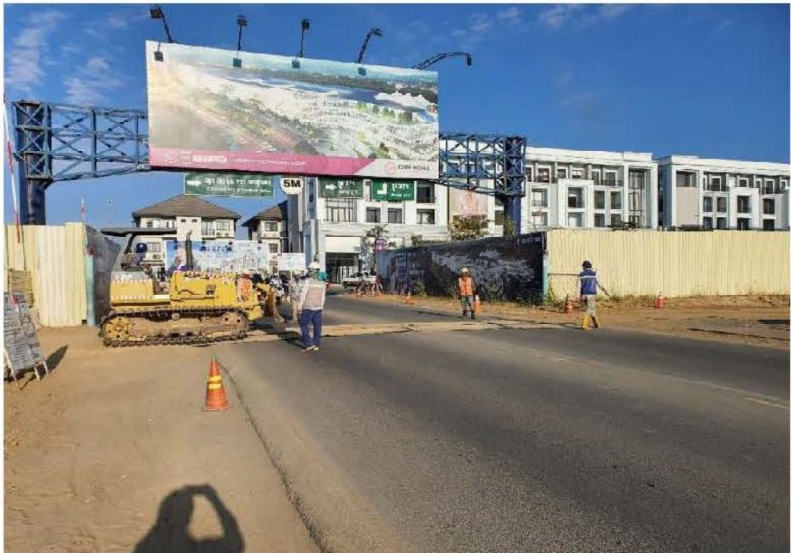
| | <p>Public Health and Safety</p> <p>Traffic control personnel are assigned on both sides when heavy vehicles are crossing on the public road.</p> |

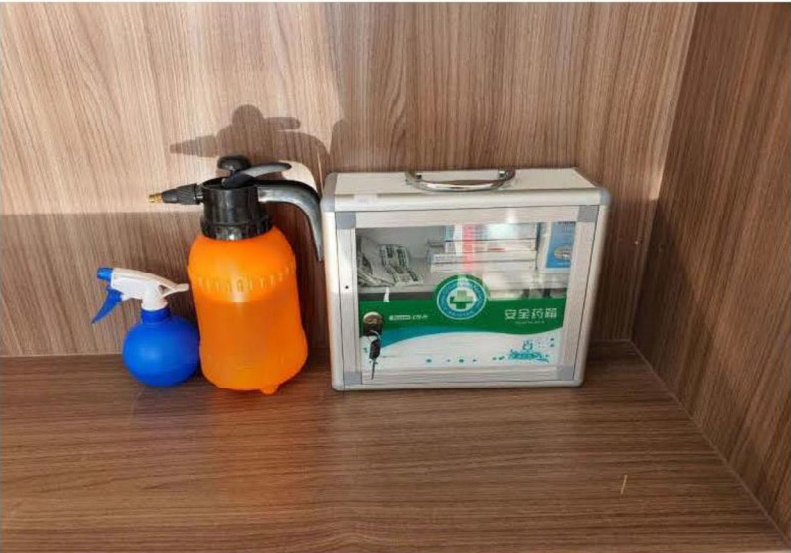
| | <p>Public Health and Safety</p> <p>First aid kit COVID-TEST Kubota office</p> |

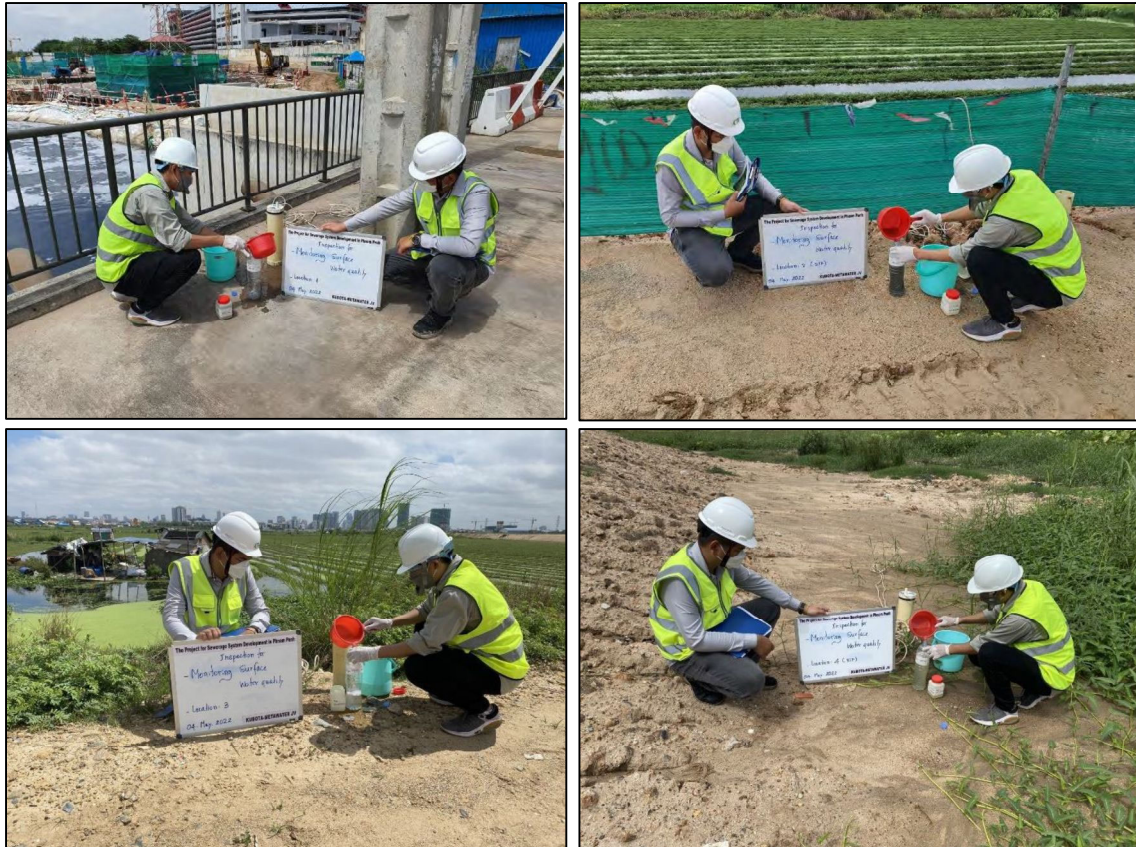
Figure2: Water quality sampling tools and equipment

- Tools and equipment: water sampler, sample bottles, cool box, etc.
- Stamping the code number and sampling date on the sample bottle.
- Sampling taken was following the WHO technique for water sampling.

The samples would keep in the cool box quickly after taking, and at the same day were sent to MoE Lab in Phnom Penh for analyzing the parameters as required by the Water Quality Survey.

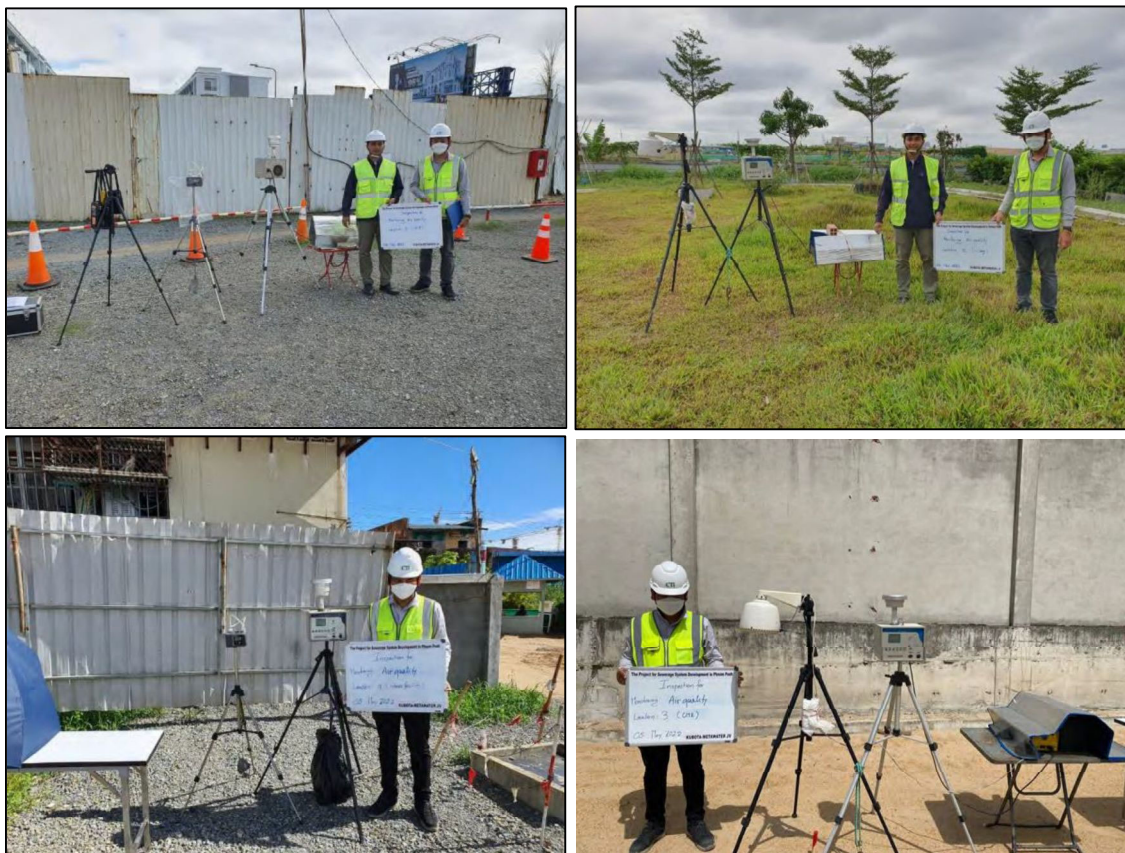
Figure 3: Air quality sampling tools and equipment

Air quality sampling was conducted on-site in the proposed project. The sampling equipment were installed at a height of 1.2 to 1.5 meters above the ground, and air quality parameters were carried out within 1 hour, 8 hours, 24 hours according to each parameter method. Air quality parameters were analyzed in the laboratory of the MOE.

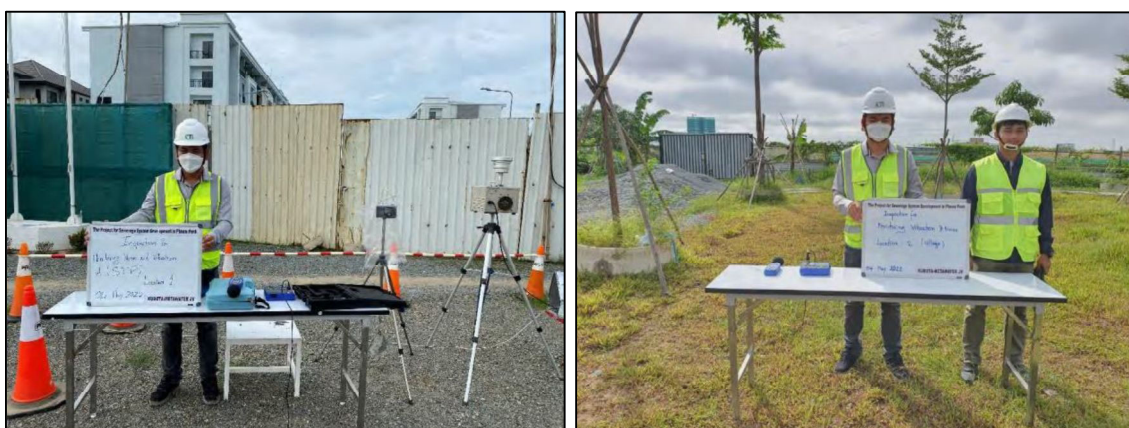
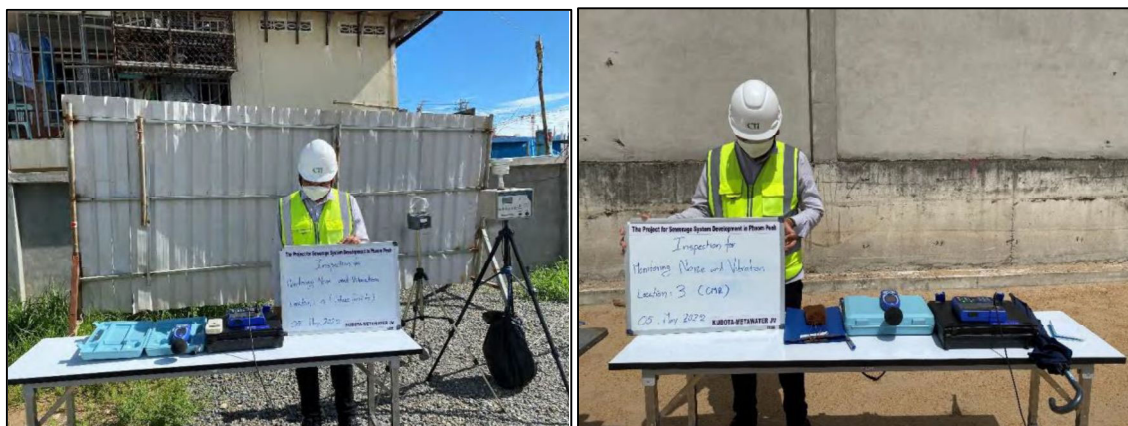
Figure 4: Noise and Vibration sampling tools and equipment

The noise and vibration were monitored from the material transportation, the operation of any machinery, generator and vehicle.

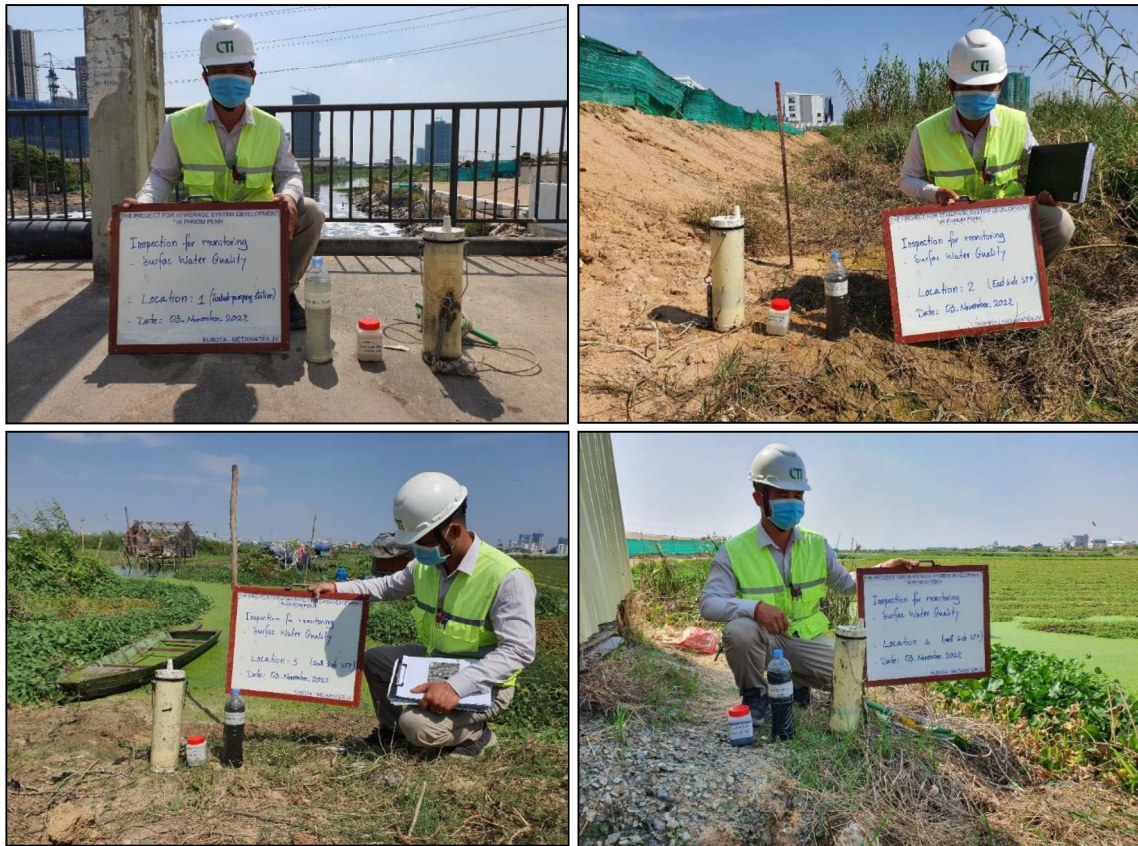
Figure 2: Water quality sampling tools and equipment

- Tools and equipment: water sampler, sample bottles, cool box, etc.
- Stamping the code number and sampling date on the sample bottle.
- Sampling taken was following the WHO technique for water sampling.

The samples would keep in the cool box quickly after taking, and at the same day were sent to MoE Lab in Phnom Penh for analyzing the parameters as required by the Water Quality Survey.

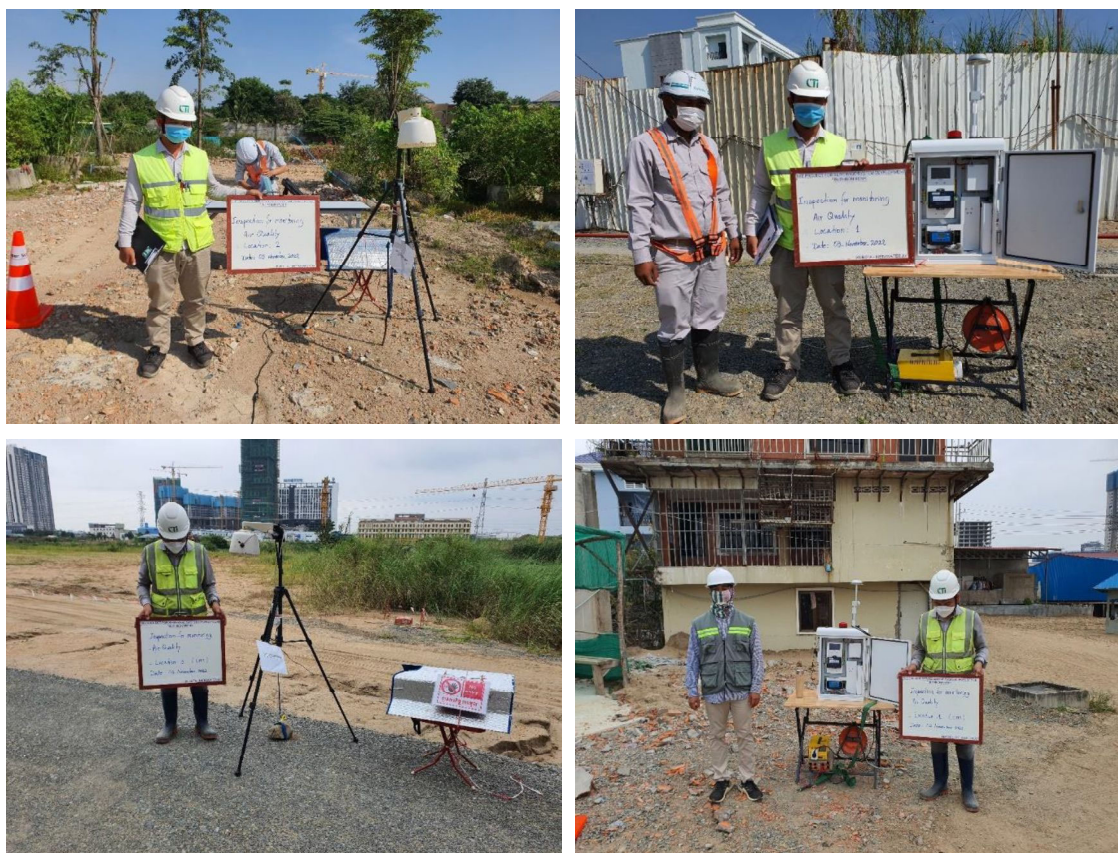
Figure 3: Air quality sampling tools and equipment

Air quality sampling was conducted on-site in the proposed project. The sampling equipment were installed at a height of 1.2 to 1.5 meters above the ground, and air quality parameters were carried out within 1 hour, 8 hours, 24 hours according to each parameter method. Air quality parameters were analyzed in the laboratory of the MOE.

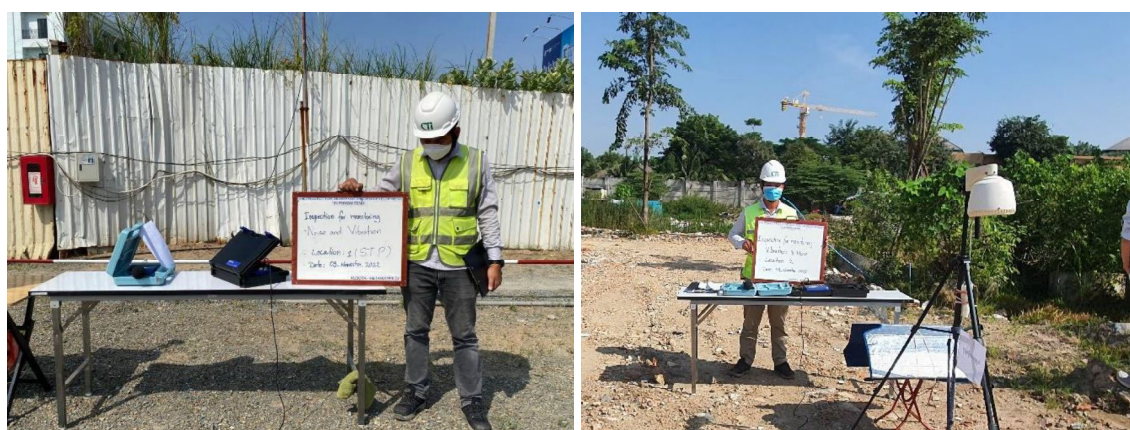
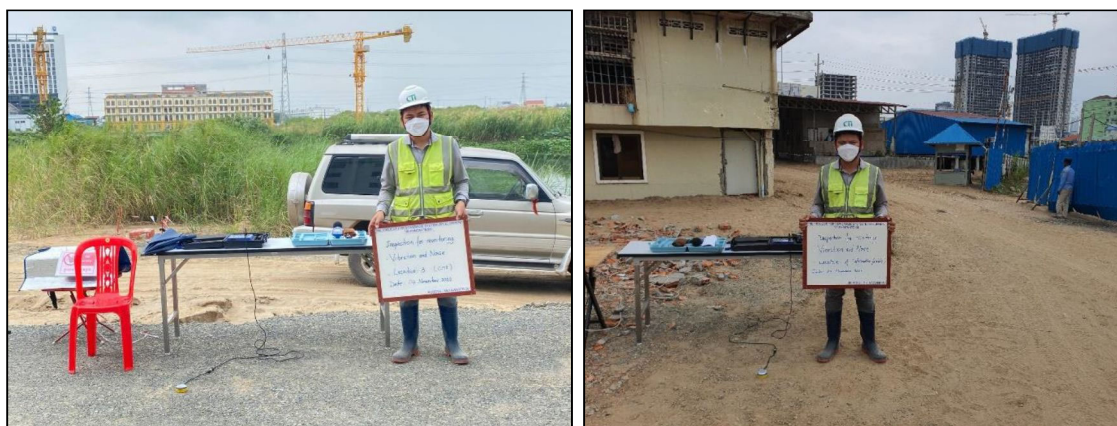
Figure 4: Noise and Vibration sampling tools and equipment

The noise and vibration were monitored from the material transportation, the operation of any machinery, generator and vehicle.

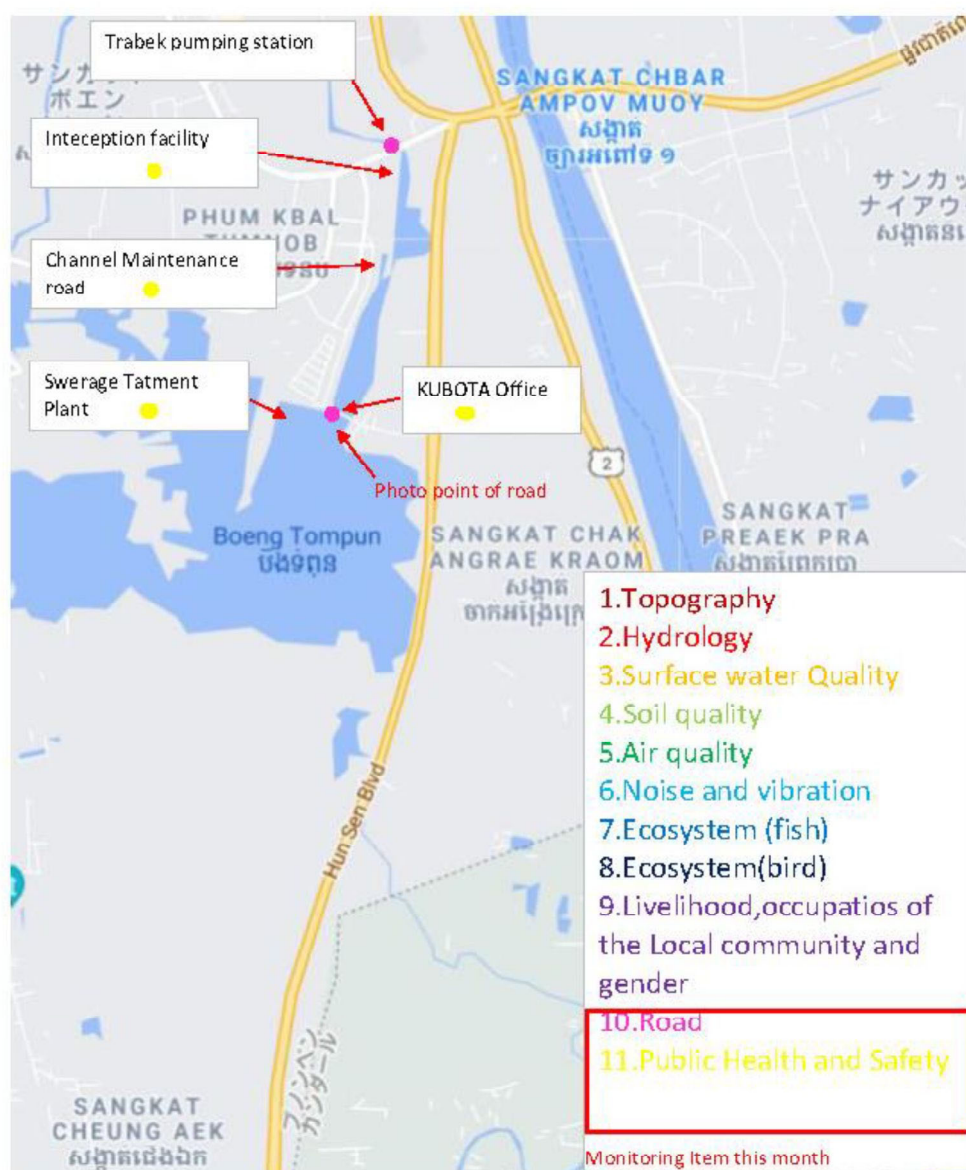
Figure 1: Monitoring Locations

The environmental monitoring was conducted in the project area and which is located in Sangkat Chak Angre Leu, Khan Mean Chey, Phnom Penh as shown in the Figure 1.

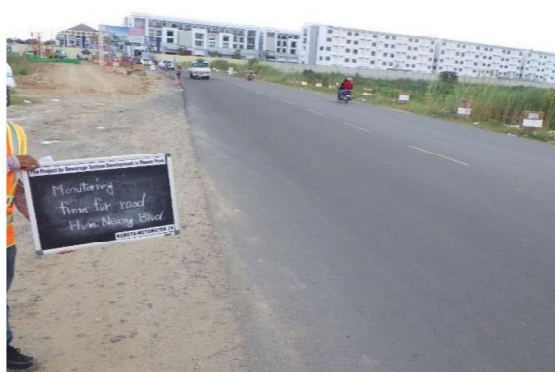
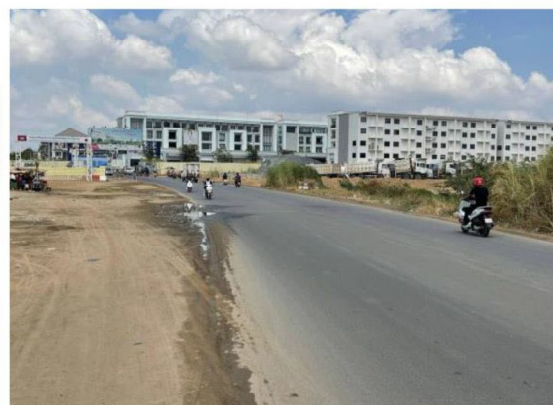
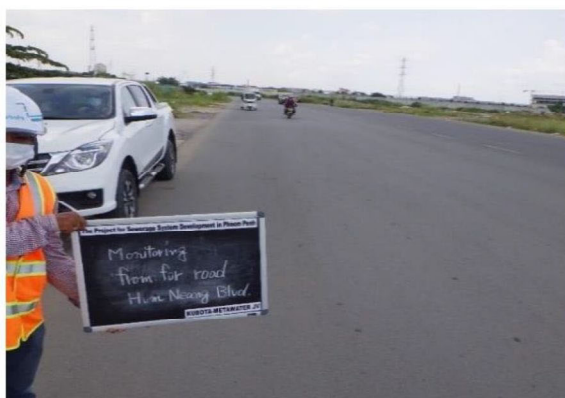
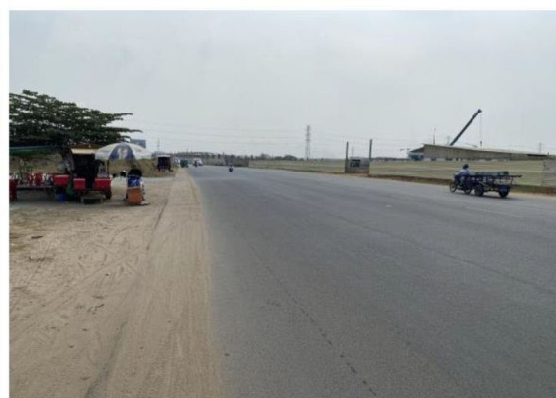
Hun Neang Road

| | | <p>The repair of damaged road by the project</p> <p>Location :Channel Maintenance Road</p> <p>Detail : Cheak the Hun Neang Road</p> <p>※ It was observed that road dusty and damaged by land owner.</p> <p style="text-align: right;">Satisfactory Unsatisfactory</p> |

※ Damage and dirt to the road is observed.

Part of road damaged condition and photo

Road damage was observed at the entrance to the landowner's backfill area on the side of the site.

Point of road damage will be discussed and repaired by landowner and road manager. The damaged road was temporary repaired (Backfilled with sand and install steel plates to prevent settlement)

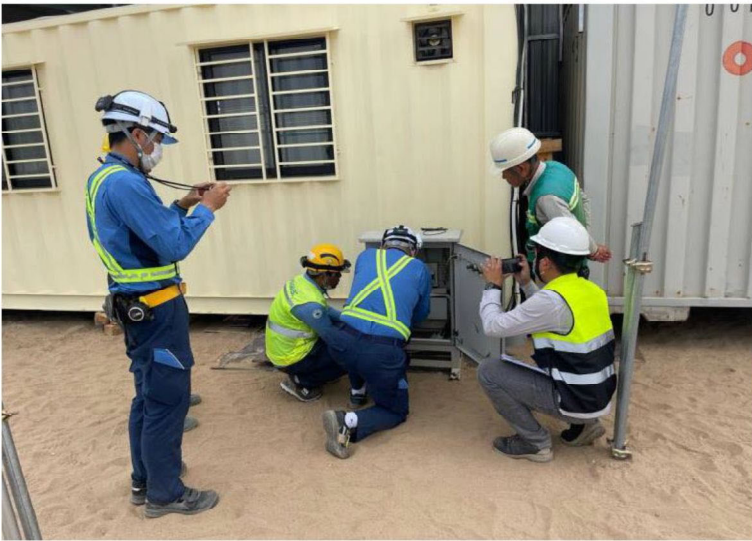
| | <div>Public Health and Safety</div> <div>ELB tested to confirm the appropriate rating and to see if it was in good working order.</div> <div>Sewerage Treatment Plant</div> <div></div> <div></div> <div></div> |

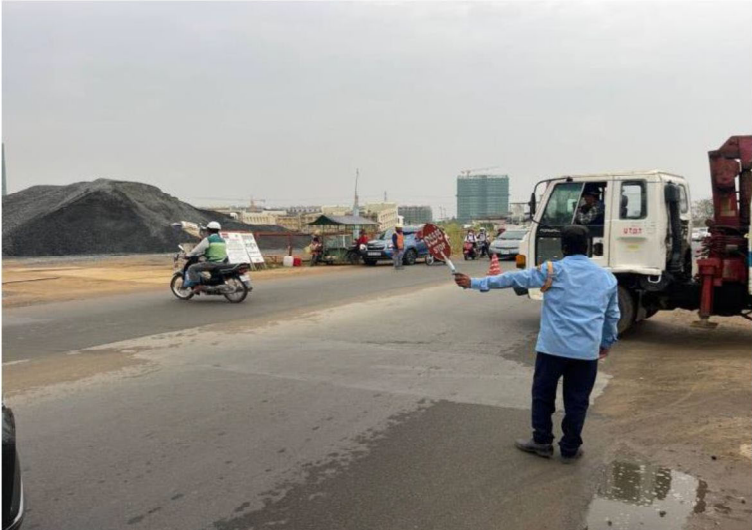
| | <div>Public Health and Safety</div> <div>Traffic control man assigned both sides when heavy vehicle grossing On the public road.</div> <div></div> <div></div> <div></div> <div></div> |

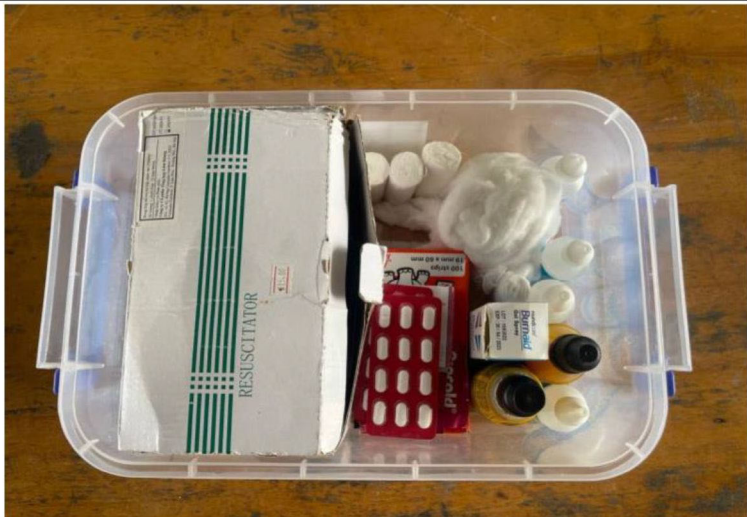
| | First aid kit |
| | COVID-TEST |

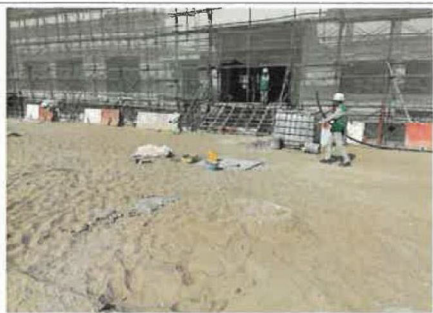
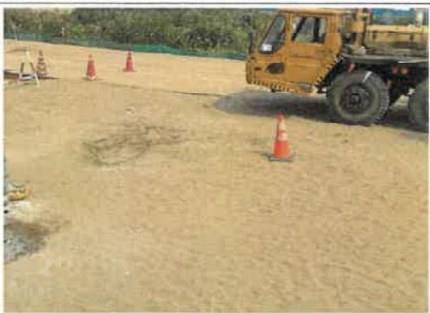
| No | Photo of Before | Photo of After (Improvement) | Action |
|---|---|--|---|
| | Finishing materials should be removed, and the area in front of the main pump building access should be kept clear. [MPB] | | Date Close 10-Feb-2023 |

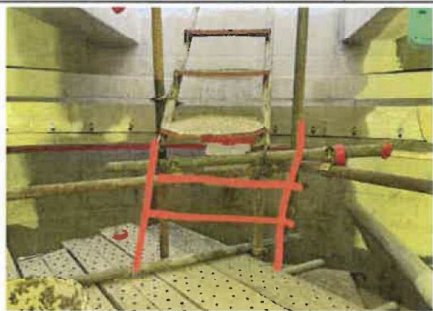
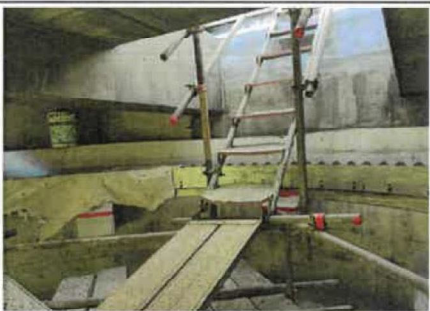
| No | Photo of Before | Photo of After (Improvement) | Action |
|---|---|--|---|
| | An equivalent length of access ladder should be prepared for workers to go inside the sludge thickener tank. [MPB] | | Date Close 10-Feb-2023 |

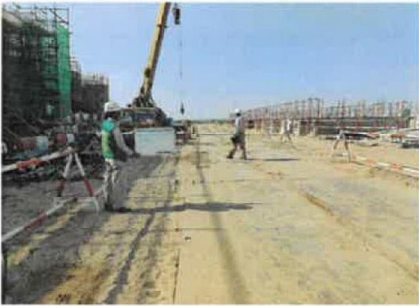
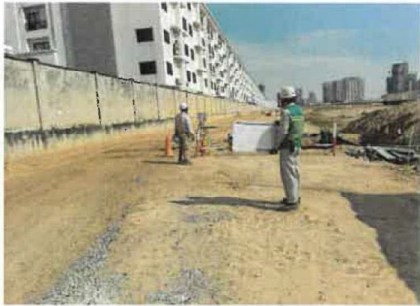
| Check site safety health and environmental condition at STP, CMR & Intake facility. | | | | Date 10-Feb-2023 | |

| <p>For Suggestion:</p> <p>Please continue to use a safety belt when working at height.</p> <p>Please continue to wear safety goggles, rubber gloves, and a mask for anticorrosive painting work.</p> <p>And scaffolding opening should be closed properly before use.</p> | | | | | |

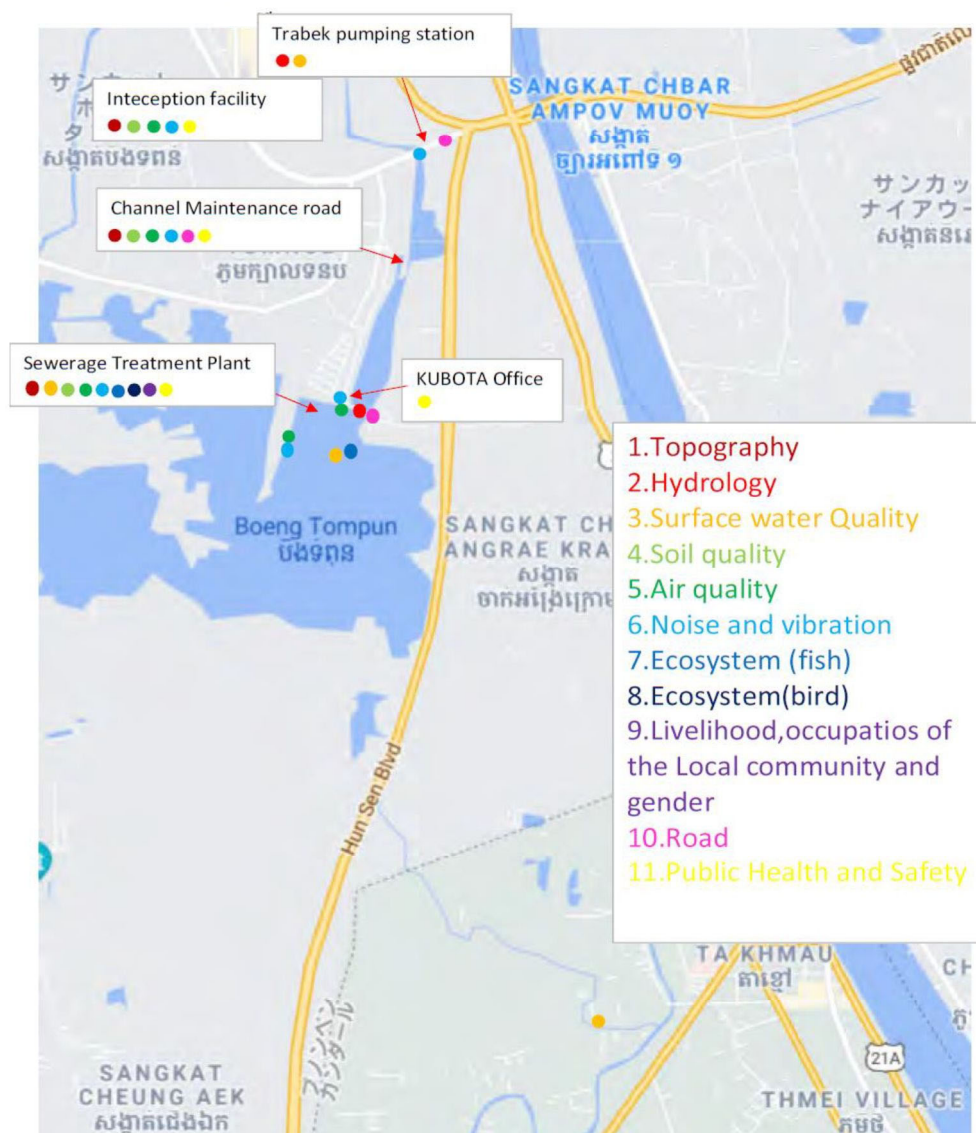
Figure 1: Monitoring Locations

The environmental monitoring was conducted in the project area and which is located in Sangkat Chak Angre Leu, Khan Mean Chey, Phnom Penh as shown in the Figure 1.

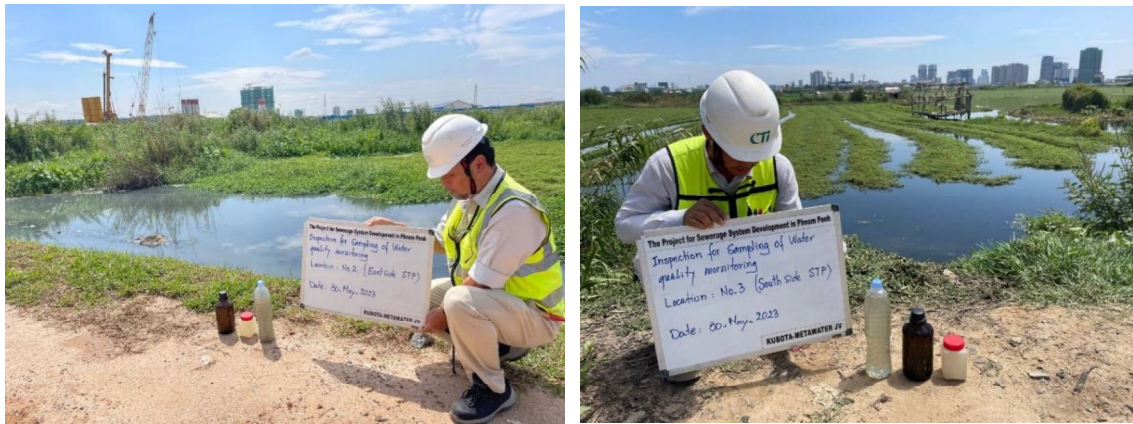
Figure 2: Water quality sampling tools and equipment

- Tools and equipment: water sampler, sample bottles, cool box, etc.
- Stamping the code number and sampling date on the sample bottle.
- Sampling taken was following the WHO technique for water sampling.

The samples would keep in the cool box quickly after taking, and at the same day were sent to MoE Lab in Phnom Penh for analyzing the parameters as required by the Water Quality Survey.

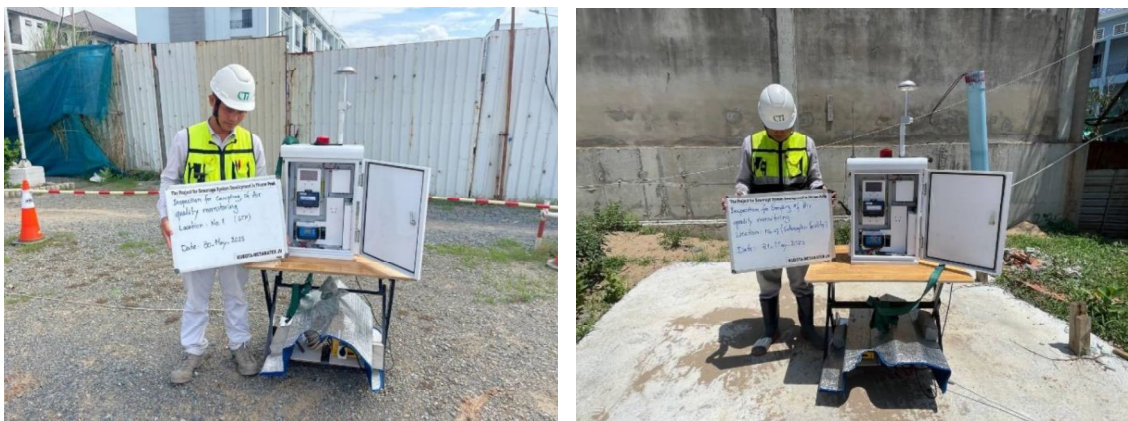
Figure 3 Air quality sampling tools and equipment

Air quality sampling was conducted on-site in the proposed project. The sampling equipment were installed at a height of 1.2 to 1.5 meters above the ground, and air quality parameters were carried out within 1 hour, 8 hours, 24 hours according to each parameter method. Air quality parameters were analyzed in the laboratory of the MOE.

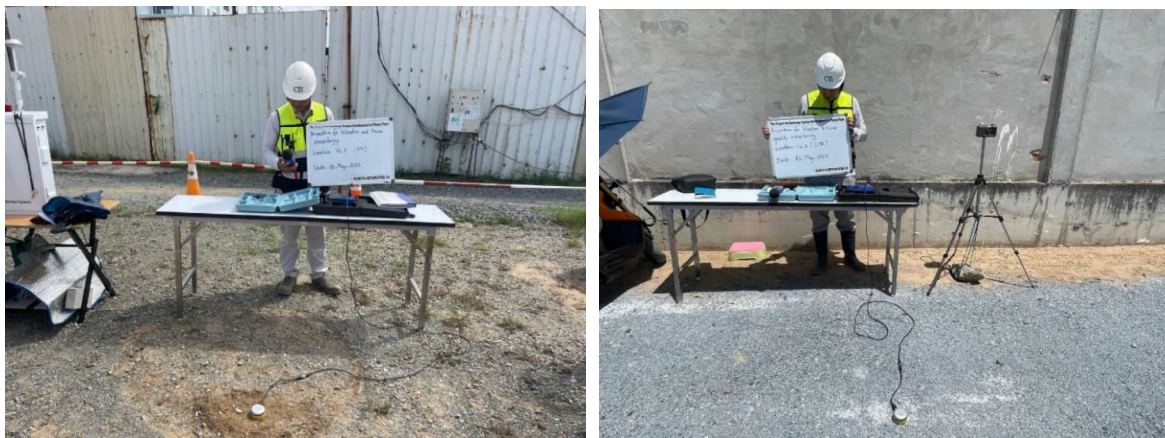
Figure 5: Noise and Vibration sampling tools and equipment

The noise and vibration were monitored from the material transportation, the operation of any machinery, generator and vehicle.

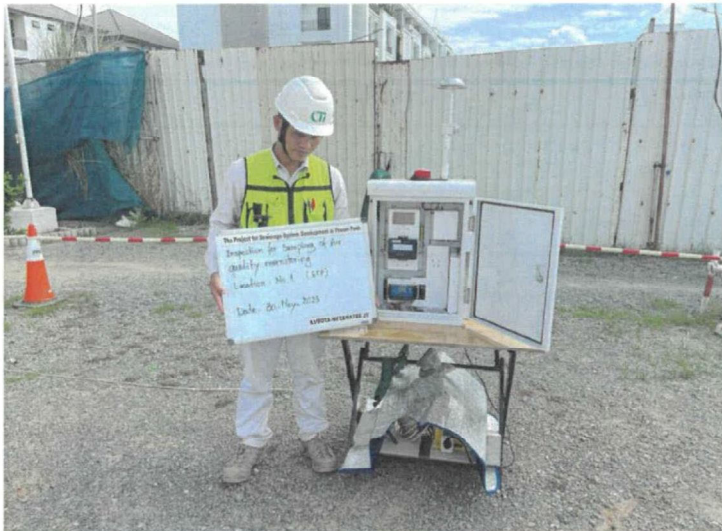
Location.1

Air quality

(Sewerage Treatment Plant)

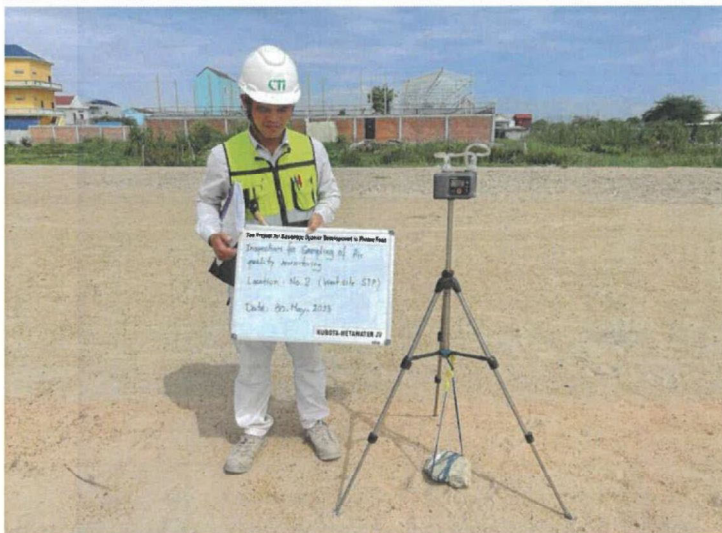
Location.2

Air quality

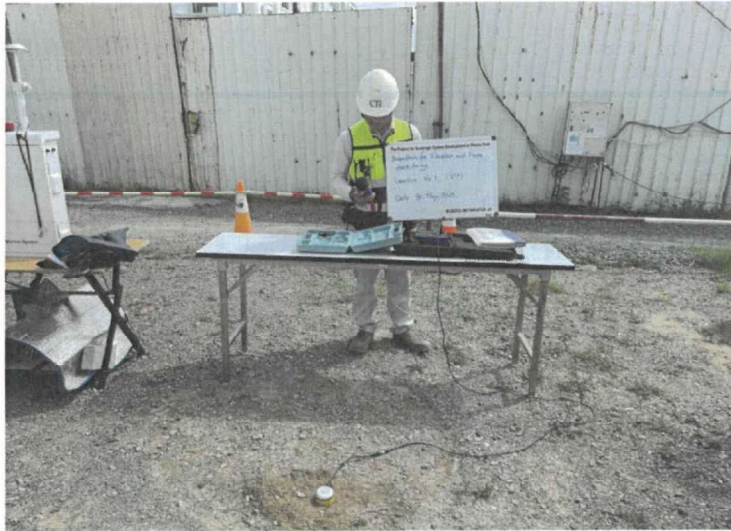
Location.1

Noise and Vibration

(Sewerage Treatment Plant)

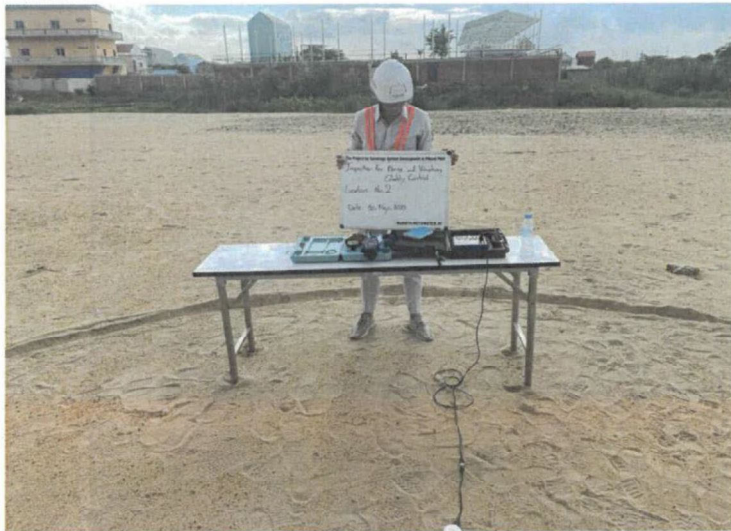
Location.2

Noise and Vibration

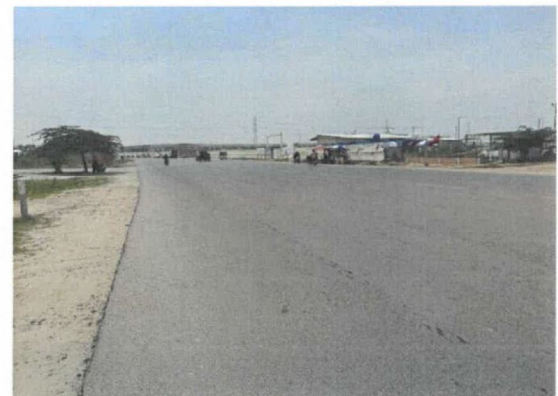
Road
Hun Neang Road
12-May-23

※ Damage and dirt to the road is observed.
Illegal parking near the site is not observed.

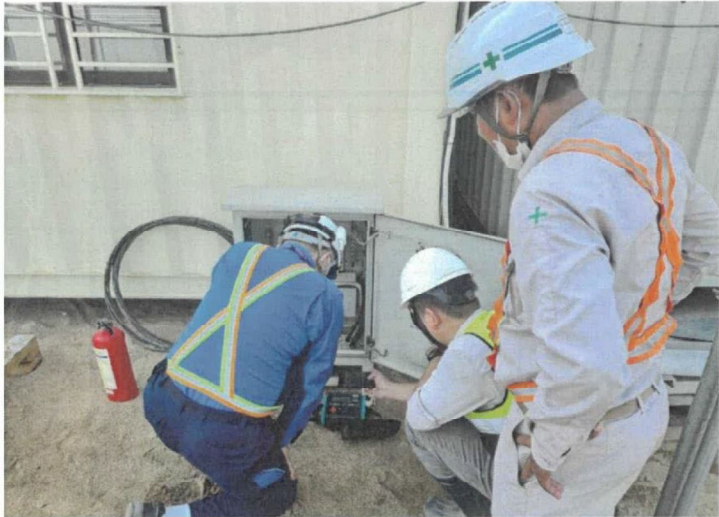
| | <p>Public Health and Safety</p> <p>ELB tested to confirm the appropriate rating and to see if it was in good working order.</p> <p>Sewerage Treatment Plant</p> |

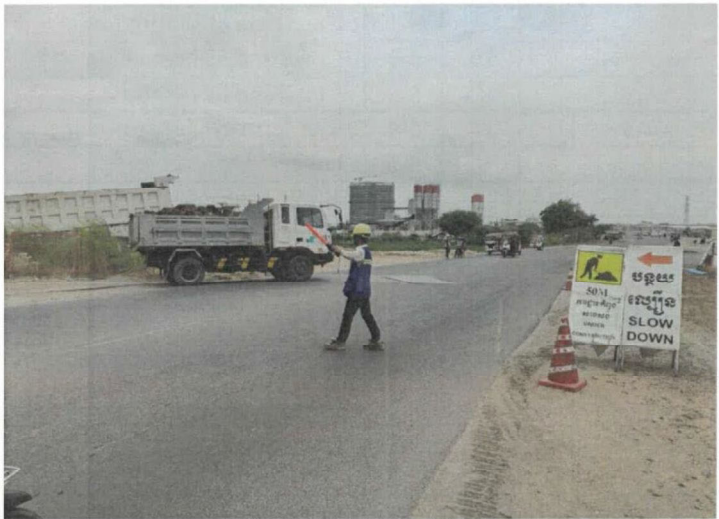
| | <p>Public Health and Safety</p> <p>Traffic control man assigned both sides when heavy vehicle crossing On the public road.</p> |

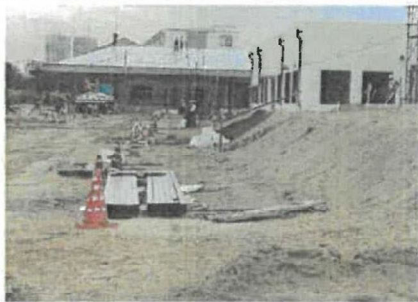
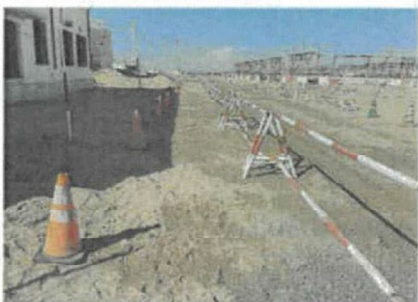
| No | Photo of Before | Photo of After (Improvement) | Action |
|---|---|--|---|
| | The temporary walkway should be well-arranged along the center access. [STP] | | Date Close 13-May-2023 |
