THE PROJECT FOR SEWERAGE SYSTEM DEVELOPMENT

JAPAN'S GRANT AID PROJECT

ENVIRONMENTAL MONITORING REPORT No.1

August 2021

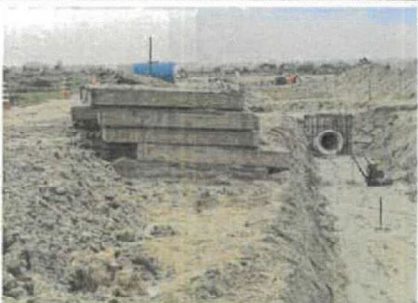
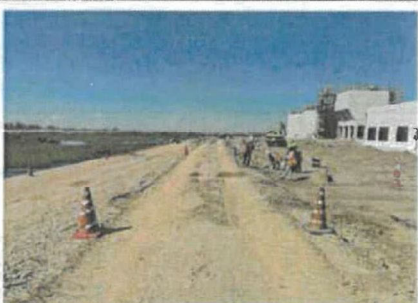
| No | Photo of Before | Photo of After (Improvement) | Action |
|---|---|--|---|
| | The steel deck should not be kept near the excavation area. and should be removed before installing concrete storm pipe. [STP- East side] | | Date Close 12-May-2023 |

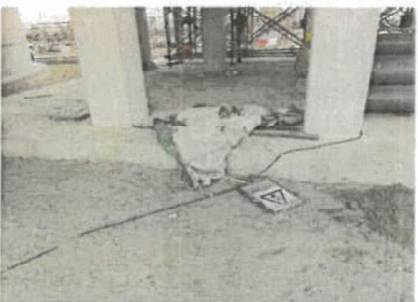
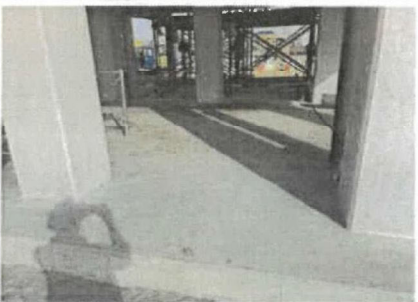
| No | Photo of Before | Photo of After (Improvement) | Action |
|---|---|--|---|
| | Unused materials must be removed, and the area must be kept clean. [FSF] | | Date Close 13-May-2023 |

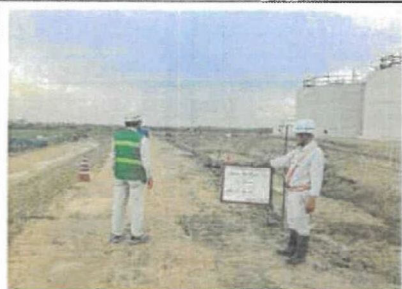
| Activity of site safety patrol | | Record by |
|--|---|--|
| Check site safety health and environmental condition at STP, CMR & Intake facility. | | Date Close 12-May-2023 |

| Activity of site safety patrol | | Record by |
|--|---|--|
| <p>For Suggestion:</p> <p>Please continue to maintain the temporary access walkway.</p> <p>All unused materials should be removed and the site should be kept properly cleaned.</p> <p>Please continue to take care to avoid falls or collapses of heavy machinery while excavating and installing concrete storm pipes.</p> | | |

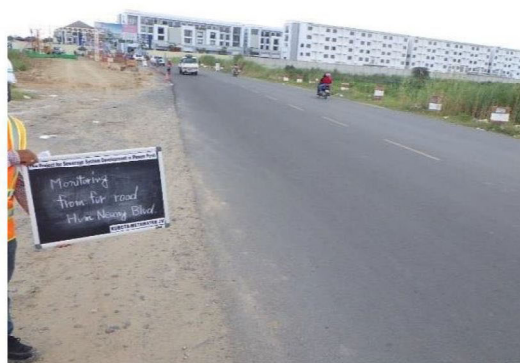
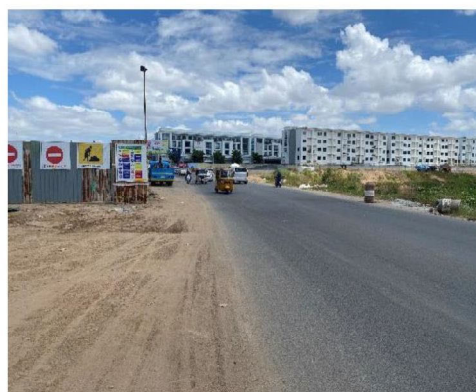
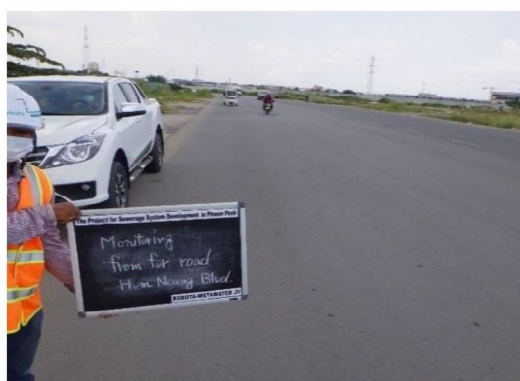
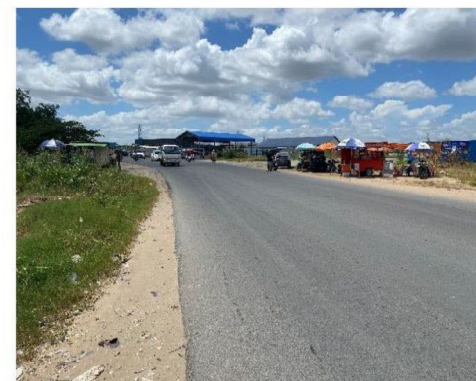
| | | The repair of damaged road by the project Location :Channel Maintenance Road Detail : Cheak the Hun Neang Road ※ It was observed that road dusty and damaged by land owner. ※ It not an effect of our project Satisfactory / Unsatisfactory |

※ Damage and dirt to the road is observed.
 Illegal parking near the site is not observed.

Road damage was observed at the entrance to the landowner's backfill area on the side of the site.

Point of road damage will be discussed and repaired by landowner and road manager.

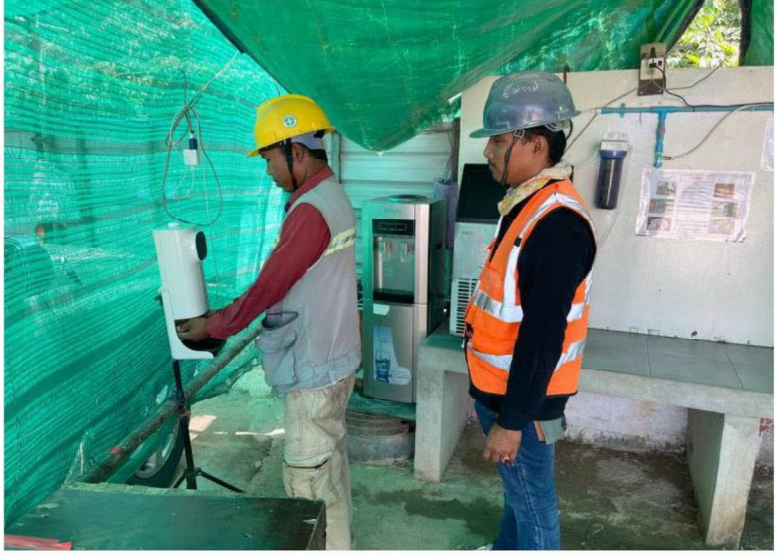
| | <p>Public Health and Safety</p> <p>Alcohol is used for hand washing in the drinking water area to prevent the spread of COVID-19.</p> <p>Sewerage Treatment Plant</p> |

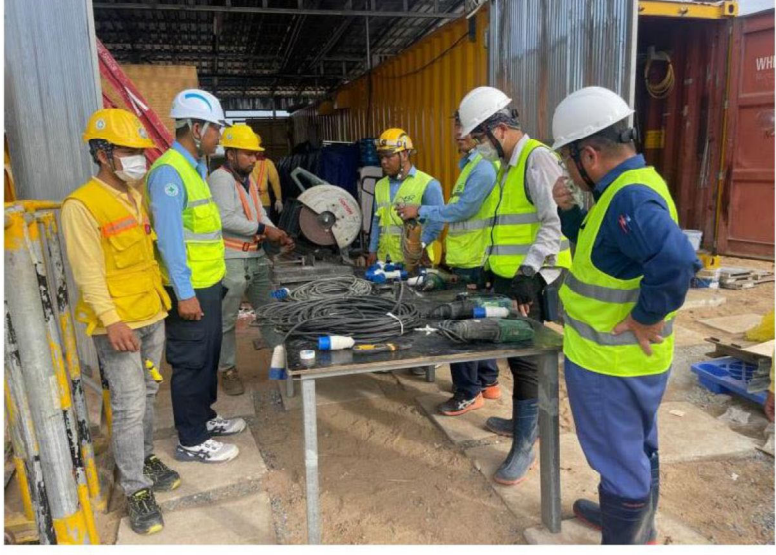
| | <p>Public Health and Safety</p> <p>Public Health and Safety</p> <p>Inspection tool and heavy machinery</p> <p>Sewerage Treatment Plant</p> |

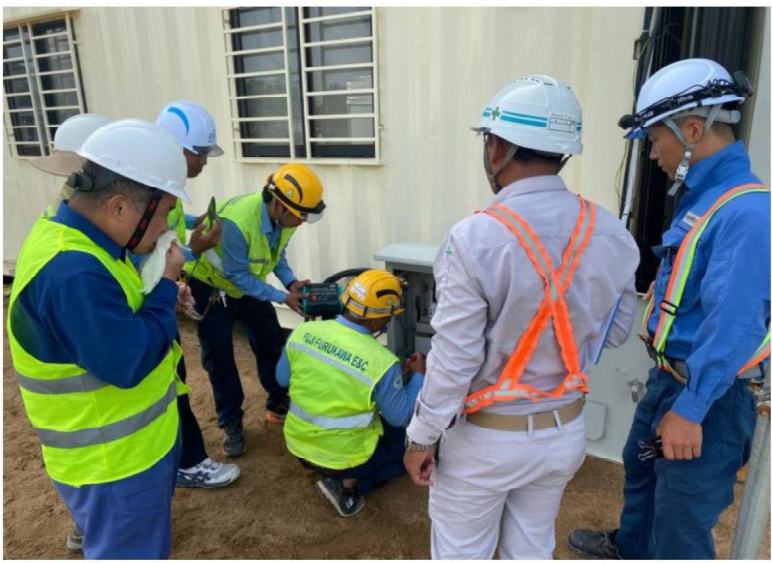
| | <p>Public Health and Safety</p> <p>ELB tested to confirm</p> <p>the appropriate</p> <p>rating and to see</p> <p>if it was in good</p> <p>working order.</p> <p>Sewerage Treatment Plant</p> |

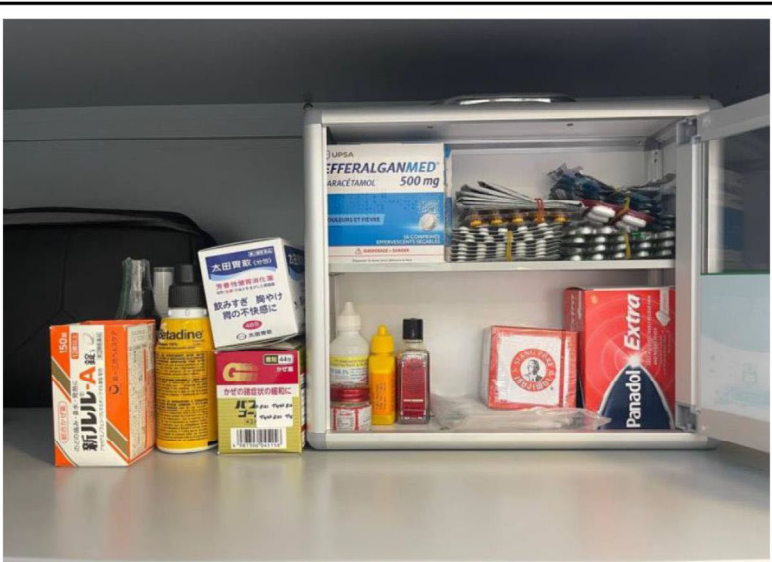
| | | The first aid room Location :Kubota and Norak office Detail : No.12, Result of site safety patrol (Items: 6-5 Other) ※Checking stock of First aid Kit and COVID test Satisfactory/ Unsatisfactory |

| | <p>Public Health and Safety</p> <p>First aid kit</p> <p>COVID-TEST</p> <p>Kubota office</p> <p>and Norak office.</p> |

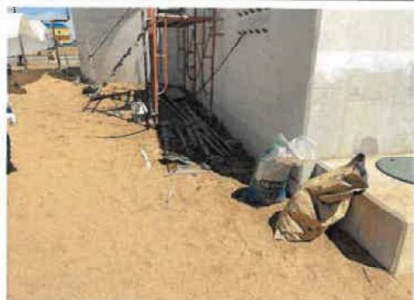
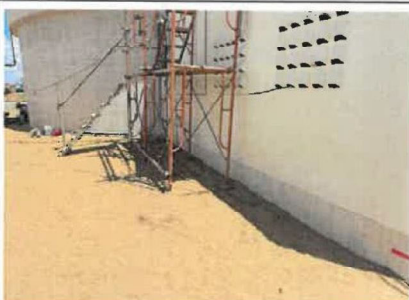
| No | Photo of Before | Photo of Improvement | Action | |
|---|---|--|--|---|
| Unused materials and concrete debris should be removed, and the site should be properly cleaned. [SDT] | | | Date Close 11-Aug-2023 | |

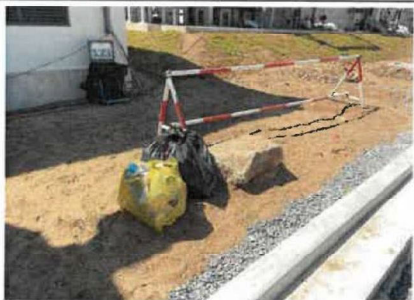
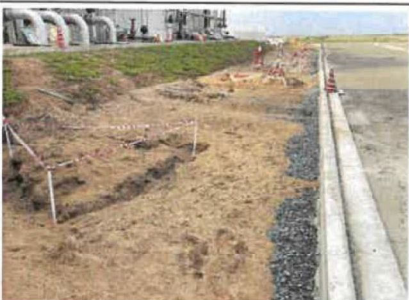
| No | Photo of Before | Photo of Improvement | Action | |
|---|---|--|--|---|
| Rubbish and concrete waste should be removed to properly clean the site. [MPB] | | | Date Close 11-Aug-2023 | |

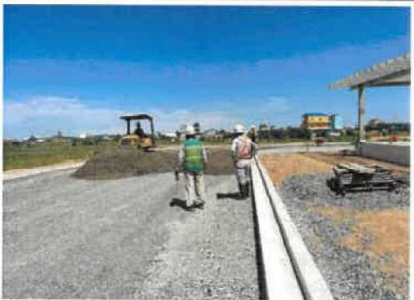
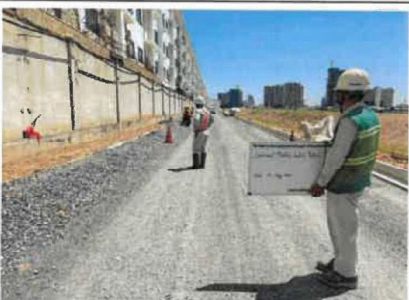
| No | Photo of Before | Photo of Improvement | Action | |
|---|---|--|--|---|
| Check site safety health and environmental condition at STP, CMR & Intake facility. | | | Date Close 14-July-2023 | |

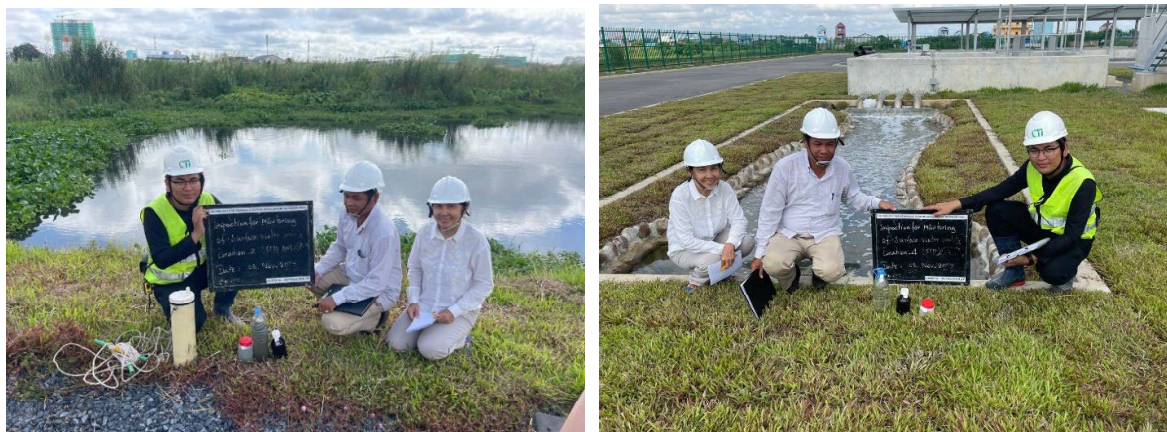
Figure 2: Water quality sampling tools and equipment

- Tools and equipment: water sampler, sample bottles, cool box, etc.
- Stamping the code number and sampling date on the sample bottle.
- Sampling taken was following the WHO technique for water sampling.

The samples would keep in the cool box quickly after taking, and at the same day were sent to MoE Lab in Phnom Penh for analyzing the parameters as required by the Water Quality Survey.

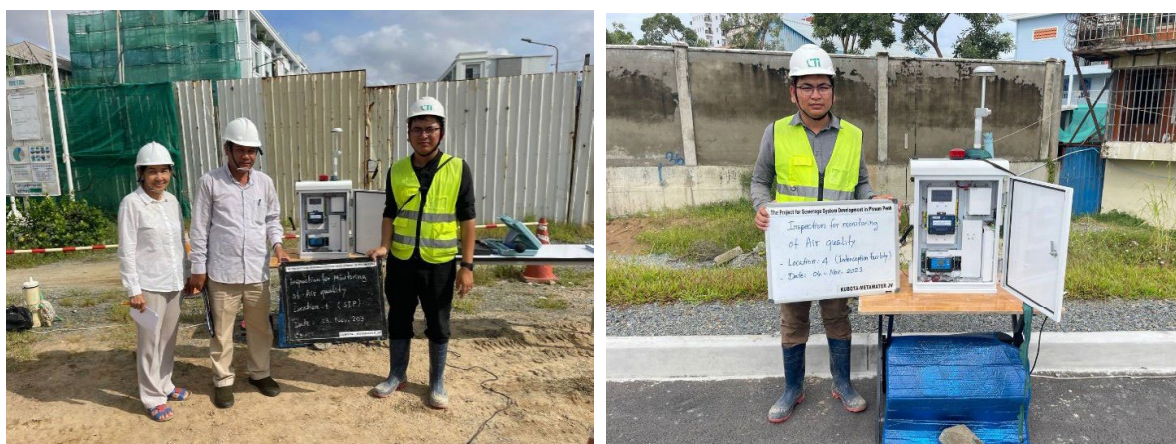
Figure 4 Air quality sampling tools and equipment

Air quality sampling was conducted on-site in the proposed project. The sampling equipment were installed at a height of 1.2 to 1.5 meters above the ground, and air quality parameters were carried out within 1 hour, 8 hours, 24 hours according to each parameter method. Air quality parameters were analyzed in the laboratory of the MOE.

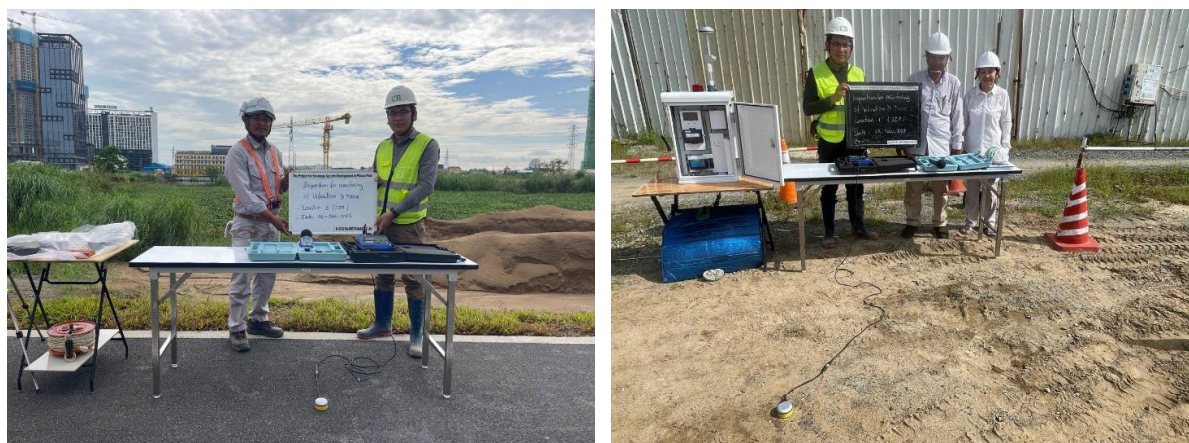
Figure 5: Noise and Vibration sampling tools and equipment

The noise and vibration were monitored from the material transportation, the operation of any machinery, generator and vehicle.

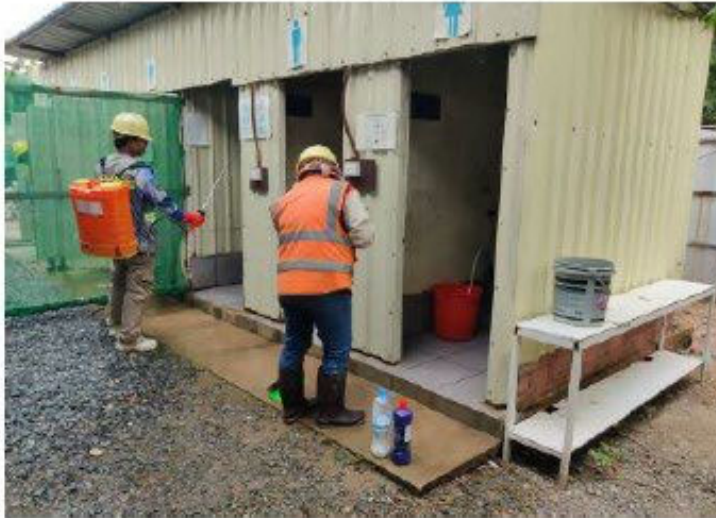
Disinfecting toilets

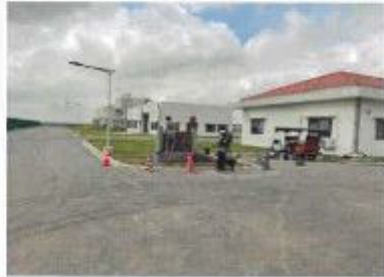
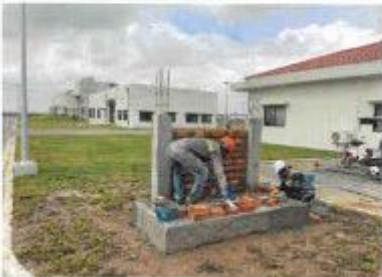
| No | Photo of Before | Photo of Improvement | Action | |
|---|--|--|--|---|
| It was observed that the worker was not wearing personal protective equipment properly. | | | Date Close 10-Nov-2023 | |

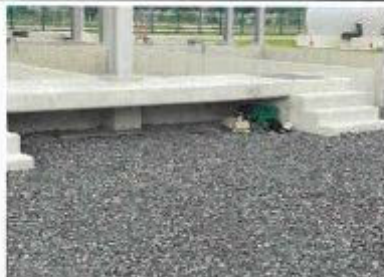
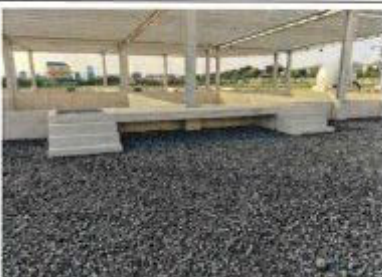
| No | Photo of Before | Photo of Improvement | Action | |
|---|--|--|--|---|
| Unused materials should be removed, and the site should be properly cleaned. [SDB] | | | Date Close 10-Nov-2023 | |

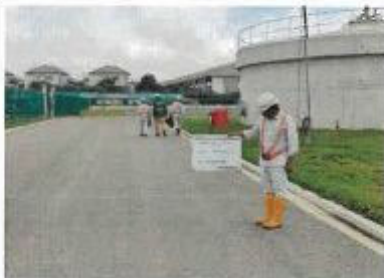
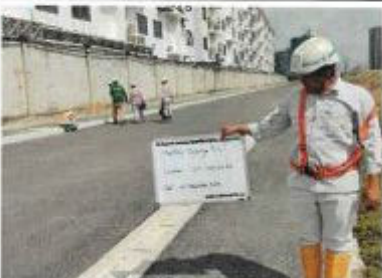
| No | Photo of Before | Photo of Improvement | Action | |
|---|--|--|--|---|
| Activity of site safety patrol | | | | |

| No | Photo of Before | Photo of Improvement | Action | |
|---|--|--|--|---|
| Check site safety, health, and environmental conditions at the Sewerage Treatment Plan, Channel Mitenance Road, and Interception Facility. | | | Date Close 10-Nov-2023 | |

| No | Photo of Before | Photo of Improvement | Action | |
|---|--|--|--|---|
| <ul style="list-style-type: none">- Please continue to take care and wear proper PPE, such as fall arrest, to avoid dropping materials on someone during the removal workshop.- A flagman should be assigned to safety control for heavy machinery for lifting and soil removal from the workshop. | | | | |
