Environmental and Social Consideration

Quarterly Progress Report

Period of October - December 2023

Directorate General of Sea Transportation

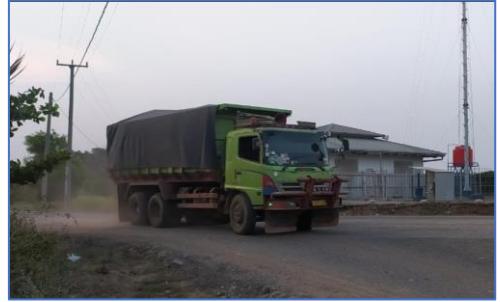
<p>Closing the tanks of material transport vehicles with tarps plays a vital role in preventing the deterioration of air quality since it could reduce the release of particulate matter and potentially harmful emissions from carry out material.</p>

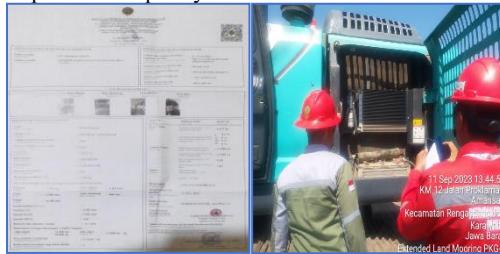
<p>Vehicles using transporting materials that have passed the KIR test and properly maintained and inspected vehicles have a lower environmental impact since those vehicles emit fewer pollutants and reduce the risk of accidents or incidents that may harm air quality. These kinds of vehicles are responsible and environmentally conscious choices when considering the impact on air quality.</p>

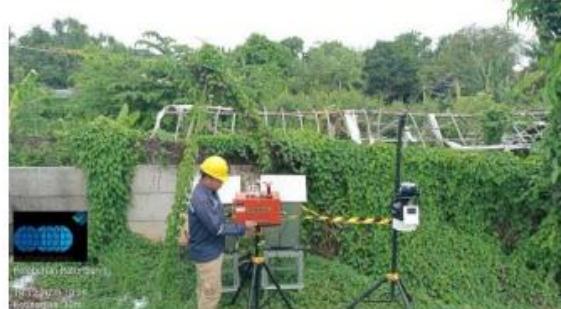
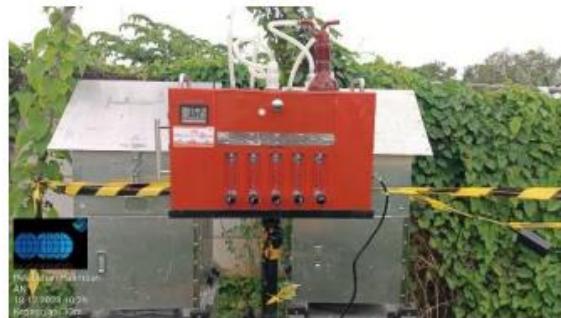
NO	Potential Environmental Impact			Descriptions of RKL/RPL		Implemented Mitigation Measures / Monitoring Results (Data and Photos are attached)
	Type of Impact	Indicators of success of Environmental Management	Impact source	Method of Environmental Management Plan (RKL)	Method of Analysis and Data Collection (RPL)	
						<p>both September 2023 and December 2023. Additionally, measurements of PM10 from both periods indicate compliance with quality standards (75), with values ranging from 16.2 to 27.6 in September 2023 and from 18.8 to 26.4 in December 2023. Finally, measurements of TSP from both periods also indicate adherence to quality standards (230), with values ranging from 39.2 to 53.1 in September 2023 and from 33.9 to 43.4 in December 2023 within the port area.</p> <p>The recent highest CO levels were recorded at location AN1 (front gate road access) at 286 µg/m³. Similarly, the recent highest PM10 levels were recorded at AN1 with a value of 26.4 µg/m³. As for the TSP (dust) parameter, the highest levels were also observed at AN1, registering at 43.4 µg/m³. These elevated levels can be attributed to heavy traffic activity along the Patimban Port access road and the Pantura road.</p>

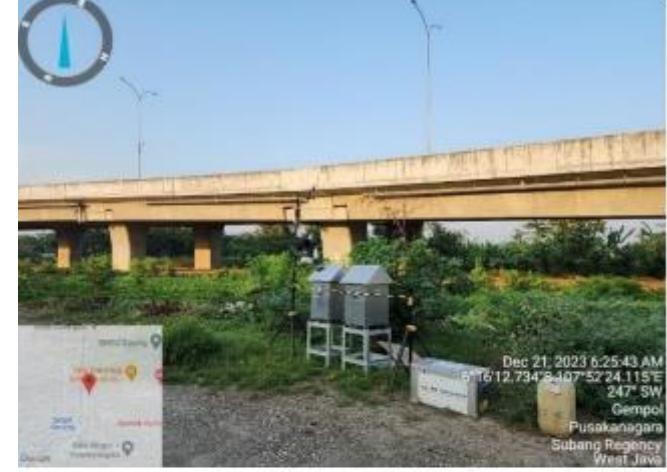
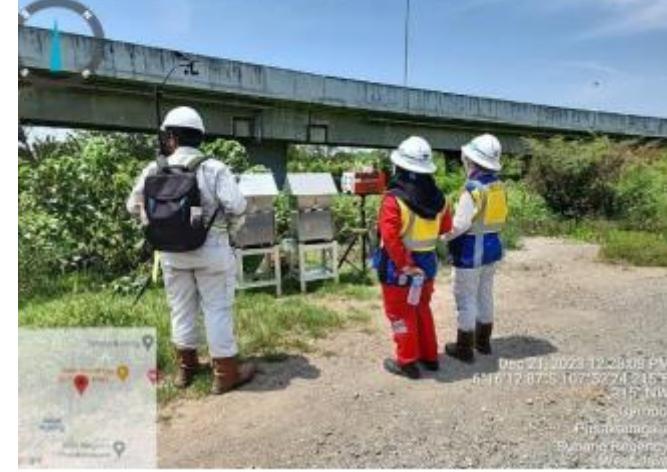
<p>Notes: The information regarding air quality sampling (TSP and emission) from is shown at Detail Natural Sub Chapter 2-3</p>

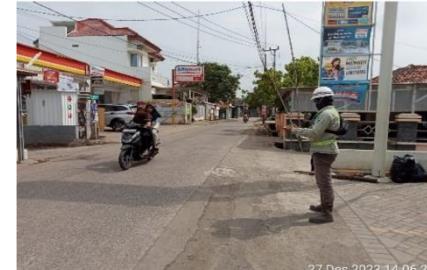
<p>Traffic count at Patimban Village Road</p> <p>Package 6 Implementation:</p> <p>The traffic count conducted by contractor of Package 6 on October and December 2023 was reported that during the monitoring period, there was no accident nor traffic jam related to the project committed by Package 6. The regulation was applied and met to avoid accident and traffic jams; as well as for regular traffic counting. As of June 2020, trucks for heavy equipment material transportation used the temporary access road to avoid influence at the public road.</p>

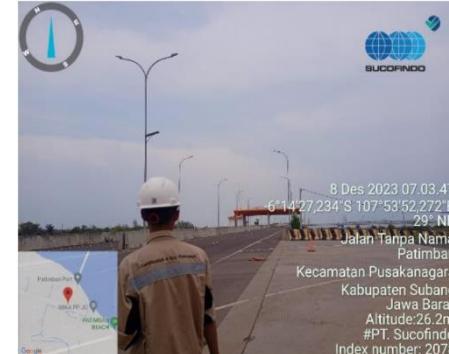
<p>8 Des 2023 07:03:47 6°14'27.234"S 107°53'52.272"E 29° NE Jalan Tanpa Nama Patimban Kecamatan Pusakanagara Kabupaten Subang Jawa Barat Altitude: 26.2m #PT. Sucifindo Index number: 2078</p> <p>Traffic count at Patimban Port Gate</p>
3C	Sea traffic disruption	No occurrence of ship collision on the Patimban area.	Heavy equipment and materials mobilization.	a. Coordinating with KSOP Class II Patimban about material sea transportation routes. b. Coordinating with Navigation District Class I Tanjung Priok about materials transportation sailing line. c. Socializing materials of sea transportation route to the fishermen. d. Organizing material sea transportation time. e. Project proponents and contractors open	a. Monitoring sea traffic conditions. b. Identifying the accident number that occurred. [CP5, CP6]	The traffic condition affected by the project was monitored periodically. During the period of October – December 2023, Contractors of Packages 5 and 6 monitored the sea traffic accidents situation. Based on the monitoring report, it showed that there were no ships that had collision in the Patimban port area. Coordination with Navigation District Class I Tanjung Priok had been conducted at the early stage of port construction activity, on 20 th February 2019, concerning the Discussion of the initial design of navigation aids placement for the sailing channel of Patimban Port. The contractor of Package 2 coordinated with Navigation District Class I Tanjung Priok Regarding Mobilization / Demobilization and Installation for Aid of Navigation as shown in the picture below.

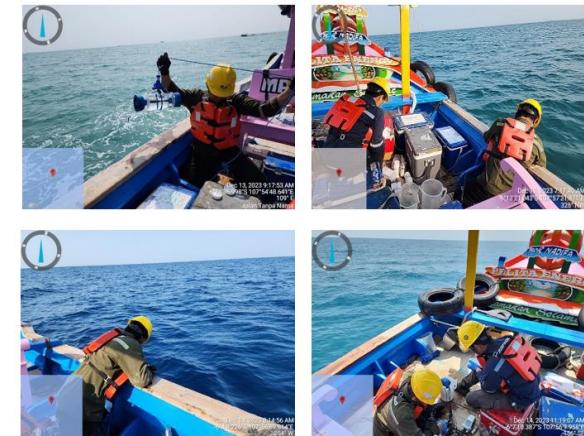
<p>Sea water quality sampling with van dorn tube and indirect measurement of TSS using turbidity meter.</p> <p>Most recent quarterly sampling activities were conducted in December 2023, encompassing four offshore dumping location and eight locations within the port area, resulting in a total of 12 samples collected. The analysis of seawater quality samples reveals that most parameters tested meet the quality standards outlined in PPRI No.22/2021, Appendix VIII, except for Transparency. Notably, mercury levels exceed the quality standards stipulated by Japan Standard. During the monitoring period, fluctuations were observed in certain parameters at each monitoring location, particularly in Transparency and coliform parameters. However, values for other parameters generally remain below the laboratory detection limit. Regarding Transparency, locations around the dumping area (W7-W10) generally exhibit values meeting quality standards (>3 m), ranging between 8 – 12 m. Conversely, Transparency values around the port area typically do not meet the quality standard, ranging between 1-3 m. The variance is attributed to sediments transported by rivers that flow into the waters of Patimban Port, namely the Cipunegara River, Genteng River, and Tanjung Pura River, which impact the transparency of seawater.</p>

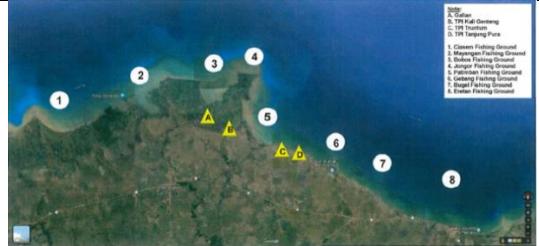
<p>Map of fishing ground area in adjacent Patimbang area</p>

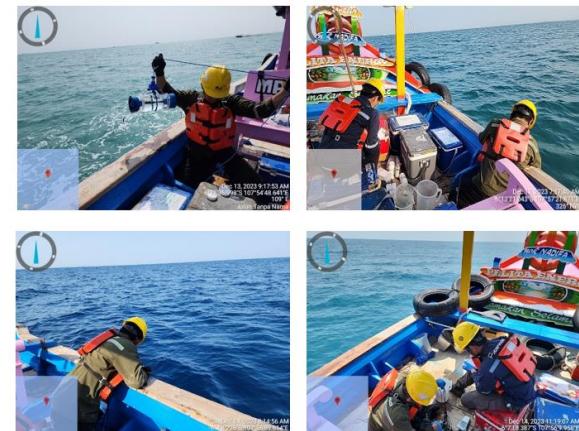
Sea water quality sampling with van dorn tube and indirect measurement of TSS using turbidity meter.

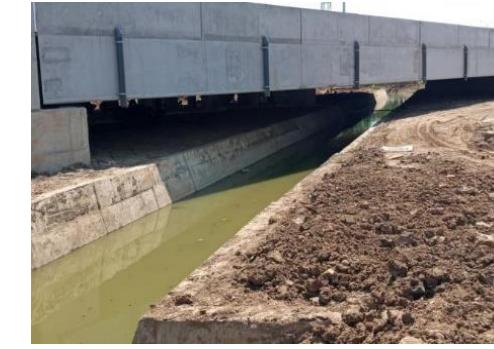
<p>Irrigation channel under the access road development</p> <p>The onshore facility development is currently limited to the construction of outer roads. In addition, KSOP Class II Patimban is presently building the drainage to anticipate the potential of water runoff and prevent flooding.</p>

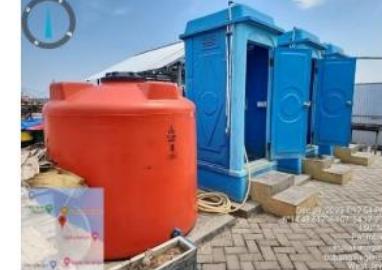
Managed other environmental impact						
CONSTRUCTION PHASE						
2.	Procurement of Labor and Basecamp operation					
2A	Deterioration of seawater quality	The worker's domestic waste does not pollute seawater.	Procurement of labor and basecamp operation	<p>Installation of portable toilet and wastewater processing facility such as septic tank and its maintenance</p> <p>[CP5, CP6]</p>	<p>Monitoring on maintenance situation of sanitary facilities, and wastewater management facilities.</p> <p>[CP5, CP6]</p>	<p>❖ <u>Implemented Environmental Management/Mitigation Measures</u></p> <p>- Installation of portable toilets</p>

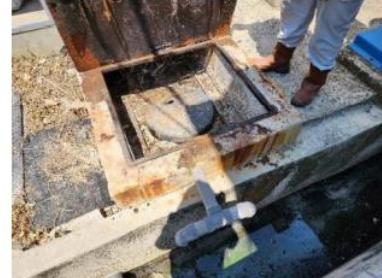
<p>Documentation of maintenance of closet and urinous/sanitation facility at administration office</p>

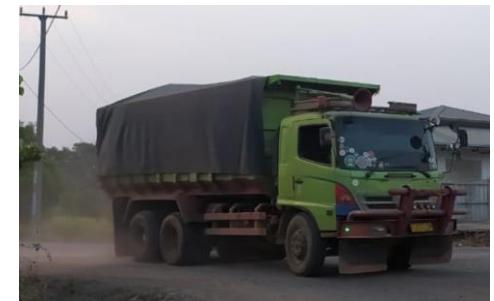
<ul style="list-style-type: none"> - Heavy equipment and materials mobilizations are not conducted in convoy.

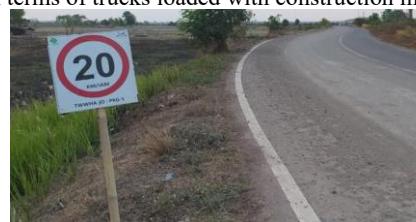
<ul style="list-style-type: none"> - Providing sign board for limiting the speed of project vehicles, especially in terms of trucks loaded with construction materials.

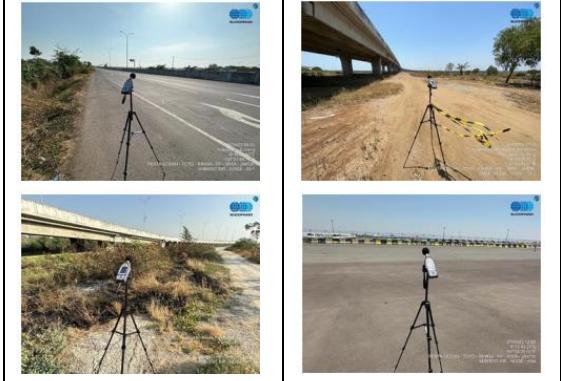
<p>Documentation of noise intensity measurement</p>
Note: More detail is described in subchapter 2.4.						
4	Reclamation and Marine Facility Construction (Supplementary Note on Approved AMDAL/EIA)					
4A	Disturbance of marine life (Nekton and Benthos)	Marine life is not much disturbed by the project	Reclamation and marine facility construction.	N/A	<p>Monitoring nekton and benthos then comparing with baseline survey result</p> <ul style="list-style-type: none"> ■ at 5 site locations at the sea for nekton (N1-N5) in 6 monthly period. ■ at 10 site locations at the sea for benthos (S4-S13) in yearly period as transition monitoring. [CP6] 	<p>❖ <u>Implemented Environmental Monitoring</u></p> <p>The diversity index (H') for nekton ranged from 0.102 to 1.006. Regarding the equitability index (E'), values across all locations ranged from 0.109 to 0.388, and the dominance index ranges from 0.163 at location N4 to 0.883 at location N1.</p> <p>In the December 2024 sampling period, benthos diversity index (H') values in both dumping and port areas ranged from 0 (B12) to 1.64 (B8). For the equitability index (E'), locations B9 and B10, situated on the east side of Patimban Port, exhibit values of 1, indicating abundant species presence. However, other locations range from 0 to 0.92. The dominance index ranges from 0.33 at location B9 to 1 at location B12, suggesting individual species dominance in certain areas.</p>

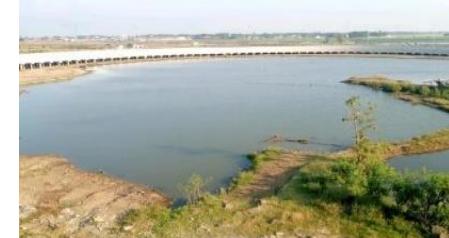
<p>Retention pond before discharging to sea.</p>

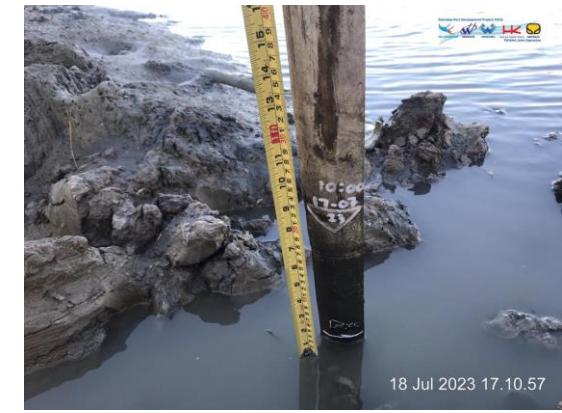
<p>Controlled dewatering of former fishpond at proposed temporary yard area.</p> <p>❖ <u>Implemented Environmental Monitoring</u></p> <p>Recent quarterly sampling activities were conducted in December 2023, encompassing four offshore dumping location and eight locations within the port area, resulting in a total of 12 samples collected.</p> <p>The analysis of seawater quality samples reveals that most parameters tested meet the quality standards outlined in PPRI No.22/2021, Appendix VIII, except for Transparency. Notably, mercury levels exceed the quality standards stipulated by Japan Standard.</p>

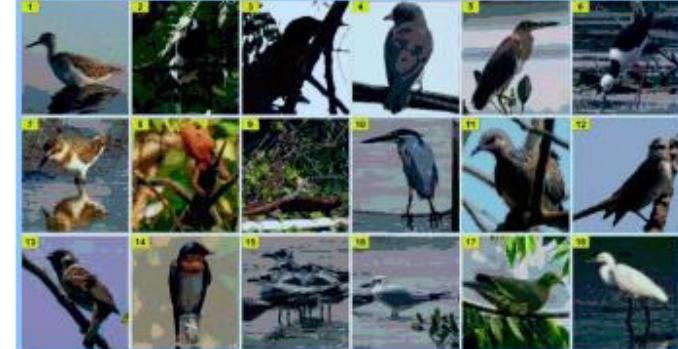
<p>❖ Monitoring fauna was conducted.</p> <p>The total type of fauna monitored during this period was recorded as 45 species, consisting of 6 types of mammals, 29 types of avifauna, 3 types of amphibians and 7 types of reptiles. Based on location, the highest fauna composition is found at location F#03 (former rice fields and ponds) and the lowest at location F#01 (shrubs/bushes). Based on family, mammal groups/taxa are divided into 5 families with the largest number of species in the Viverridae family. The group of birds/taxa (avifauna) is divided into 20 families with the largest number of species in the Apodidae, Ardeidae and Estrildidae families, each with 3 species. Amphibian groups/taxa are divided into 2 families with the largest number of species in the Ranidae family. Reptile groups/taxa are divided into 6 families with the largest number of species in the Colubridae family. As for the protection status, there are 2 types of mammals and 5 types of avifauna that are protected based on Government Regulation Number 7 of 1999; Meanwhile, based on</p>

<p style="text-align: center;">Fauna survey documentation</p>

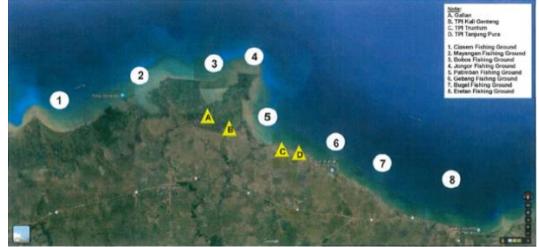
<p>Map of fishing ground area in adjacent Patimban area</p>

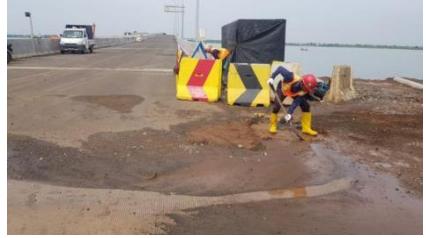
<p>Road cleansing</p>

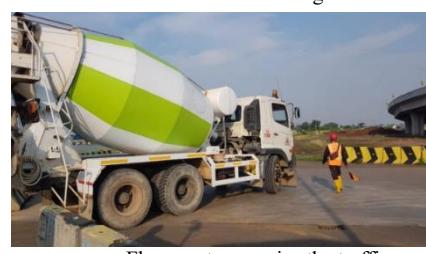
<p>Flagman to organize the traffic</p>

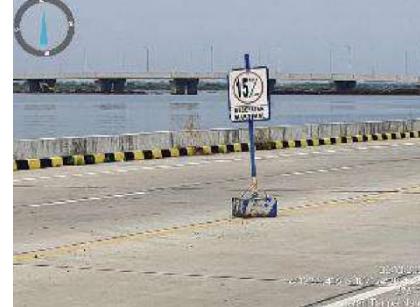
Speed vehicle limitation information

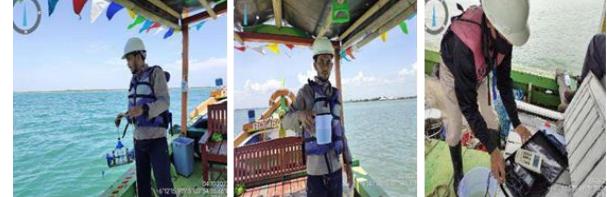
<p>Sea water quality sampling with van dorn tube and indirect measurement of TSS using turbidity meter.</p> <p>Sampling results from the sea water quality quarterly laboratory indicate that almost all parameters met the Indonesian standards, except for transparency and pH (exceed Japanese standard). Note: Further detailed description is reported in Subchapter 2.1</p>

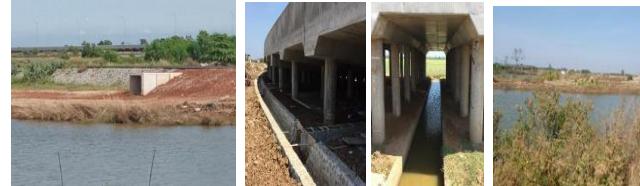
b. Maintaining drainage [KSOP]		<p>❖ Construction of Side drain and Cross drain, as well as several retention ponds (from ex-site clearing basin or ponds), are still maintained to support the area's drainage system.</p>

<p>Box culvert in drainage system at pond's area Construction of Side drain, Cross drain Temporary retention pond</p>
9C	Alteration of land use/land conversion	The appearance of settlements and various public facilities and economic facilities around the access road location	Access road operation	a. Making guardrail along Patimban access road was constructed, but still provides underpass/overpass access, box curvet, or bridge for people access. b. Developing appropriate design which is regulated by Subang regency RTRW (Spatial Plan) c. Directorate General of Sea Transportation give suggestions to local government regarding land use policy around project area. [KSOP]	a. Direct monitoring to changes in land use that appropriate with RTRW (Spatial Plan) regulation of Subang regency. b. Monitoring and maintaining planted trees (park and protector road) [KSOP]	<p>a. The construction of the access road is carried out above ground level or known as pile slab and is equipped with a guardrail. b. The underpass has been built to make it easier for people who want to cross the access road safely. c. Patimban Port international stipulated in the National spatial plan as National Strategic Project, and judicial review for Subang Regency spatial plan revision to revise the status from feeder port to main port. d. ROW area aside access road has been restricted by panel wall, but at some location crossing with the existing road, there were underpasses provided for local people's accessibility. e. In addition, the outer ring road was built to accommodate community access.</p>

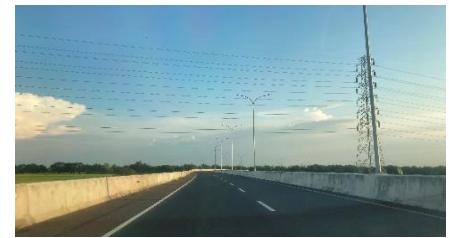
NO	Potential Environmental Impact			Descriptions of RKL/RPL		Implemented Mitigation Measures / Monitoring Results (Data and Photos are attached)
	Type of Impact	Indicators of success of Environmental Management	Impact source	Method of Environmental Management Plan (RKL)	Method of Analysis and Data Collection (RPL)	
						<p>Guardrail along the access road.</p>

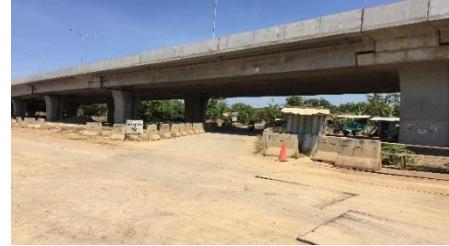
<p>Underpass access</p>

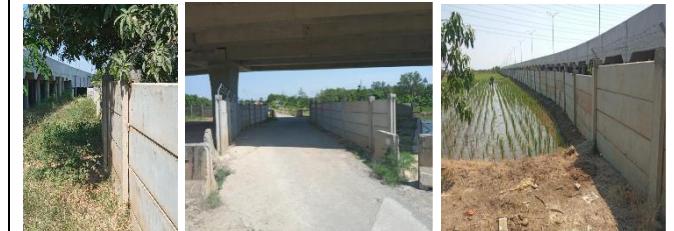
<p>Panel wall as ROW boundary with the underpass</p>
9D	Road damage	Road damage can be minimized	Traffic on the access road operation	Coordinating with related institutions to conduct the increasing and repairing of road which is connected to seaport access road	Direct monitoring of roadway deterioration	<p>KSOP Class II Patimban manages the access road by regularly maintaining the access road condition so that vehicles can pass the access road.</p> <p>The road damage monitoring showed that the monitoring met the recommendation in RKL and RPL to minimize the road damage. There are no Heavy equipment and material mobilization for this period. The Contractor used the temporary access road then switched to flyover access road from October 2020. The contractor did not use the public road since June 2020 but used the temporary access road, and since October 2020, used the flyover access road.</p>

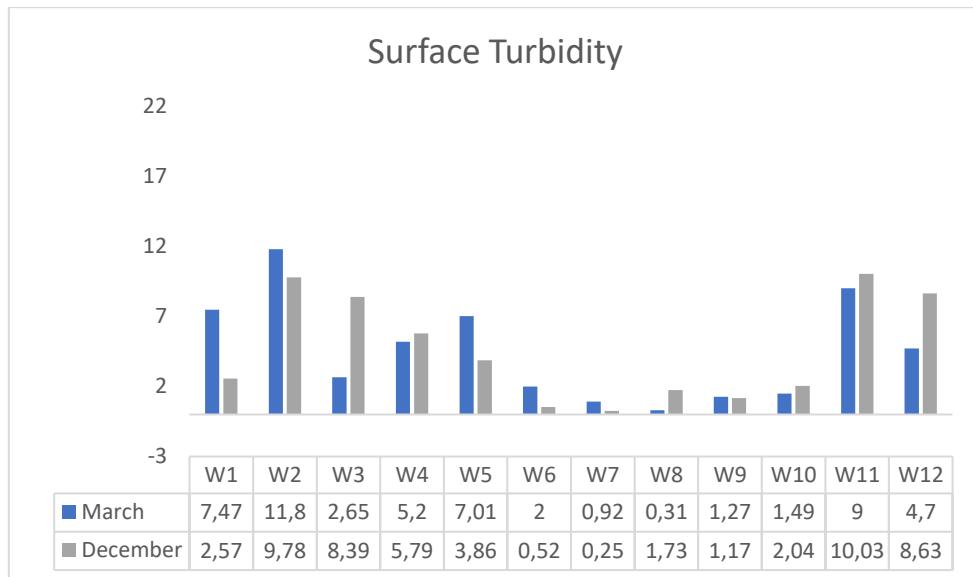
Figure 3 Surface Turbidity Comparison

Turbidity levels were measured within the range of 00.25 – 10.03 NTU with the highest turbidity levels typically observed in the vicinity of the port area. These levels are influenced by the influx of water from the surrounding rivers (W2, W11, W12).

The survey results and a comparison with the previous survey conducted in March can be found in the figure below.

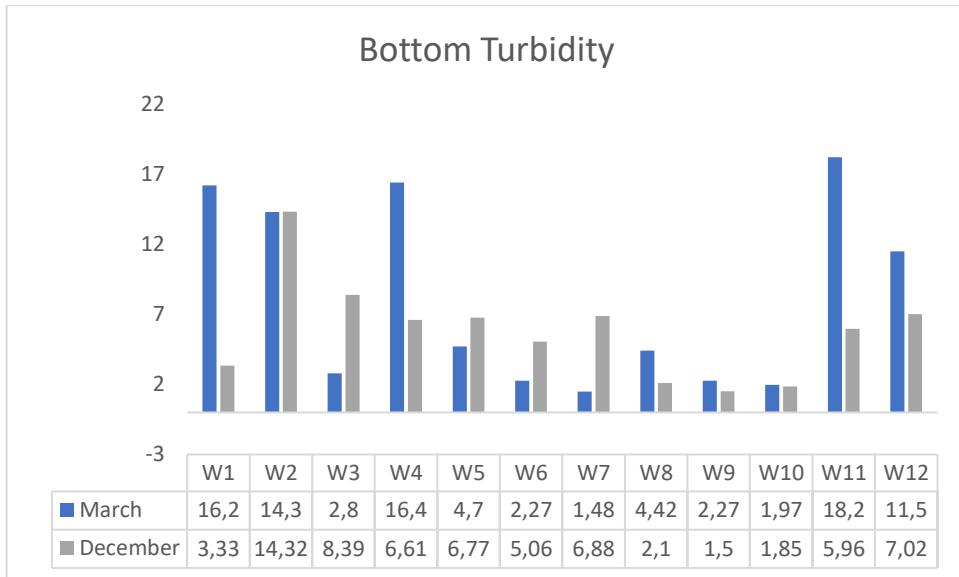
Figure 5 Bottom Turbidity Comparison

Measured turbidity levels of 1.5 – 14.32 NTU, with higher turbidity levels generally recorded around the port area which are affected by the flow of the surrounding rivers (W2, W11, W12). The turbidity levels generally higher in the bottom layer than in the surface, this can be caused by strong currents on the seabed which cause the sediment resuspension, although on some locations it is higher in the surface.

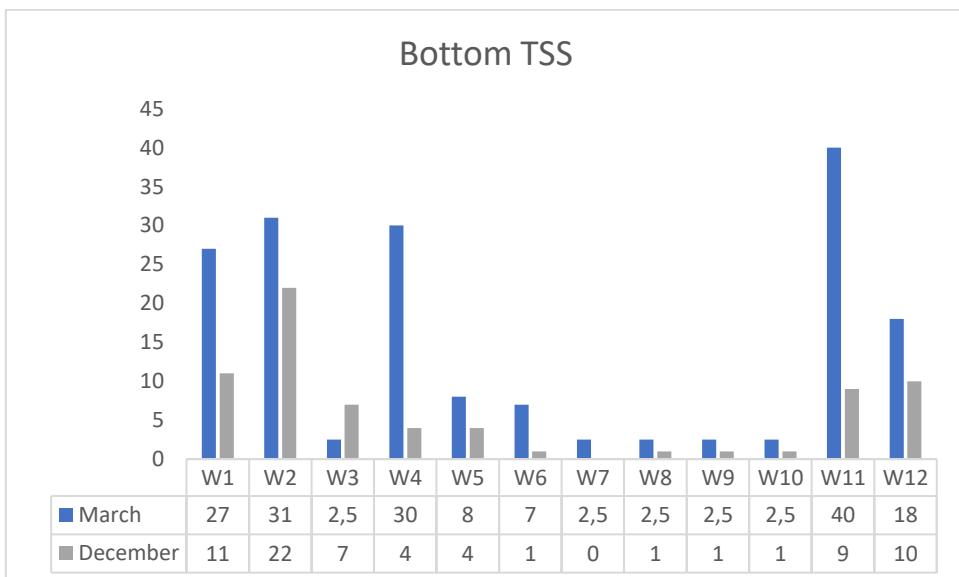
Figure 6 Bottom TSS Comparison

The figures presented above indicate a comparison of the Total Suspended Solids (TSS) parameter with the baseline survey. In March, the bottom TSS levels were observed to be higher than those in December.

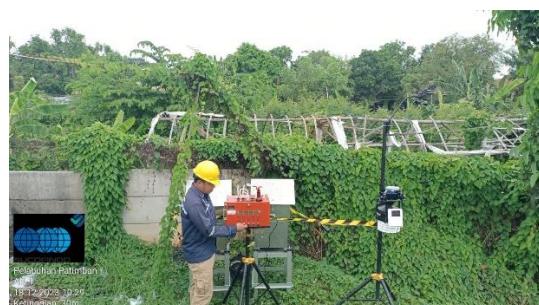
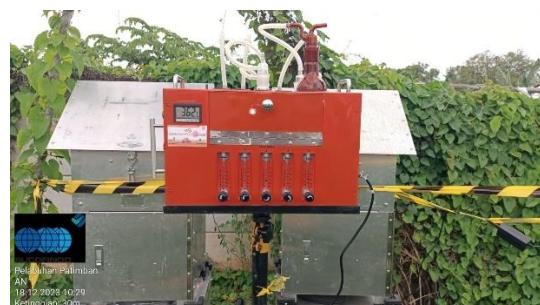
AN1 Location (Access road - front gate)

Recent air quality sampling found that highest CO levels were recorded at location AN1 (front gate of access road), with a value of 217 µg/m3. The highest PM10 levels were also recorded at location AN1 with a value of 18.6 µg/m3. The high levels of these parameters can be influenced by the sampling location where there is a lot of traffic activity from the Patimban Port access road and Pantura road.

Documentation of sampling and measurement can be seen in the figures below.

The noise level at settlement area AN2 (52.5 dB(A)) still meets the quality standard for settlement area (55 dB(A)), and for port area (70 dB(A)). This settlement area is located near the port access road (under the port access road fly over). Sources of noise are generally caused by vehicle traffic, both on access roads and residential neighborhood roads, but the recorded noise levels still meet the required quality standards.

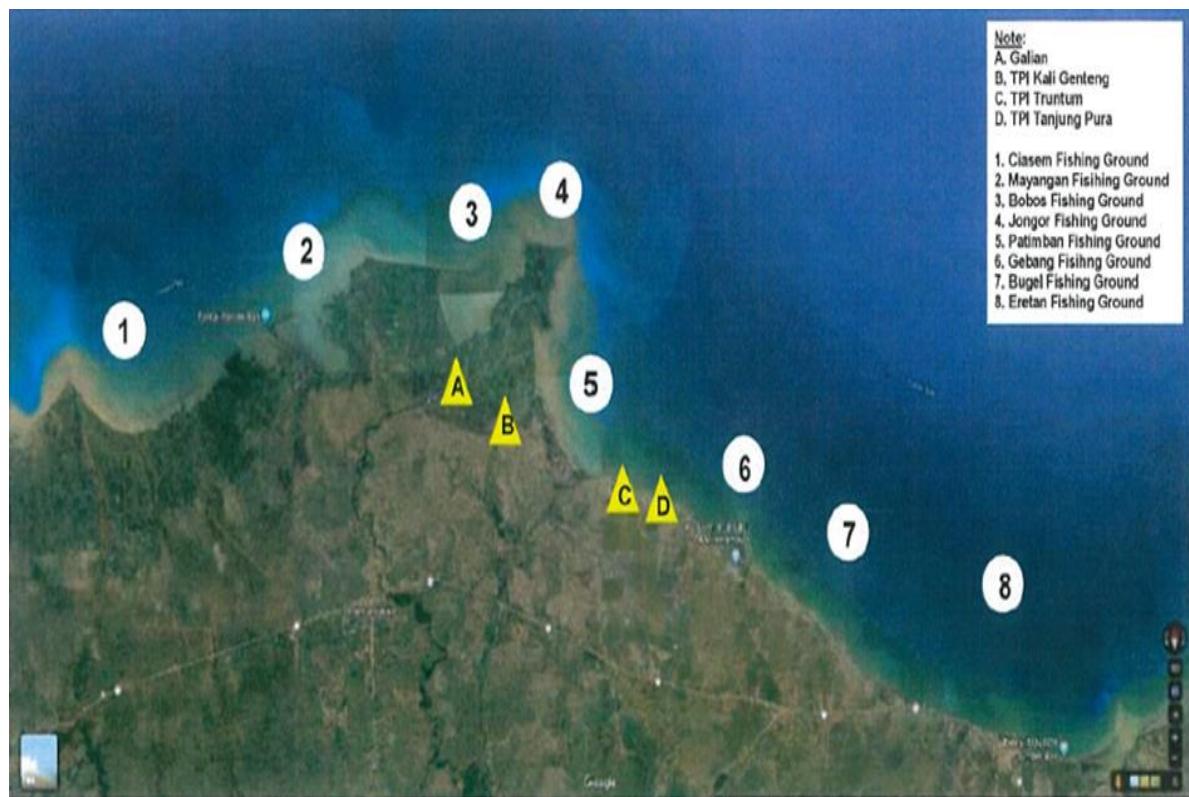
Figure 33 Patimban Fishing Ground Map

The fishing ground area for DKP Subang consists of 8 fishing ground waters as shown in the figure below.
