# Supplementary Environment Assessment Study for the Port and Road Development of the Mombasa Special Economic Zone (SEZ).

## FINAL REPORT

13<sup>th</sup> March 2023

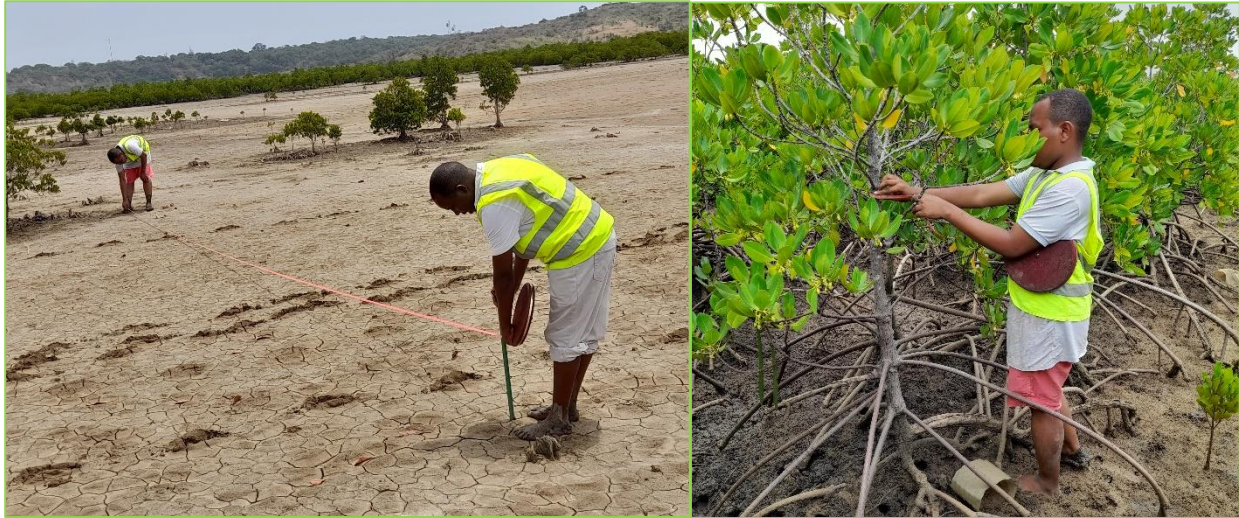
Figure 2: Transect setting (left) and Diameter at Breast Height (DBH) (right) measurement during the mangroves baseline survey at the project site (Source: Field survey, February 2023).

Mangroves distribution and species composition was conducted using 30m line transects and 5m × 5m quadrat sampling based on ordinal degradation values obtained from the Normalized Difference Vegetation Index (NDVI) analysis and oriented from sea to land. At least four transects were laid for each degradation formation in Port Reitz, Mteza and Bombo Creeks based on the size and configuration of the forest. At each quadrant data was collected on mangrove species present, number of mangrove trees, stumps, mean canopy and mean Diameter at Breast Height as shown in Figure 2.

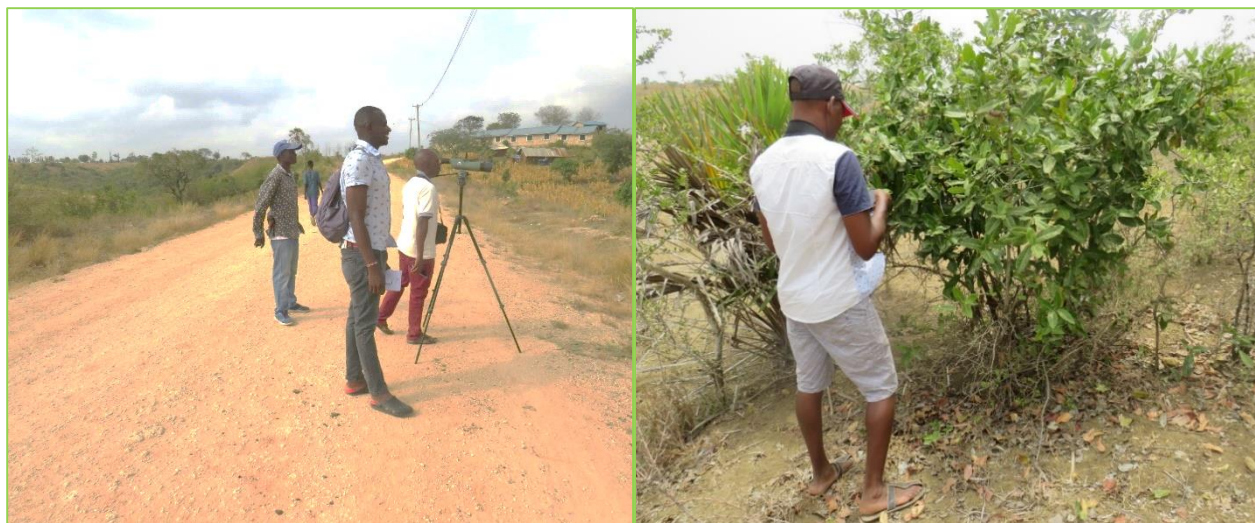
Figure 3: Land bird's survey using a telescope (Left) and terrestrial vegetation assessment (Right) at one of the monitoring stations along the proposed road transect (Source: Field survey, February 2023).

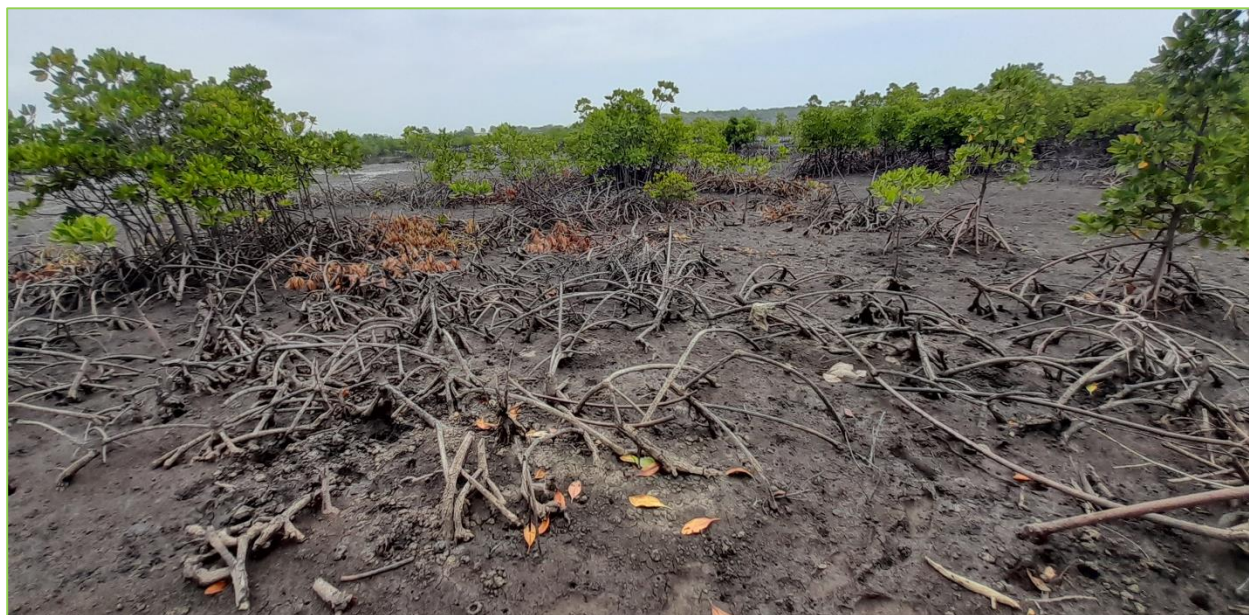
Figure 11: Mangrove stumps observed within Kenya Navy monitoring station (Source: Field survey, February 2023).

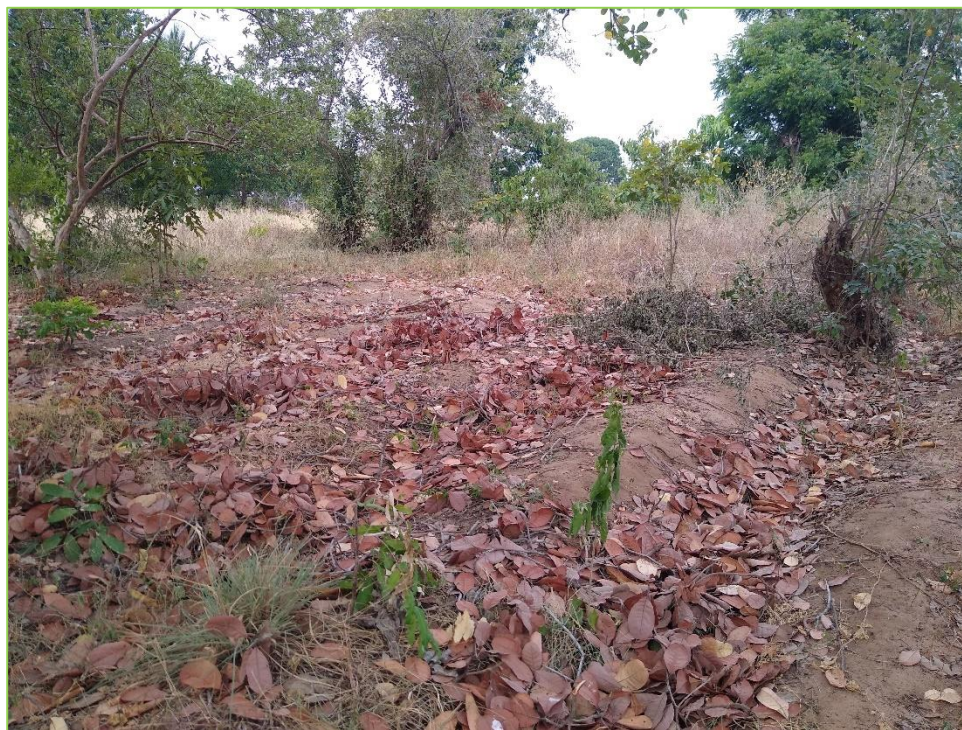
Figure 13: Evidence of farming activities (trenches) at one of the monitoring stations where *Vitellariopsis kirkii* was recorded in 2019 (Source: Field survey, February 2023).

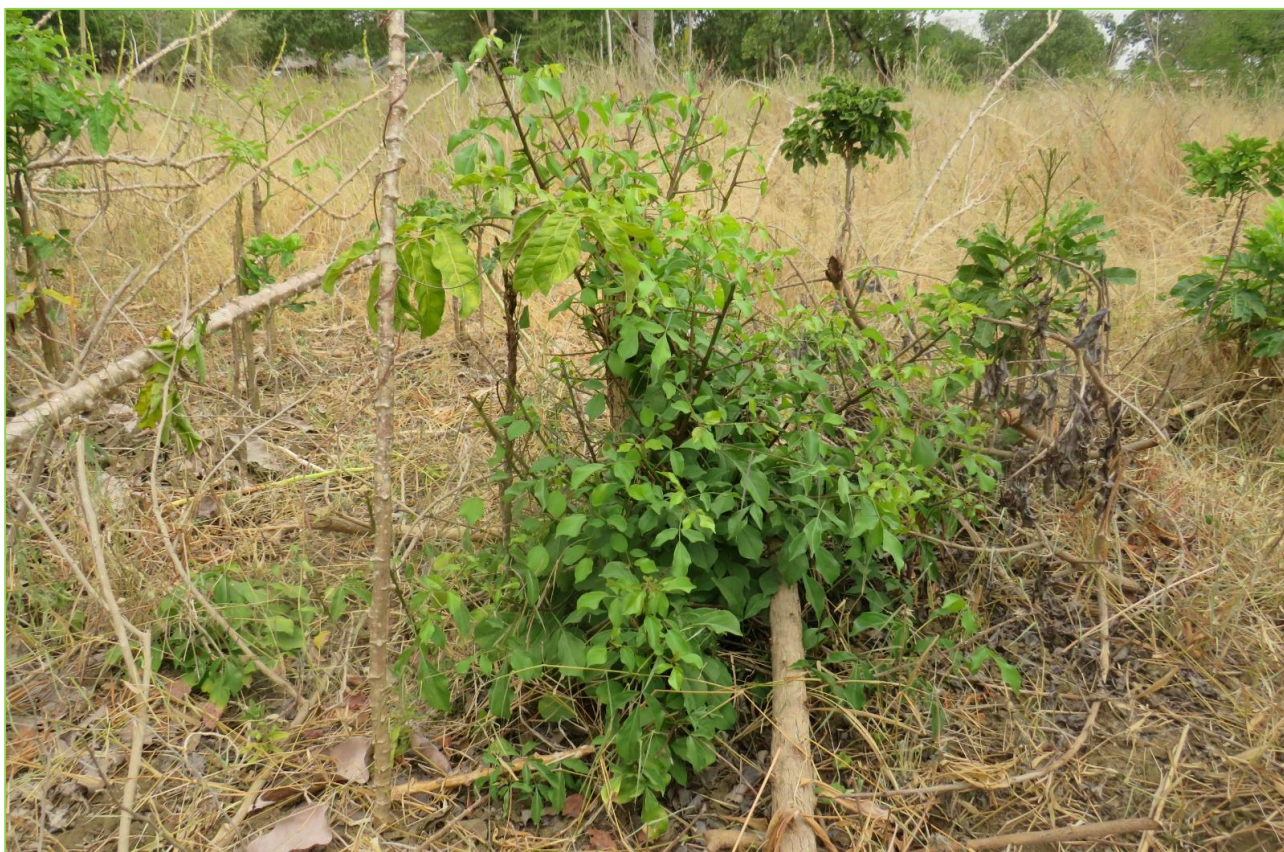
Figure 15: *Lannea scheinfurthii* var. *acutifoliata* (IUCN: NT and CITES: NT) found within the SEZ area (Source: Field survey, February 2023).

*Lannea scheinfurthii* var. *acutifoliolate* was the only plant of conservation status (IUCN: NT and CITES: NT) observed during the current survey at Latitude 4°05'30.88"South and Longitude 39°36'11.03"East (Figure 15). Several stands of the species were noted within and outside the SEZ. The construction of the road component is likely to impact on the species through clear felling and hence propagation in other areas within and without the SEZ by either cuttings and/or seeds is recommended. All the tree species counted during the survey were documented (Annexure 4 & 5).

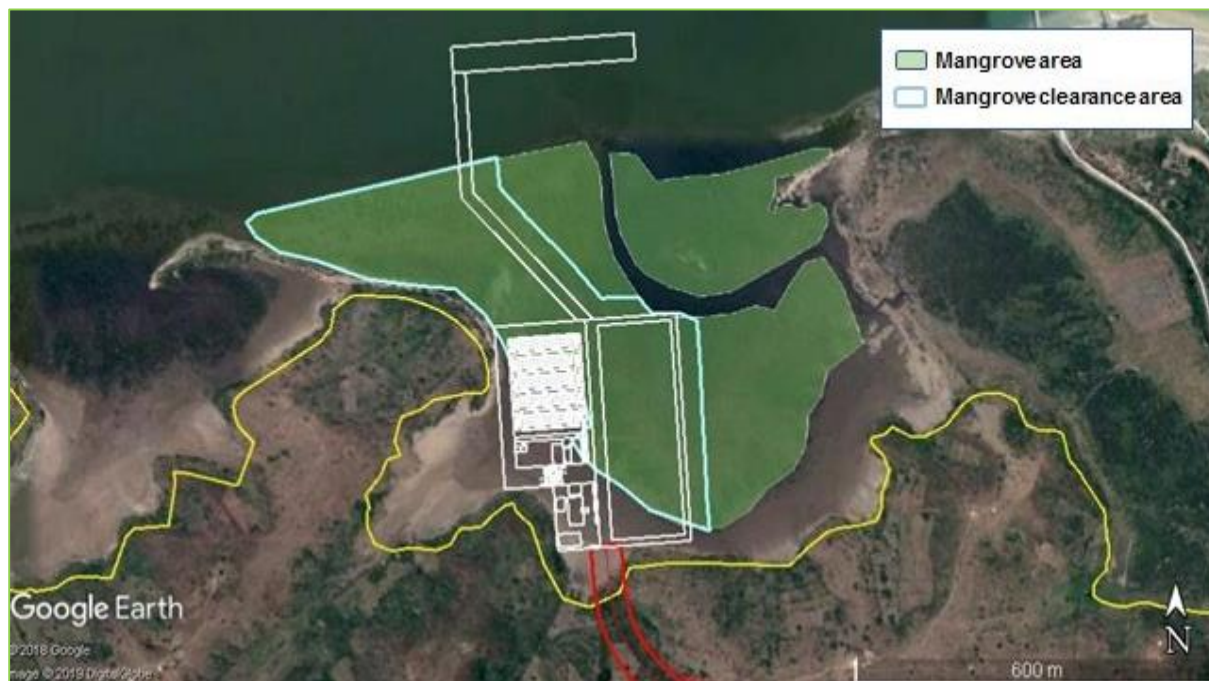
Figure 17: The mangrove area to be cleared during the construction of the port development project (Source: EIA Study, 2019).

Since the proposed port is located within a mangrove forest area, the additional reclamation required for the cargo yard construction (i.e., approx. 4 ha) will likely result in more mangrove clearance. However, the cumulative impacts from such additional mangrove clearance are likely to be insignificant as majority of the additional reclamation area is within the mangrove clearance area that was set under the EIA (Figure 17). Hence the total mangrove clearance area will likely remain within the estimation (i.e., 15 ha) made under the EIA. Nevertheless, to compensate the loss of mangrove, the Project plans to conduct mangrove transplantation as proposed in the EIA. While the EIA proposed to transplant 1.5 seedlings per cleared tree, the transplantation quantity has been raised to 2 seedlings per cleared tree based on the mangrove transplantation study conducted under the detailed design (D/D) study. During the 3 & 4<sup>th</sup> stakeholder meeting held in Mombasa, Kenya Forest Service noted that the recommended number of mangrove seedlings is 10,000 trees/ha and this stocking rate should be considered during the implementation of the project.
