Madiun River Urgent Flood Control Project

Report date : October, 2002

Field Survey : August, 2001

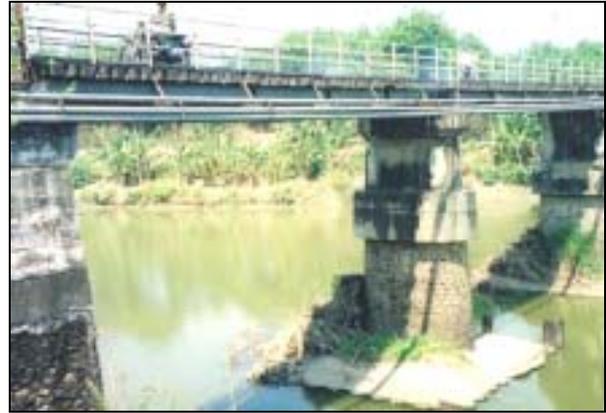
Madiun River (improved river section)

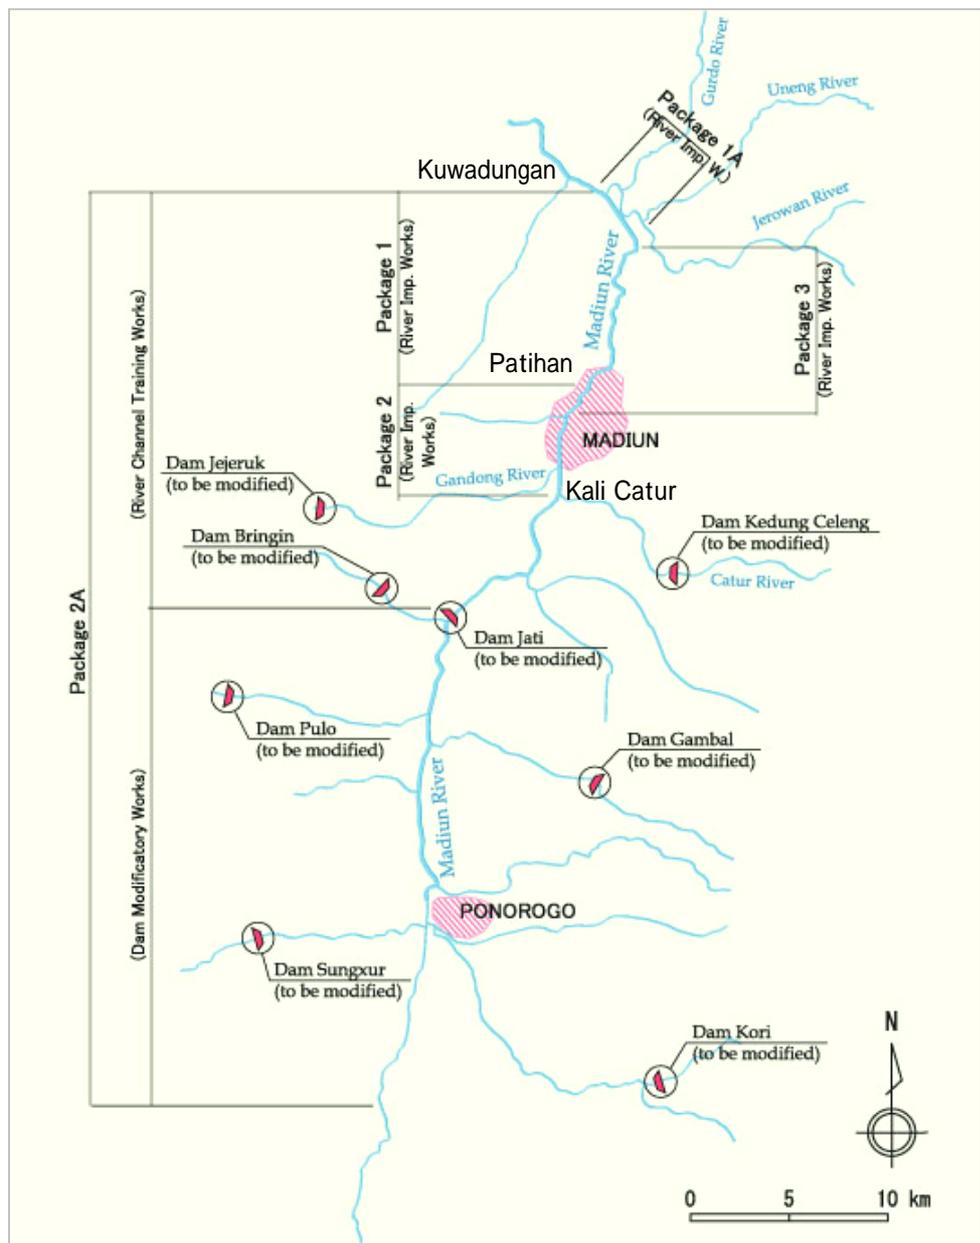
Figure 1 : Project Map

- (i) Package 1 : Kwadungan – Patihan (± 14 km), covering Madiun River and Jerowan River
 ...excavation, dyke, bridge, drainage, river system structure
- (ii) Package 2 : Patihan – Kali Catur (± 8 km), covering Madiun River, Jerowan River, Gandong River and Catur River
 ...excavation, dyke, heightening of bridge, drainage, river system structure
- (iii) Package 3 : Kwadungan – Patihan (± 13 km), covering Madiun River
 ...excavation, river system structure

Package 1A and Package 2A were incorporated as additional works after project appraisal, bringing the total to five packages in all (Packages 1, 2, 3, 1A and 2A). The Scope of Works and the reasons for modifications are stated in 2.2.1.

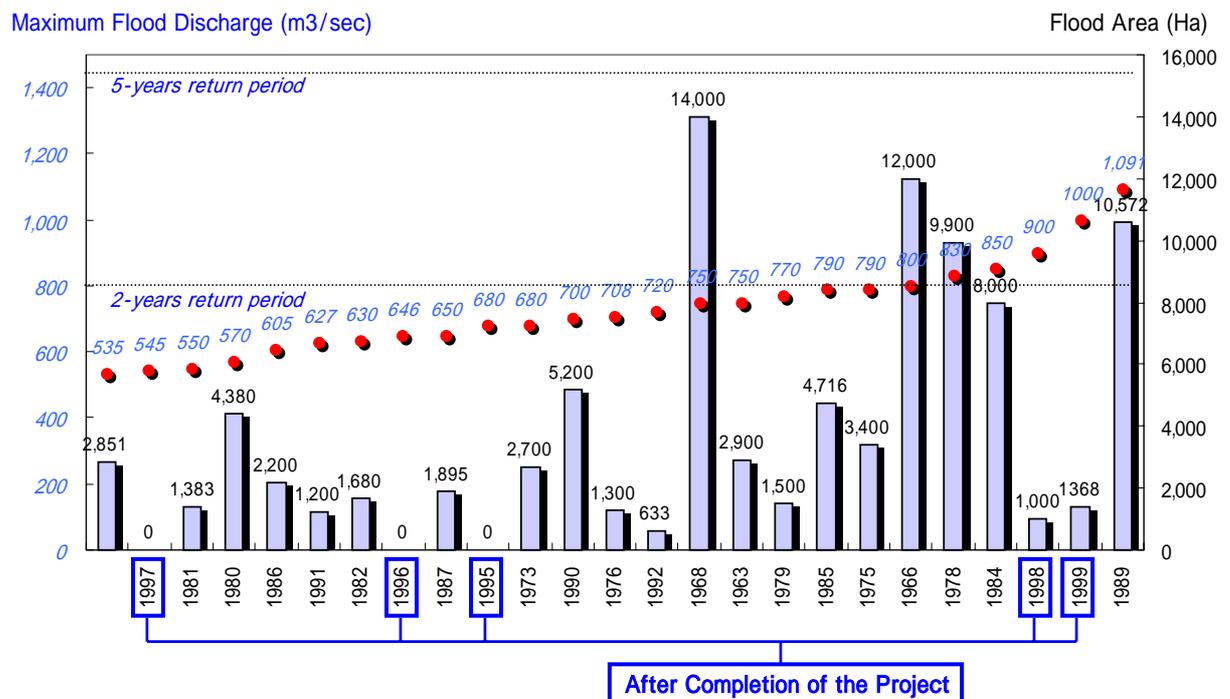
Figure 2 : Flood Record

Figure 2 illustrates the record of flooding in the project area, covering Madiun (including Jerowan area) and Ngawi, specifically Maximum Flood Discharge (MFD) (m^3/sec) and flood area (ha). The data for MFD are arranged in order of magnitude; the corresponding data for flood area are indicated for each year. In general, the bigger the MFD, the larger the flood area, although 1968 represents a significant exception.

As the figure shows, the area subjected to flooding decreased after project completion in 1995. For instance, flood magnitude in 1998 was 900 m^3/sec of MFD, of greater magnitude than a 2 year return-period flood, but the flooded area was only 1,000 ha at that time. When floods of the same magnitude occurred before the project (e.g. 1966, 1978, 1984 or 1989), there was flooding over as much as 12,000 ha.

In light of these data, the project dramatically contributes to mitigating flood damage. Some areas are still likely to be inundated due to insufficient flood control at its tributaries, which is out of the project scope, when the flood magnitude is larger than a 2-year return period flood, as in 1998 and 1999.

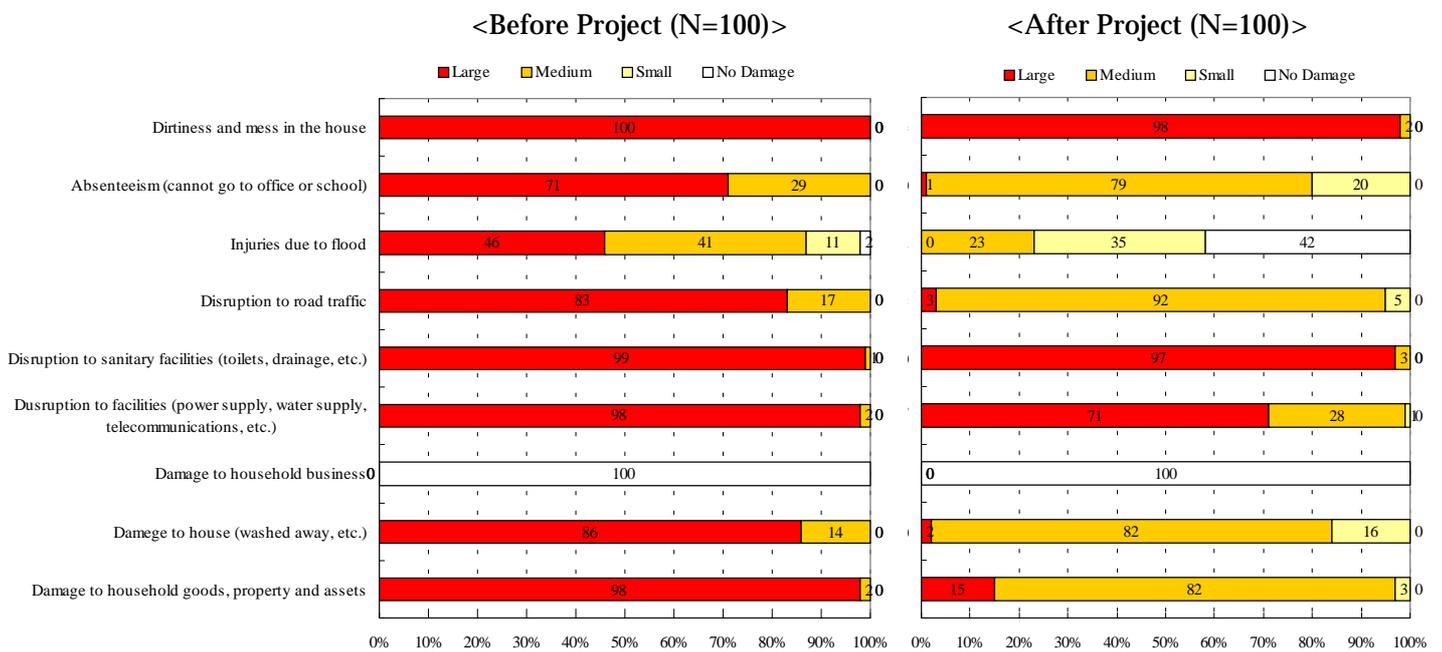
Figure 5 : Comparison of the extent of flood damage before and after the project

Figure 5 and Figure 6 also show results of the Interview Survey; the former compares the extent of damage before and after the project and the latter shows how respondents felt regional safety improved as a result of the project.

Even though this kind of comparison is based on the subjective impressions of respondents, it is helpful in understanding the effects of the project, and shows that the project contributed to improving living conditions, in terms of safety and security.

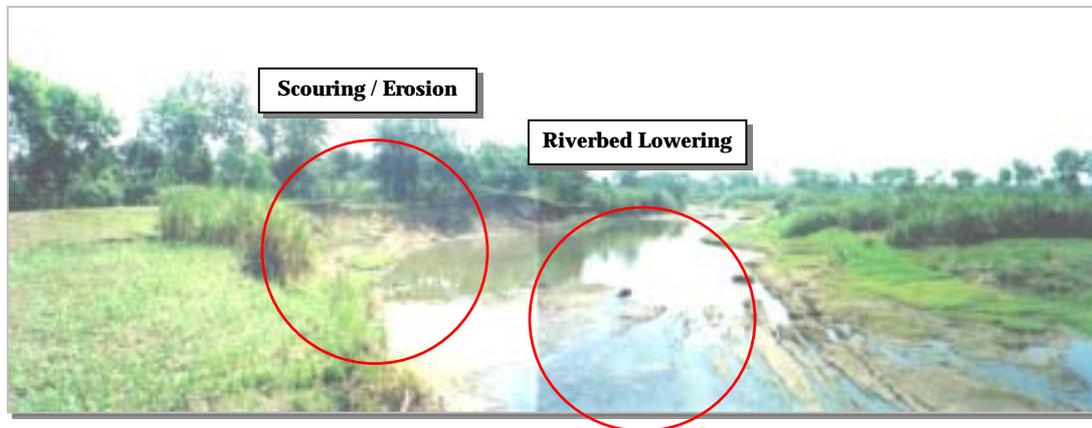
Riverbed degradation is causing various problems at the project site. These problems include intensive bank erosion and unstable conditions of the existing revetments and ground sills. The riverbed degradation may have been caused by a combination of the following factors:

- a) The Sabo dams built in upstream in the 1970's and 1980's have reduced the sediment flow.
- b) Active sand mining activities along the river channel.
- c) The construction of a short-cut channel accelerates riverbed scouring at its upstream reaches.

There are some areas of the tributaries to the Madiun River where serious scouring/erosion and riverbed lowering have been observed. According to the Project Official, this situation developed after the commencement of the project, and has been growing gradually. People living in the surrounding area worry that continuous scouring/erosion will reach their land/property in the near future, if appropriate countermeasures are not implemented. They have requested that the Project Office, through the local government, treat/solve the problem, but no proper action has been taken, because of the lack of government funds.

Current status of a problem river segment (Jerowan River)

Rehabilitation of structures damaged by riverbed degradation is needed urgently restore their original functions. Furthermore, it is necessary to build several drop structures and ground sills to stabilize the river channel is necessary to cope with the lowering of the riverbed. In addition, the existing masonry revetments have been damaged due to heavy scouring at Jati and Kori weirs. The immediate repair of the revetments is necessary to prevent adverse impacts on the stability of downstream apron structures, which is likely to be serious. One of the three rubber gates at the Sungkur Weir broke because of a rupture where a temporary masonry weir had been constructed to supply irrigation water. At Jati Weir, one of two rubber gates was broken and is temporarily being repaired to restore intake of irrigation water. In order to ensure a sustainable supply of irrigation water, the reinstallation of the rubber weirs is indispensable.
