Kenya

Mombasa International Airport Improvement Project

Report Date: October 2002

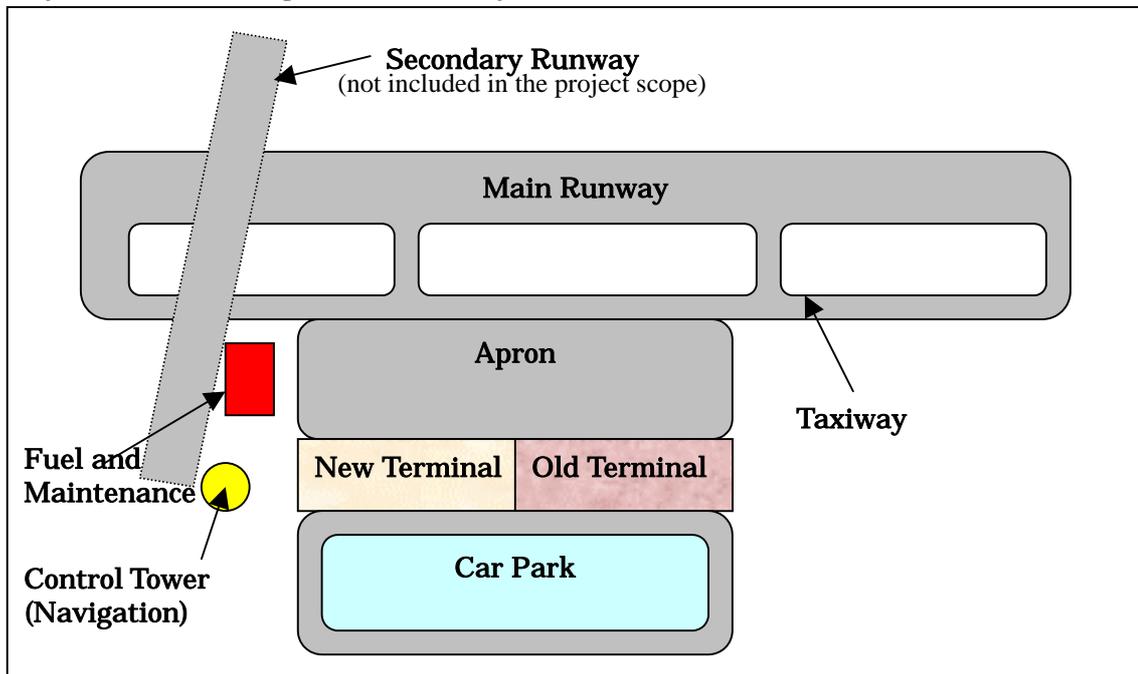
Major Civil Work Components of the Project⁴

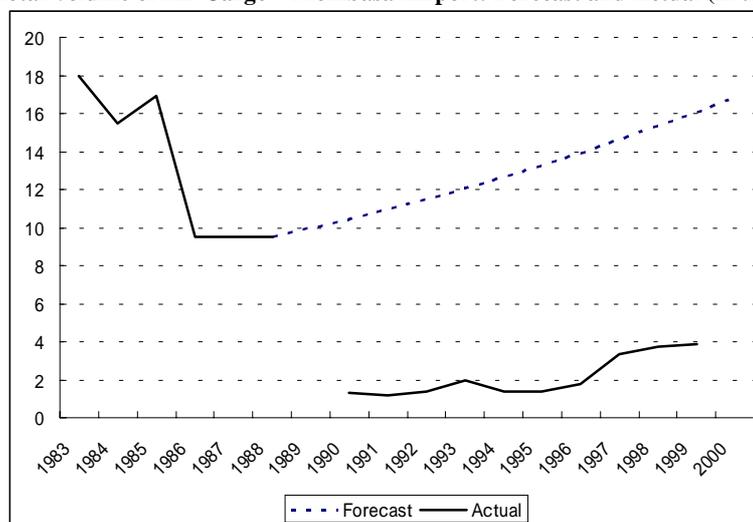
With the same assumption, the cargo handling volume was forecast to grow 4.9% annually at the time of appraisal. The actual air cargo volume has remained substantially below the forecast demand. This sharp decline is due to, in addition to the worsening macroeconomic situation, the fact that the infrastructure for alternative transportations (especially roads) has

Figure 2: Total Volume of Air Cargo – Mombasa Airport: Forecast and Actual (in thousand ton)

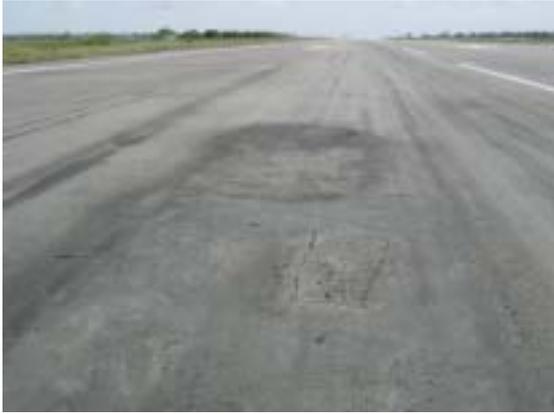
1) Cracks in Touchdown Area: The right-hand side touchdown area of the main runway is relatively in good condition. However, surface cracks are observed on the left touchdown area around the intersection with the secondary runway over a length of approximately 150 meters. Due to the prevailing wind directions, the problem area of the runway is used only February - March and October - December.

According to the airport officials, some cracks already started appearing in the sub-base after the completion of rehabilitation works of runway and taxiway in 1995 and the surface cracks started appearing after heavy rains under influence of the El Niño in 1997. Based on the preliminary inspection, the cracking of the runway is attributable to continuous changes in the moisture content in the base and sub-base of the runway. Further geotechnical testing will have to be carried out to confirm this point, based on which possible solutions to curtail the cracks could be proposed.¹³

Cracks in Main Runway

¹³ While temporary and partial repairs on the surface have been made from time to time, a full-scale repair work on the deteriorated area including the sub-base remains undone. The consultant for project management during the implementation period roughly estimates it would cost 600-700 mil yen.

- It is recommended that technical inspections shall be carried out by the executing agency for the technical problems reported herein (i.e., cracks in runway and deteriorated luggage turntable) as soon as possible.
- The executing agency should address the issues as mentioned in the section 2.5, by fostering its organizational capacities to enhance the sustainability, in the field of operation and maintenance in particular.

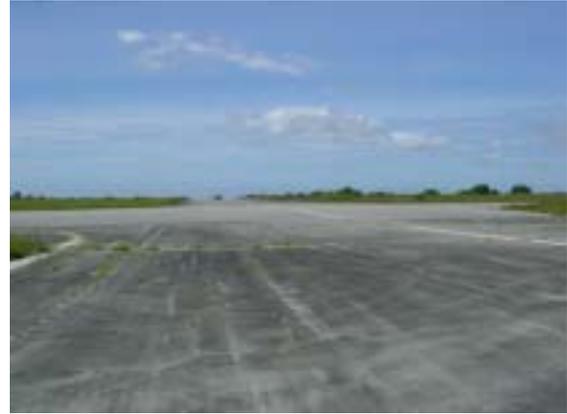
Cracks in Secondary Runway

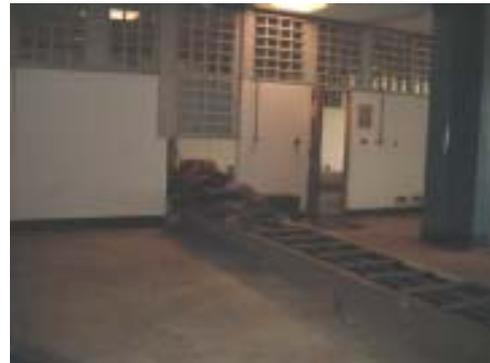
2) Unused Luggage Handling Facilities in Old Terminal: According to the airport manager, the conveyer system in the arrival lounge of the old terminal, originally installed in 1974, was rehabilitated under the project.¹⁴ The rehabilitation included replacement of some rollers and bearings, which subsequently ceased to function, however, due to lack of proper maintenance. The rehabilitated conveyer worked only for a short period.

At the time of appraisal, it was anticipated that, upon completion of the new terminal, some operators including the Kenya Airways would continue to use the old terminal, whereas other airlines would use the new terminal. However, no major operator¹⁵ actually uses the old terminal and it has been neglected for long, resulting in its deterioration of equipment and buildings over time. The second luggage

Luggage Turntable in Deterioration

conveyor was operational during the rehabilitation of the first one, but was dismantled. The conveyor in the departure lounge is not operational either.
