## Krueng Aceh Urgent Flood Control Project Stage 2 Phase 1

Report Date: March 2001

Field Survey: September 2000

### 1. Project Profile and Japan's ODA Loan

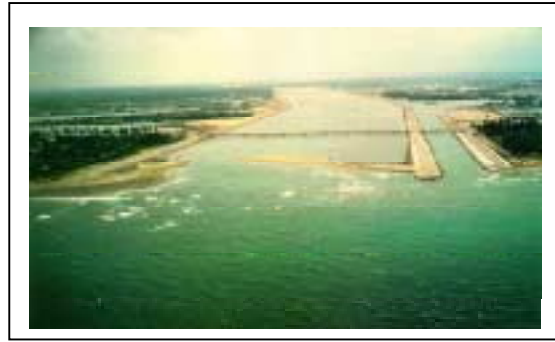
A Part of Estuary for the Project
