Indonesia

Krueng Aceh Irrigation Project

Report Date: March 2001

Field Survey: August 2000

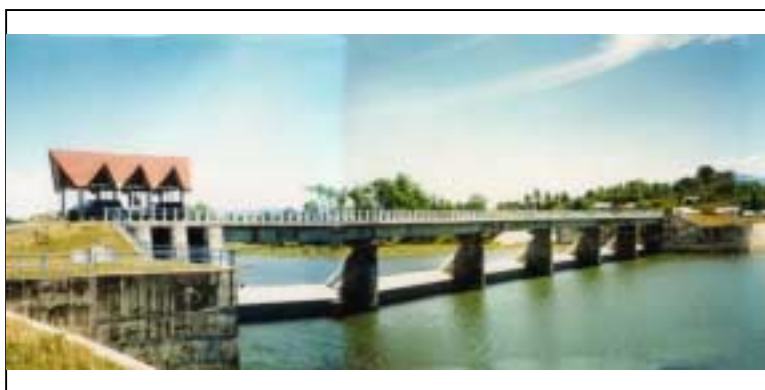
Headwork Constructed by this Project

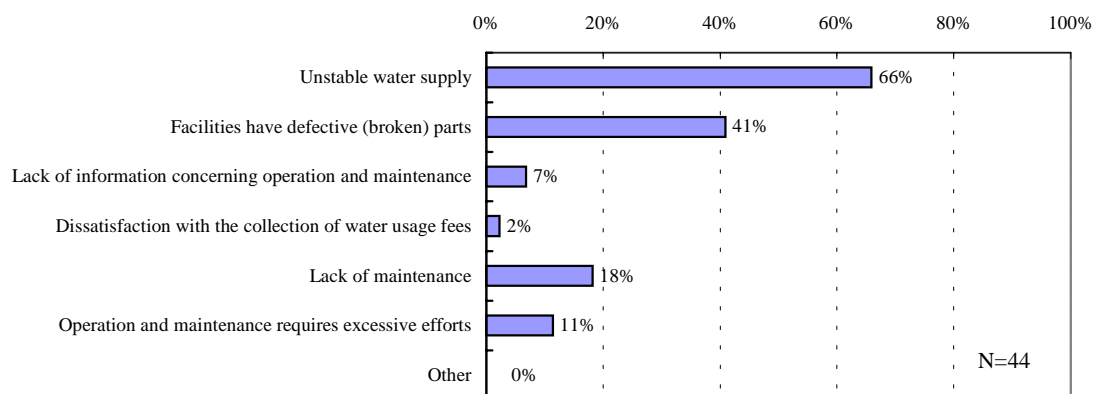
Figure 1 Reasons for Dissatisfaction with the Current Water Management System (only those who responded that they were dissatisfied)

The facilities have been maintained by the local government since the project was completed. When asked about their satisfaction with the current maintenance system of water, 56% said they were satisfied and 44% said they were not, indicating that the majority are satisfied. The main reasons given by those who were dissatisfied were that “water supply is unstable“ and “the facilities have defective (broken) parts“ (Figure 1).

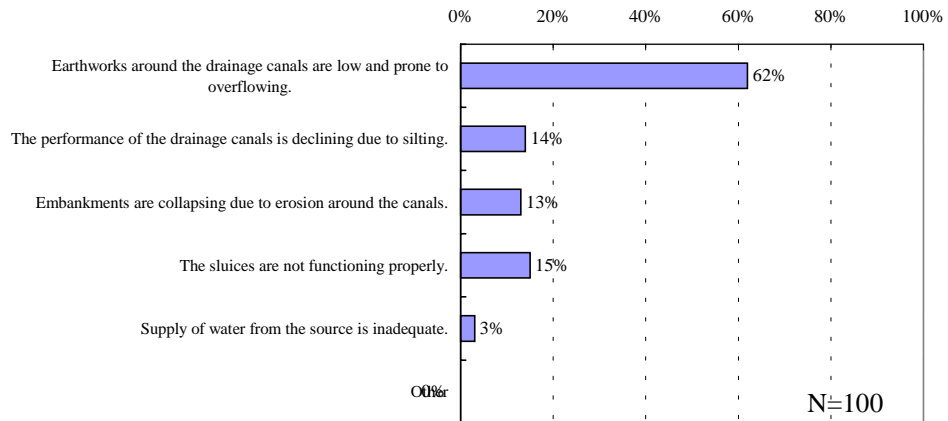
Figure 2 Current State of the Irrigation Facilities (multiple responses permitted)

On the current overall state of the irrigation facilities, the overall evaluation was favorable, but slightly over 60% of respondents admitted “earthworks around the drainage canals are low and prone to overflowing“ (Figure 2). Nearly 70% of respondents said they had suffered damage due to poor drainage (Figure 3).

The opinions and requests listed below were expressed regarding improvements to the facilities. It is considered that the maintenance agency needs to clearly identify the problems and examine appropriate remedial measures.

- The banking of water channels is too low and prone to flooding.
- The drainage canals do not have adequate capacity, and they often overflow.
- The access roads should be improved.
- Damaged parts of the facilities need to be repaired.
- The volume of water drawn from the source is inadequate.

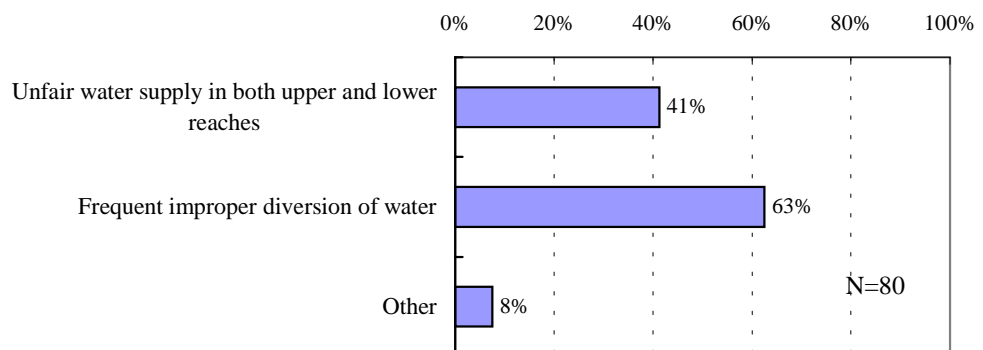
**Figure 4 Problems for Water Supply (multiple responses permitted)
(only those who responded that there had been problems for water supply)**

On the question of water supply, 80% of respondents perceived some problem. “Frequent improper diversion of water“ was particularly pointed out in high percentage.

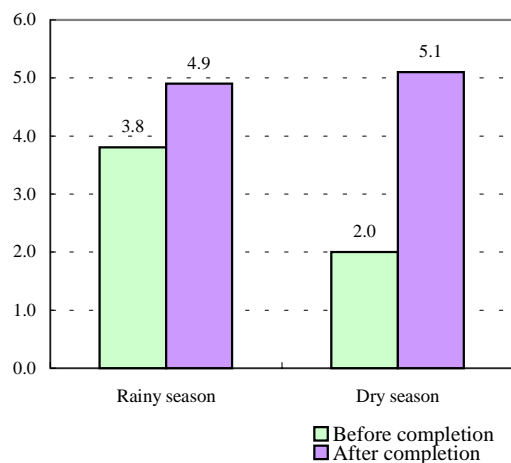
Figure 5 Rice Productivity Before and After Completion of the Project (average of responses: tons/ha)

Figure 5 shows the results obtained when interviewees were asked about changes in rice productivity between before and after the completion of the project. Figures are averages of all valid responses received. Production increased by 29% in rainy season and by 155% in the dry season (Figure 5), from which it can be particularly inferred that the increased rate in the dry season is worthy of special mention.
