Indonesia

Lower Jeneberang River Urgent Flood Control Project

Report Date: March 2001

Field Survey: September 2000

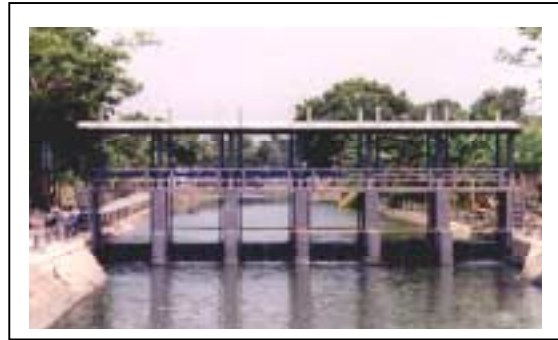
Jongaya Drainage Canal

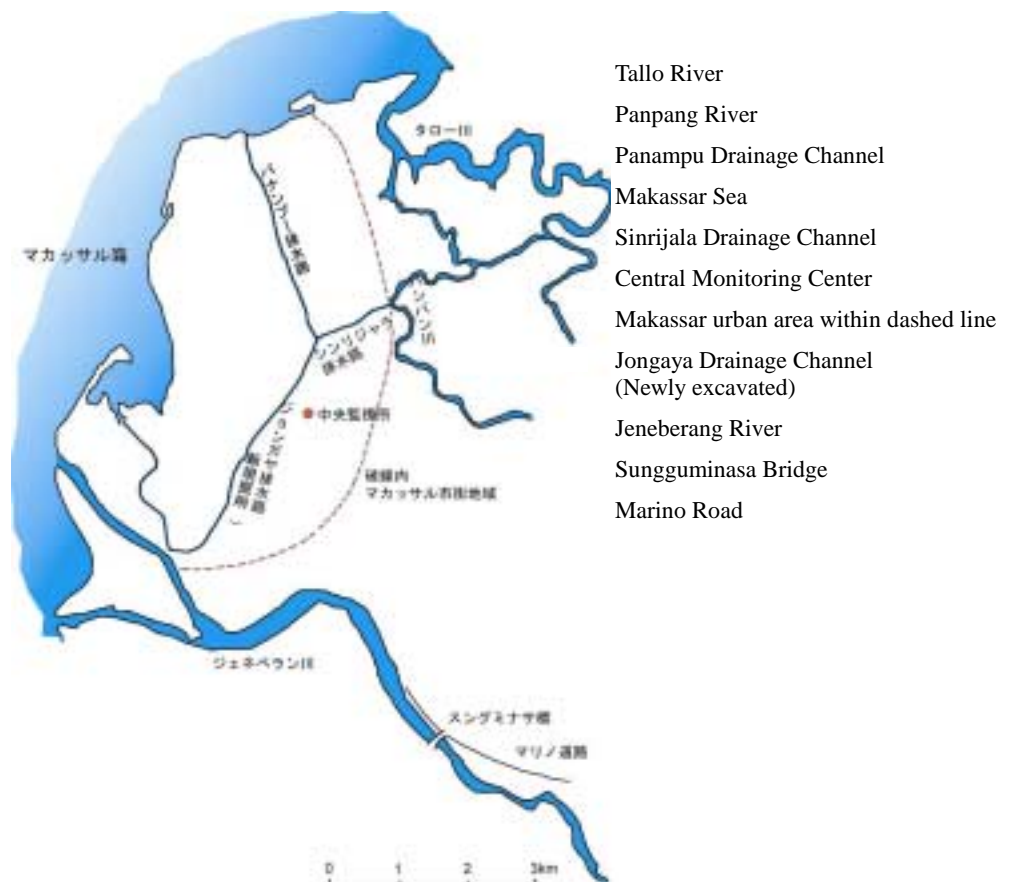
Figure 1 Project Region

The scope of this project covered the following four areas.

1) River Improvements

Dredging, excavation, embankment and revetment constructions for a 9.6km section between the mouth of the Jeneberang River and the Sungguminasa Bridge, and the raising of a 2.5km section of the Marino Road.

2) Improve City Drainage System

- (1) Improve the Panampu Drainage Channel (4.9km section)
- (2) New excavation of the Jongaya Drainage Channel (7.8km section)
- (3) Improve the Sinrijala Drainage Channel (2.4km section)
