## Indonesia

### Pamarayan – Ciujung Irrigation System Rehabilitation Project

Report Date: March 2001

#### 1. Project Profile and Japan's ODA Loan

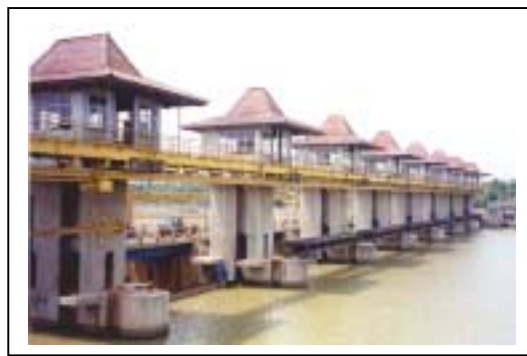
Overall View of Pamarayan Headwork

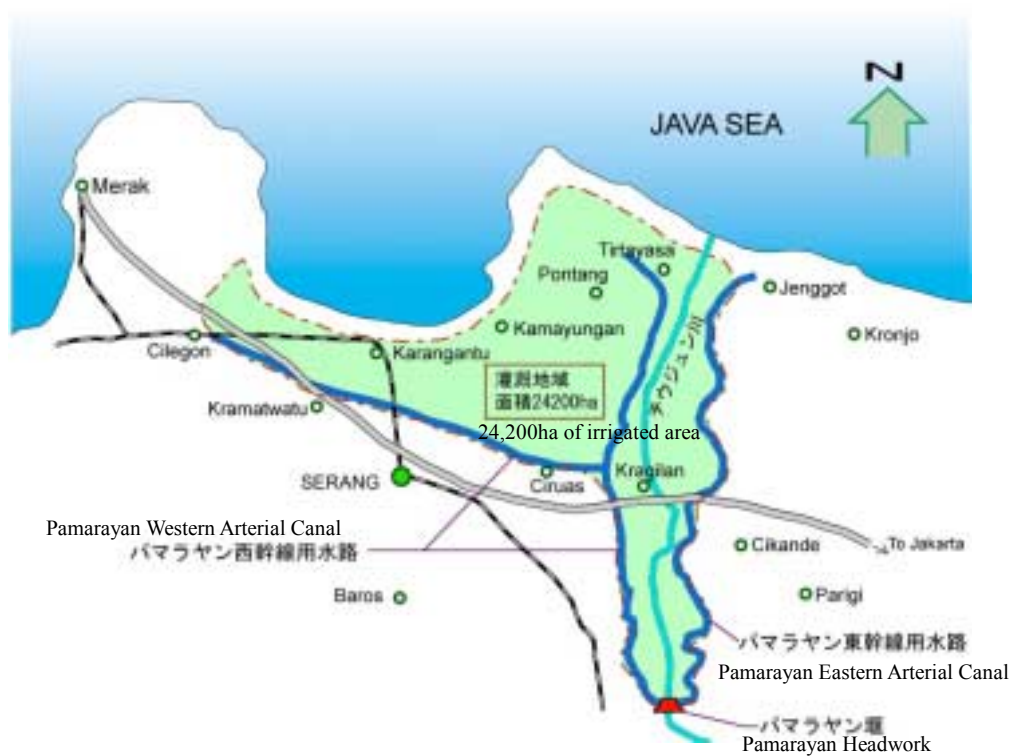
**Figure 1 Summary Map of This Project (non-scaled)**

- i) Reconstruction of the Pamarayan headworks and improvement of related facilities
  - Construction of the headworks
  - Rehabilitation of maintenance access roads
- ii) Purchase of maintenance equipment
- iii) Consulting services
  - The detailed design and construction supervision required 686.5m/m of consulting service.
