## Brantas River Middle Reaches Improvement Project (II)

Report Date: March 2001

Field Survey: September 2000

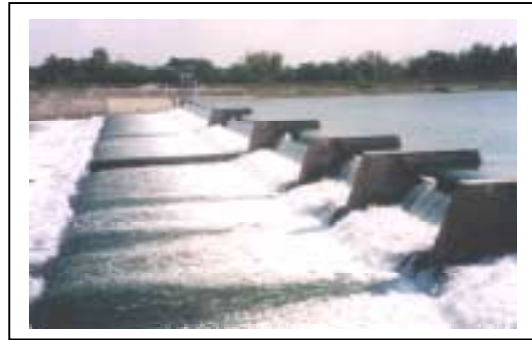
Rubber Dam of Brantas River Middle Reaches
