Way Curup Irrigation Project

Report Date: March 2001

Field Survey: September 2000

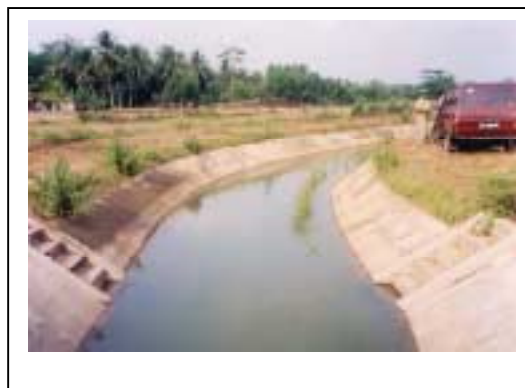
Trunk Canal of the Project Area

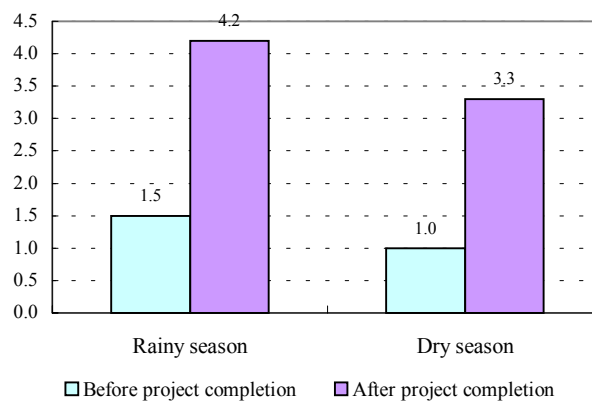
**Figure 4 Rice Productivity Before and After the Completion of the Project
(average of responses: tons/ha)**

Figure 4 shows the responses to the question of how productivity had changed between before and after the project. The figures are averages of the valid responses. Production increased by 180% in rainy season and 230% in dry season, the latter being a particularly large increase.
