Krueng Aceh Urgent Flood Control Project (I)

Report Date : October, 2002

1 . Project Profile and Japan's ODA Loan

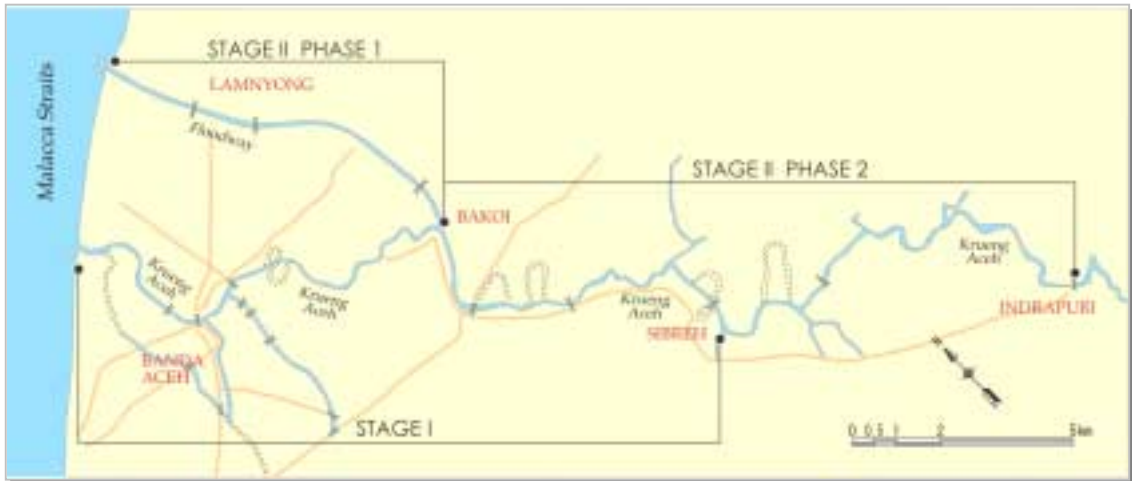
Figure 1: Project map

- (a) Improving the existing river channel from the estuary to Bakoi, including two tributaries of the Daroy and Lueng Paga rivers, and installing a FFWS (Flood Forecasting and Warning System) at three locations.
- (b) Constructing dikes on the left bank of Krueng Aceh River from Bakoi to Sibreh in order to secure the main target area, the center of Banda Aceh, against floods. Dikes would also be constructed on some portion of the right bank.

- (Phase 1) Constructing the floodway from Bakoi to the estuary along the existing Lamnyong River and improving the upper reaches of the river from Bakoi to Indrapuri,
- (Phase 2) Constructing additional dikes on the right bank from Bakoi to Sibreh.
