Indonesia

Mt. Merapi and Mt. Semeru Volcanic Disaster Countermeasures Project(2)

Field Survey: July 2003

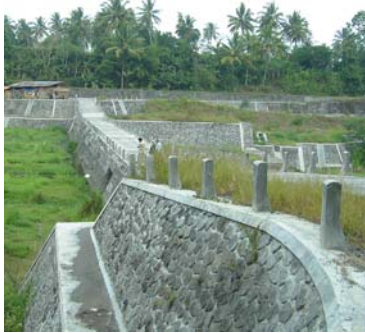
Check dam on Mt. Merapi

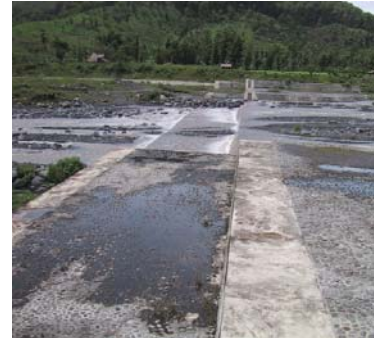
Consolidation dam on Mt. Semeru

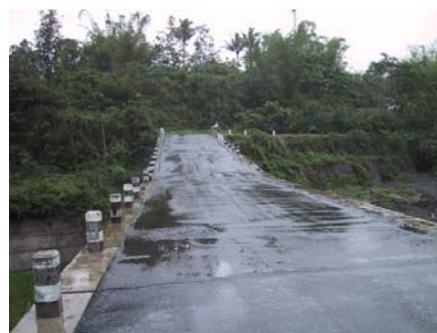
The Mt. Merapi eruption of 1998 caused debris flows in the Boyong River. The check dam (see Fig. 6), which had retained available capacity, were filled with the sediment that flowed into the dam. This means that the check dam succeeded in breaking the momentum of the debris flow. In the interview with the headman of a local village, he mentioned that the biggest debris flow in living memory was produced by the eruption of 1969 and the check dam prevented the debris flow of 1998 from causing damage. Whilst it is difficult to estimate how much damage would have occurred if the check dam had not been installed, it is

Figure 2: Check Dam on the Boyong River (headwaters are on the right)

believed that this dam protected residents in neighboring areas from debris flow damage.

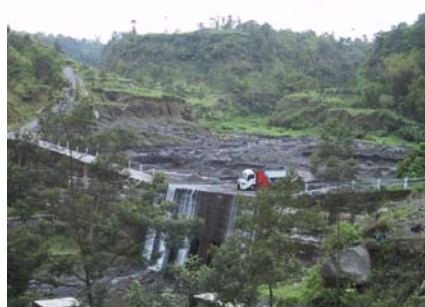
The debris flow in the Apu River in January 2003 completely filled the check dam. The force of the flow is suggested by the fact that the guard rail on the road running across the top of the dam was partially damaged. According to the project manager, had the check dam not been there, the village located down river (Muntilan) would likely have sustained considerable damage. This suggests that the check dam developed through this project produced the effects.

Figure 3: Check dam on the Apu River

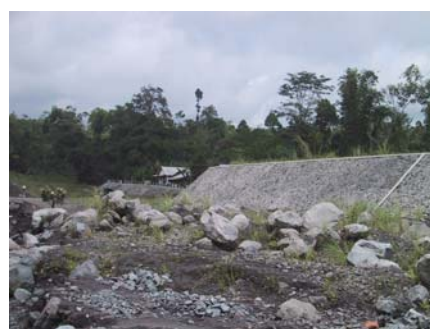
This project involved the construction of a training dike on the upper reaches of the Mujur River. There has been a check dam nearby constructed from the national budget, which was full of sediment at the field survey. The project manager reports that the sediment had occasionally flowed as far as neighboring villages when floods occurred, while there has been no such damage since the construction of the training dike. In the interview with the local village headman, he mentioned that in former years flooding had resulted in sediment flows reaching the village, but that thanks to the training dike no such events now occurred.

Figure 4: Training dike on Mujur River headwaters

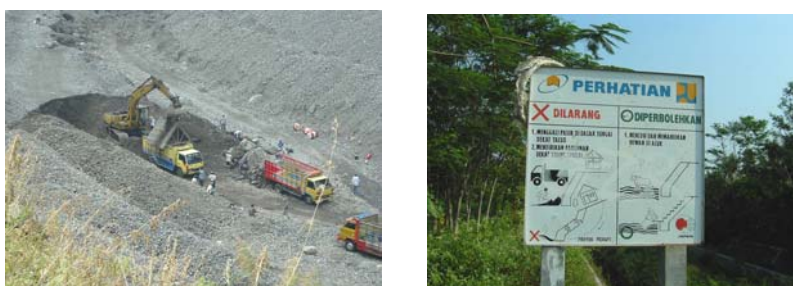
On the other hand, given that the heavy equipment used by private-sector sand mining companies has the potential to cause damage to sabo facilities, mining activities by private sand miners must be appropriately monitored. Currently, sand mining on Mt. Merapi is governed by a licensing system⁷, which involves technical assessments and the issuing of licenses by the district government (for example, licenses are not granted when forest conservation issues exist or when there are concerns about the impact on control structures, etc.). In Magelang District, where sand mining is at its most vigorous, mining rights have been granted to twelve operators (excluding those mining zones with a surface area of 1ha or less). The mining companies are subject to a tax of 1,500Rp./m³. A part of the tax is assigned to the project office's O&M budget, which helps to strengthen its financial sustainability. Furthermore, the project office has formulated guidelines for sand mining and signboards standing near each structure indicate where sand mining may be undertaken (at least

100m and more from the headwater side of structures, etc.). Despite evidence that the guidelines are not being adhered to in some areas⁸, most operators are in conformity.

Figure 6: Sand mining at Mt. Merapi (left) and a signboard near a control structure (right)
