## The Philippines

### Boracay Environmental Infrastructure Project

External Evaluator: Masashi Takano (Nomura Research Institute, Ltd.)

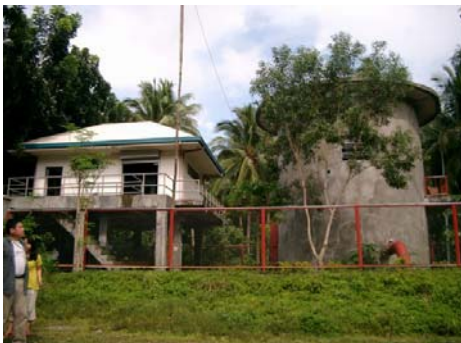
Nabaoy intake plant

Water supply system	Plan	Actual
1) Intake facilities	<ul style="list-style-type: none"> <li>install infiltration wells at 16 locations along the Nabaoy River</li> </ul>	<ul style="list-style-type: none"> <li>intake plants and intake pump condensed into one location</li> </ul>

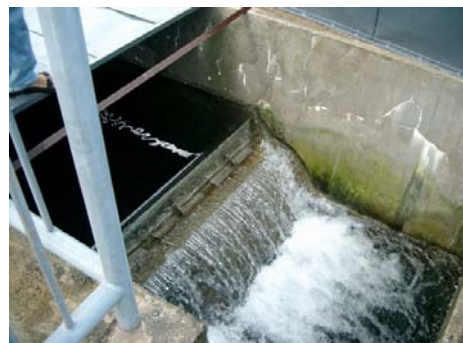
Water treatment plant

2) Water treatment facilities	<ul style="list-style-type: none"> <li>water treatment plant: water treatment capacity of 4,000m<sup>3</sup>/day</li> <li>chlorination facilities</li> </ul>	<ul style="list-style-type: none"> <li>water treatment plant: water treatment capacity of 6,000m<sup>3</sup>/day</li> <li>equipment procurement: chlorination facilities, set of generators, electricity supply facilities, water meters</li> </ul>

Aside from these, as a result of a review of the feasibility study concerning the water treatment capacity of the water treatment plant, the capacity was deemed too small given the projected increases in the island’s population and the number of tourists. As such, the 4,000m<sup>3</sup>/day of the initial plan was revised upwards to 6,000m<sup>3</sup>/day. The actual number of service connections installed was about half the number in the initial plan. This was the result of an increase in the project cost caused by the drop in the peso wherein the number which could be installed through the planned project cost range decreased, as well as delays in the project wherein the number which could be installed within the project period decreased. Moreover, regarding the submarine pipeline, the results of a bedrock excavation survey performed prior to laying the submarine pipeline proved that the geological conditions of the site planned for the burial of the pipeline were unsuitable so that a material of the transmission pipeline was changed from the initial plan.

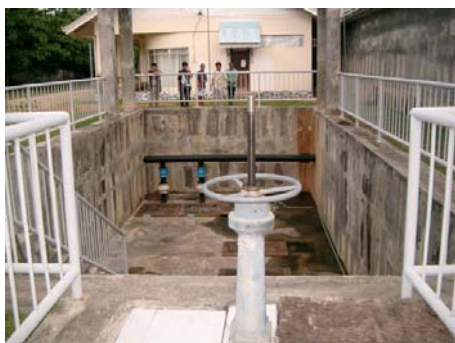
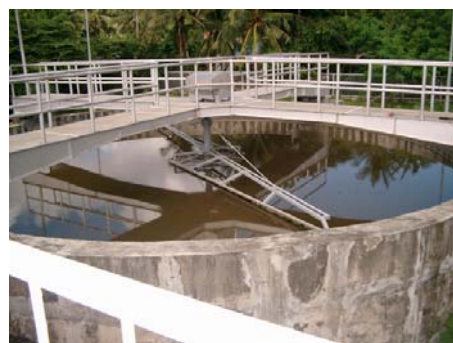
Sewerage treatment plant

3) Sewerage treatment plant	<ul style="list-style-type: none"> <li>▪ installation of a sewerage treatment plant (2.5ha): anaerobic pond, maturation pond, chlorination pond, facultative pond, regulating pond</li> <li>▪ discharge conduit: extension of 1,000m, inner diameter of 300mm</li> </ul>	<ul style="list-style-type: none"> <li>▪ 14,198m<sup>3</sup>/day oxidation ditch disposal site development and management (generator set, laboratory, distribution panels): grit chamber, pump station, 2 sedimentation tank units, 2 oxidation ditch units, disinfection tank, power distribution lines, sludge thickener, vacuum truck, sludge drying bed: 6 chambers</li> <li>▪ discharge conduit: extension of 840m, inner diameter of 250mm, CLEC steel pipe</li> </ul>
