Ecuador

Catarama River Basin Irrigation Project

External Evaluator: Kenji Momota (IC Net Limited)

Field Survey: September 2005

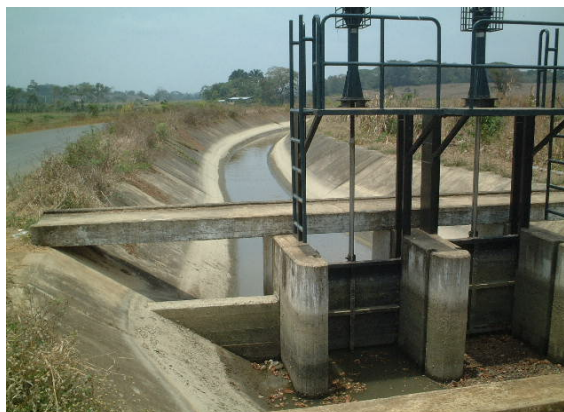
Secondary canal outfitted by the project

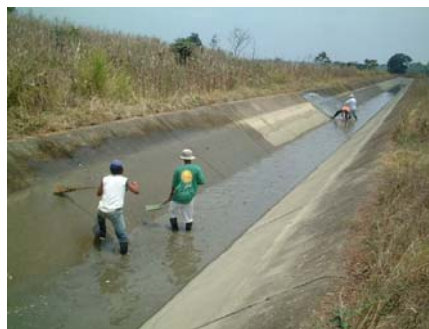
Fig. 3 Cleaning Work Performed on a Canal

A contractor has been responsible for the day-to-day handling of irrigation facilities, and it has assigned staff who possess actual management experience with irrigation projects in neighboring areas. The general operation and maintenance of irrigation facilities will eventually be turned over to an irrigation association managed by farmers. After the transfer, no major problems are expected because arrangements have been made to engage the contractor that has been responsible for operation and maintenance so far with providing the staff to handle the practical running of operations.
