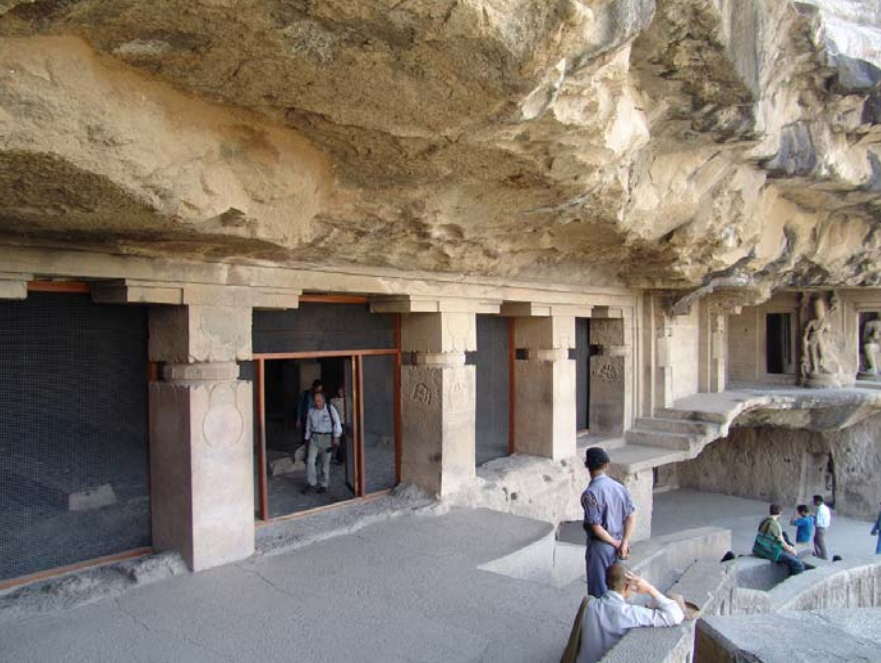
(Figure 51) Installation of bat proof mesh
Cave 5 (above and below)

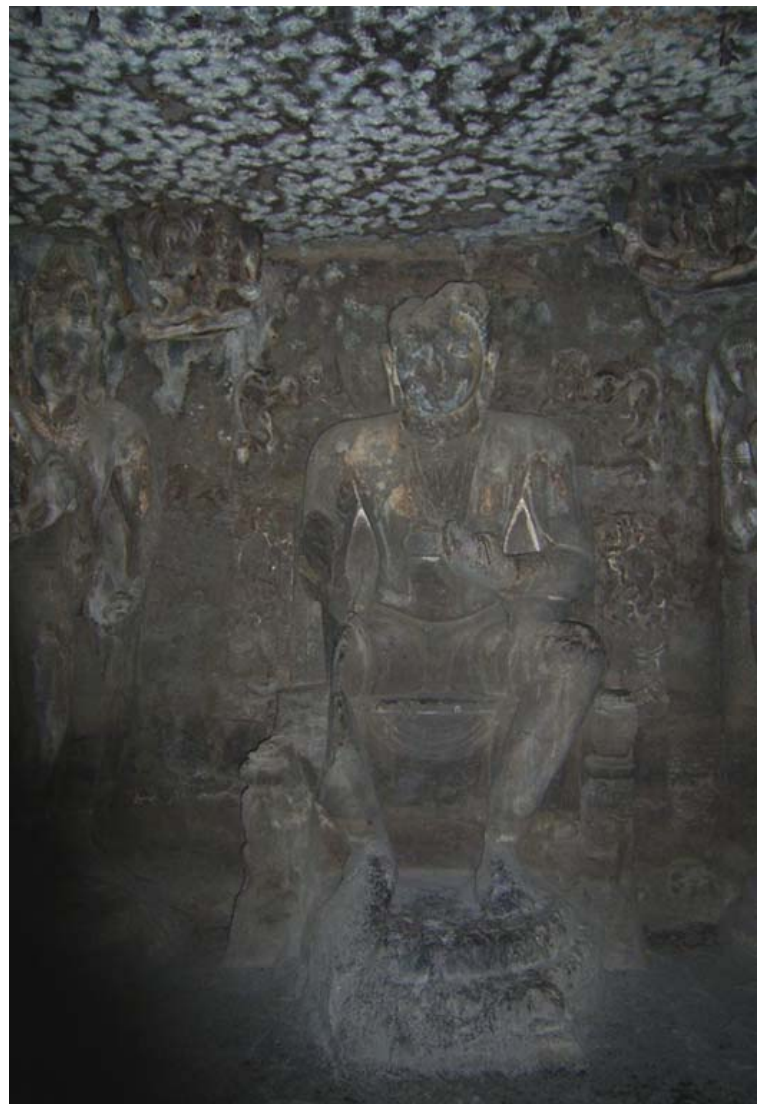
(Figure 52) Reference: Cave at the historic site of Aurangabad
The cave has become a nesting place for bats, which caused serious damages to mural paintings and sculptures. At the historic sites of Ajanta and Ellora, this situation has greatly improved thanks to the cleaning work and installation of bat proof mesh.
