The Philippines

Agno and Allied Rivers Urgent Rehabilitation Project

External Evaluator: Junko Saikawa

Field Survey: November 2007

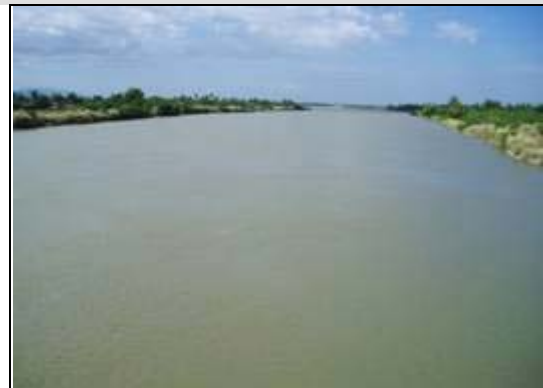
Bugallon short-cut channel

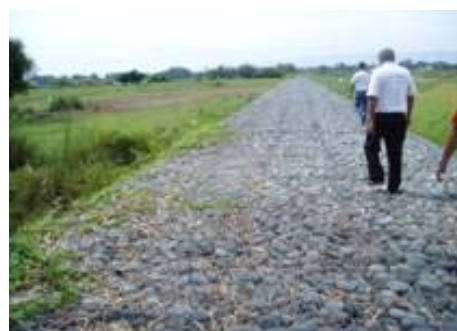
Figure 3: TRIIW current works

- The implementation of TRIIW (Tarlac River Interim Improvement Works) was added as a condition when the Region III Local Development Council approved the Agno River Flood Control Project (II).
- It became necessary to repair levee sites (Colibanban, Maleyep) which were damaged by the typhoon in August 2004.

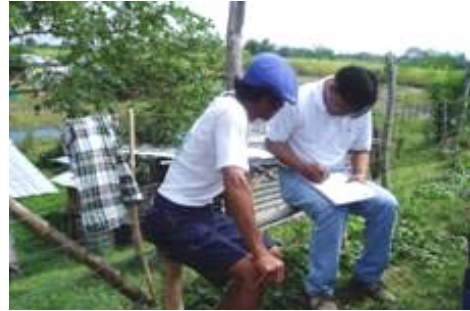
Figure 5: Reduction of Frequency of Flooding/Inundation

According to the beneficiary survey (sample size: 198 persons; target: residents living near the project site [Agno River and Tarlac River] who have experienced flooding/inundation in the past 15 years⁸), 1) 86% (171 persons) responded that the project reduced the frequency of flooding/inundation, 2) 87% (173 persons) responded that the project lightened the scale of flooding/inundation, and 3) 87% (173 persons) responded that the project reduced the damage from flooding/inundation. Thus, the large majority of residents perceive the project as having reduced the frequency, scale, and damage of flooding/inundation.

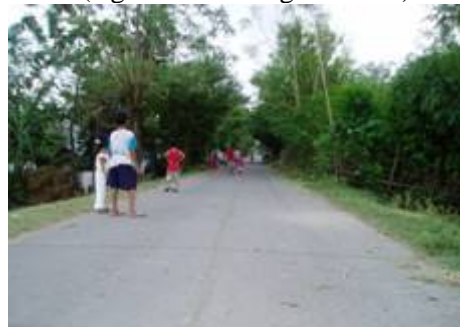
Figure 9: Paved levee (right bank of Agno River)

In this project, asphalt pavement was laid on the Lingayen–Wawa segment of the levee on the right bank of the Agno River. According to the beneficiary survey (total sample size: 188 persons; target: residents near Agno River), 89% (160 persons) responded that access to other areas was improved due to the asphalt pavement.
