### Tiete River Basin Depollution Project

External Evaluator: Kenichi Inazawa  
(Office Mikage, LLC)

Field Survey: April and July 2009

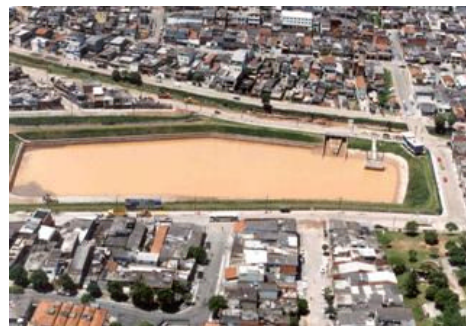
Figure 7: Rainwater Runoff Reduction Facilities (Flood Control Reservoirs)

On the other hand, around the tributaries of the Tietê River and the Cabuçu de Cima River, there are locations in which floods occur at times of heavy rain, causing damage to surrounding areas. The major reason for this is that effluent treatment is not being fully carried out due to rapid urbanization from the expansion of commercial and residential areas. The Executing Agency is cooperating with local governments in an attempt to alleviate flood damage by constructing rainwater runoff reduction facilities (flood control reservoirs) along the banks of the rivers (tributaries); however, at the current time, they have not been able to prevent all flood damage in the tributaries. Nonetheless, it is expected that future flood damage will be reduced further with the addition<sup>13</sup> of more facilities.

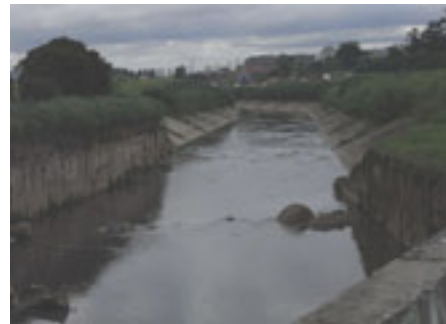
Figure 15: Cross-sections of the Cabuçu de Cima River. The near side is rectangular concrete, and the

The initial plan was to acquire approximately 25ha of land, but in practice approximately 50ha of land was acquired. According to the Executing Agency, the area subject to land acquisition increased because the initial plan was to carry out river improvement using rectangular concrete (high cost), but in 1995, the plan was revised and under the new plan, rectangular concrete was adopted only in areas with a high population density, with trapezoid concrete (low cost) being adopted in many zones instead.

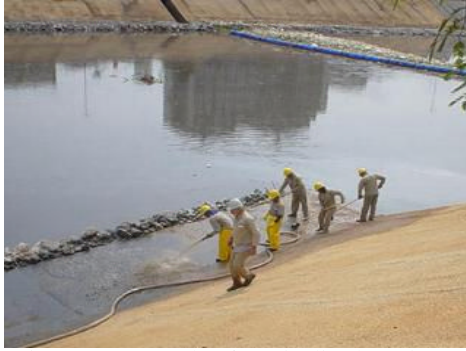
Figure 16: Work of Periodical Maintenance

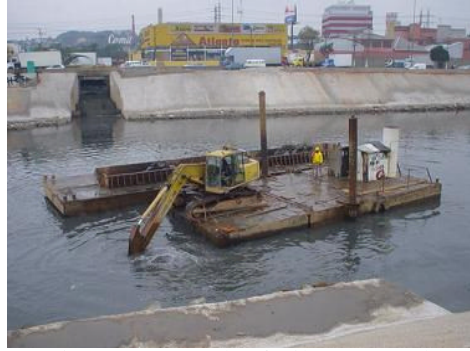
Figure 17: Work of Silt Removal

Meanwhile, over time, silt builds up on the riverbed of the Tietê River, and in some places, this is causing corrosion and sediment contamination (buildup of sludge, etc.). According to the results of a research survey that was commissioned to a local research institution by the Executing Agency, it is expected that approximately 400,000m<sup>3</sup> of silt builds up in each of the Tietê River Phase 1 and 2 zones every year. As a result, there is a possibility that the silt will result in waterweed and algae growth in the river, resulting in a decline in its discharge capacity. According to the Executing Agency, the O&M budget is insufficient, so adequate removal work and disposal has not been possible; as a result, there are now approximately 2,500,000m<sup>3</sup> of silt that has built up throughout the river improvement zone. Given this situation, the Executing Agency is carrying out silt removal by outsourcing the work to a private company within the O&M budget<sup>26</sup>.

<sup>26</sup> In this fiscal year, the work of removing approximately 400,000m<sup>3</sup> of silt has been commissioned to a private company, and the work is currently underway.

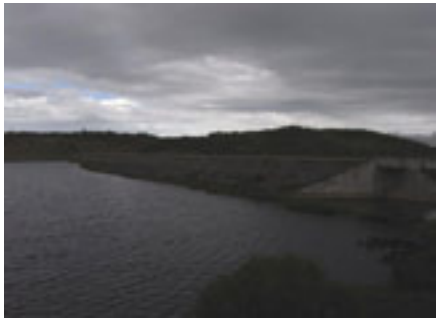
Figure 18: Paraitinga Dam

Regular maintenance is not carried out on either dam, apart from the O&M budget allocated in 2008 as a labor cost for monitoring personnel. At present, there is no major problem due to lack of maintenance work, including the banking sand in the dams. As stated previously, the responsibility of the O&M of both dams will be transferred to SABESP. SABESP claims to carry out proper maintenance with diligence.

There is one radar post for each dam to measure the amount of rainfall and floodwater levels, and there have been no problems about their O&M conditions.
