FY2020 Simplified Ex-Post Evaluation Report of Japanese Grant Aid Project

Country name	Project for improvement of Queensway substation
Republic of Uganda

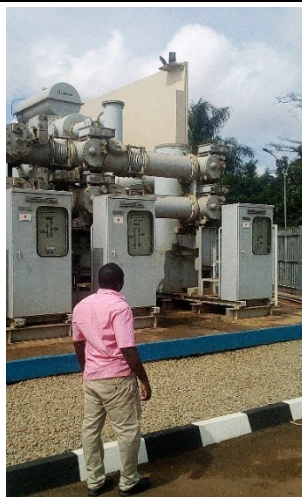
Outdoor 132 kV gas insulated switchgears

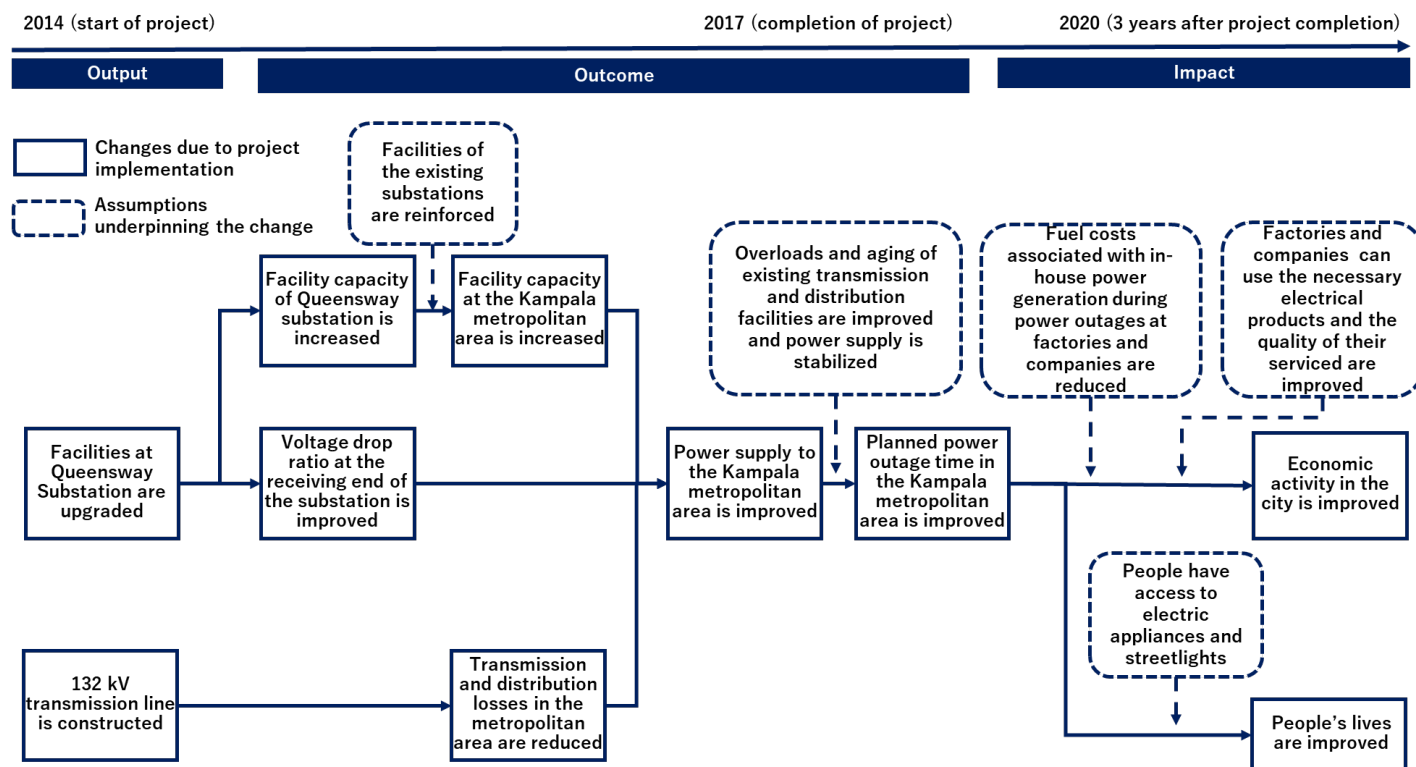
Figure 1: Logic of the project

The project aimed to improve the power supply capacity to the Kampala metropolitan area (Outcome) by enhancing the 132/33 kV substation facilities at the Queensway substation (Output). Furthermore, it aimed to improve economic activities and people's lives in Kampala city (Impact). Figure 1 shows the logic from the implementation of the project to the realization of the impact.

The expansion of the Queensway substation will increase the substation facility capacity, which will contribute to the increase in the substation facility capacity in the entire Kampala metropolitan area. In addition, the reinforcement of the substation facilities is expected to improve the voltage drop ratio of the power receiving end of the substation. Moreover, transmission and distribution losses occurred because of the lack of high-voltage transmission lines before the project⁶, and the construction of the 132 kV transmission line is expected to reduce the transmission and distribution losses in the Kampala metropolitan area. The improvement of the power supply capacity to the Kampala metropolitan area will improve the situation with the overload and aging of the existing transmission and distribution facilities, reduce the

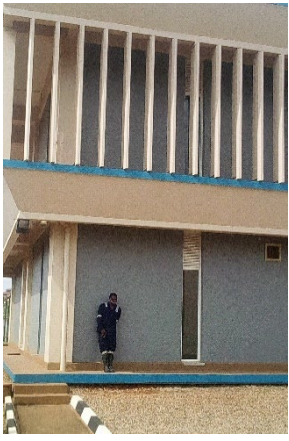
Control building

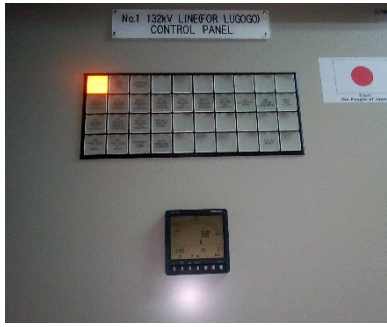
Control panel

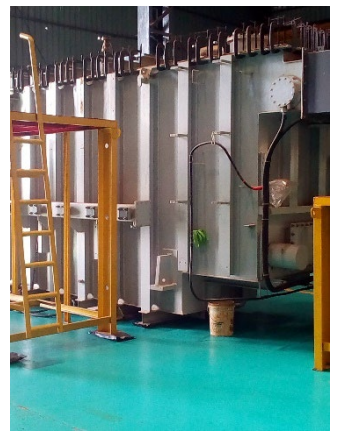
After routine maintenance in March 2019, unknown person entered the Queensway substation and vandalized the substation grounding copper wire. The transformers were left disconnected to the grounding system and this subsequently led to failure of Transformer No.3 (TX 3) when it was exposed to fault. According to the post-incident investigation by the manufacturer conducted in February 2020, the other two transformers (Transformer No.1 (TX 1) and 2 (TX 2)) had sustained mild damage during the incident; and were still in operation at the time of ex-post evaluation. UETCL believes that in addition to non-earthed substation operating condition due to theft of earthing conductor, the reason why the transformers got damaged is the weak design of the tertiary winding of the transformers. The damaged TX 3 is currently in the process of being repaired and UETCL has scheduled to embark on reinforcement for the tertiary winding of TX 1 and 2 as recommended by the manufacturer, upon completion of repairs of the already damaged TX 3. The reason for the time taken to repair TX 3 after the discovery of the malfunction is as follows. After the malfunction was confirmed, the transformer could not be opened on site, and it took time to assess the degree of damage. It also took time to locate a contractor who could handle the problem, as malfunctions of this sort do not occur frequently. Since the parts needed for the repair were not available in Uganda, UETCL contacted the manufacturer in Japan, estimated the cost of the repair, and applied for a budget. However, after approval was granted, it was found that the spare materials were taxable, yet the tax was not included in the budget estimates; and consequently, UETCL needed to reapply for the budget. In addition, after the procurement funds were secured, the manufacturer was unable to send engineers to repair the transformer because of the travel ban imposed owing to the COVID-19 pandemic. For this reason, UETCL is currently importing the parts and the transformer repairs are scheduled to commence by the Japanese supplier in January 2022 at a company that specializes in repairing substation equipment. It should be additionally noted that on 2nd November 2021, while awaiting reinforcement of its tertiary winding, TX 1 malfunctioned and is currently pending repair. The repairs for TX

1 are expected to be completed by the end of March 2022.

Transformer under repair

One transformer developed under the project has been out of service since March 2019 and is currently under repair. In addition to external factors such as the COVID-19 pandemic, the reasons it has taken time to repair the transformer are the procurement of parts that are unavailable in Uganda repair measures, and the complexity of the procurement process. When reinforcing substation facilities in the future, as well as the prompt repair of transformers, it is desirable to confirm that the parts are available in Uganda and to check thoroughly that there are no mistakes in the procurement procedures if the parts are difficult to obtain and must be procured from overseas.
