Noise Monitoring Program

Water Quality Monitoring - Km 115, Chicalo River

Water Quality Monitoring - Km 142, Lunguena river

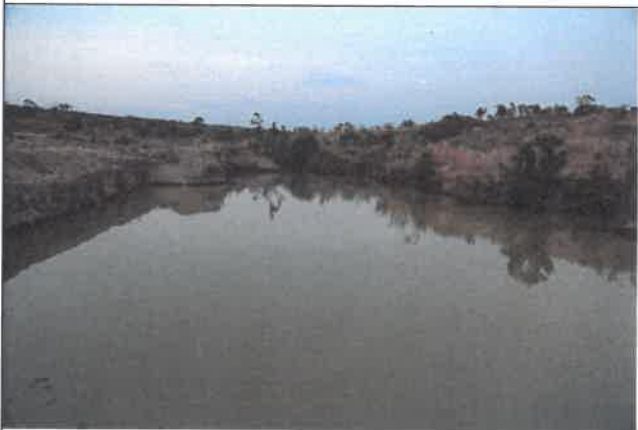
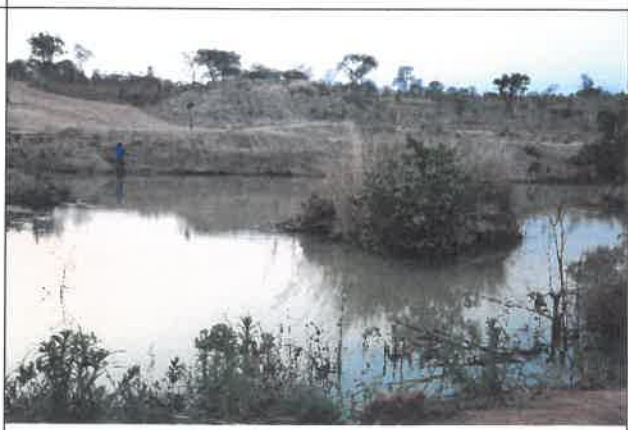
Location		Km 115, Chicalo river		
Date		17 th October 2018		
Start Time (hh:mm)		5:42pm		
Weather		Sun		
Sea Conditions		N/A		
Tidal Mode		N/A		
Water Depth (m)		N/A		
Monitoring Depth		Surface	Middle	Bottom
Salinity		N/A		
Temperature	(°C)	N/A		
DO Saturation	(%)	N/A		
DO	(mg/l)	N/A		
Turbidity	(NTU)	Only visual observation		
SS Sample Identification		N/A		
SS	(mg/l)	N/A		
Observed Construction Activities	<100m from location			
	>100m from location	The water from River stream the contractor is monitoring the quantities of extraction.		
Other Observations		The colour of water is not clean.

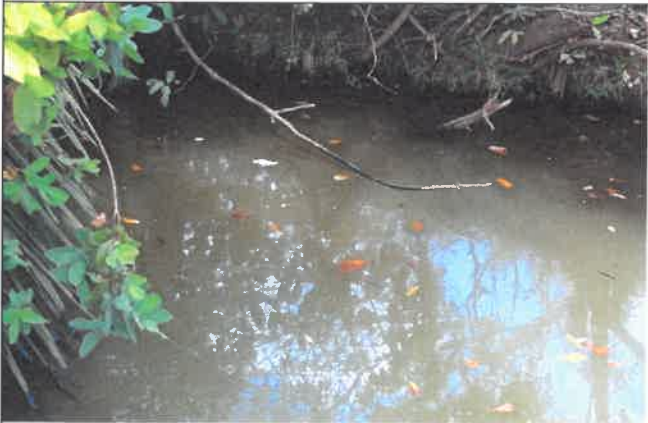
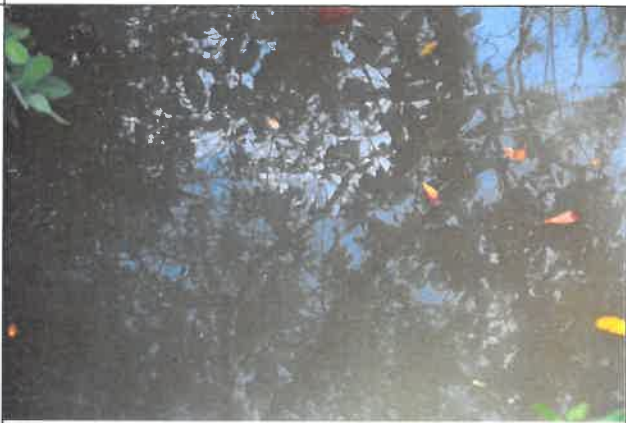
Location		Km 142, Lunguena river		
Date		17 th October 2018		
Start Time (hh:mm)		11:00		
Weather		Sun		
Sea Conditions		N/A		
Tidal Mode		N/A		
Water Depth (m)				
Monitoring Depth		Surface	Middle	Bottom
Salinity		N/A		
Temperature	(°C)	N/A		
DO Saturation	(%)	N/A		
DO	(mg/l)	N/A		
Turbidity	(NTU)	Only visual observation		
SS Sample Identification		N/A		
SS	(mg/l)			
Observed Construction Activities	<100m from location			
	>100m from location	The water from River stream the contractor is monitoring the quantities of extraction.		
Other Observations		The colour of water is not clean.
