# **Environmental and Social Consideration**

## **Quarterly Progress Report**

Period of October - December 2019

**Directorate General of Sea Transportation**

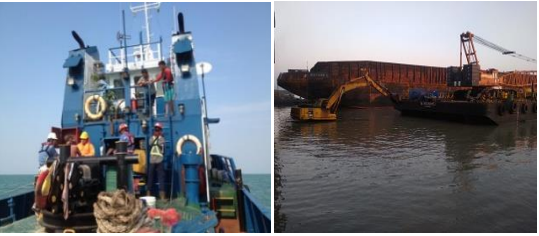
Mobilization of heavy equipment were conveyed by sea transportation (Materials for seawall construction)  
 CP 3. Implementation:  
 Work has not yet started

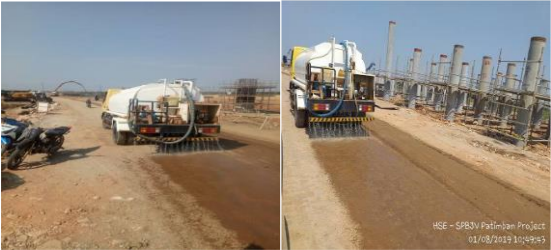
- Roads were sprinkled periodically to reduce dust pollution by road sprinklers

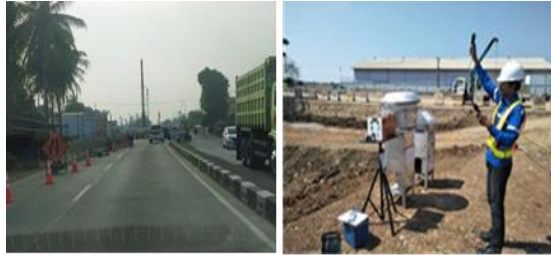
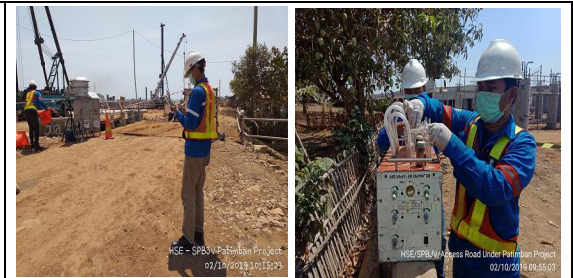
• Air quality measurement was conducted in October 2019. The monitoring results of air quality with five parameters (SO2, CO, NO2, PM10, TSP) were below the threshold, as shown in the attachment. The next measurement will be conducted in April 2020.

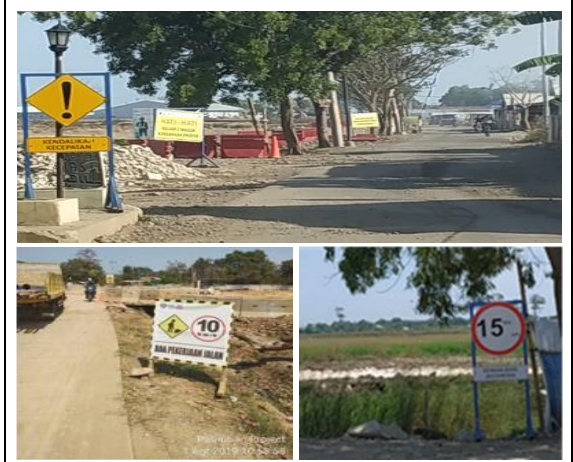
Speed control sign

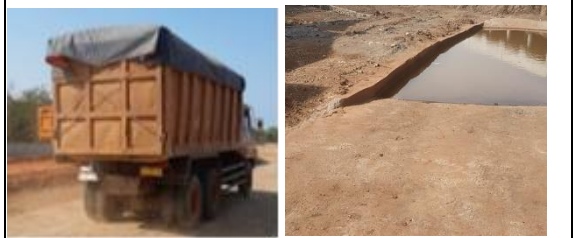
<p>The Truck of transporting material vehicle were closed with tarps and installed wash-house for vehicle wheels</p>

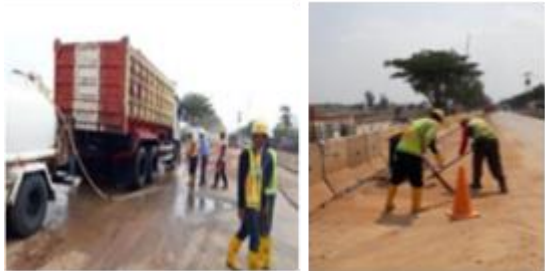
<p>The washing of vehicle tyre wheels and road cleaning at project Access due to soil materials spilled</p>

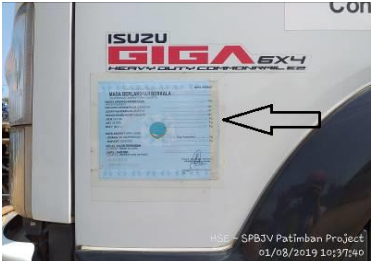
<p>Proper operational labeling for project vehicle by sticker (KIR) from Authority Office</p>
3B	Land traffic disruption	No occurrence of traffic jam as the effect of heavy equipment and materials mobilization	Heavy equipment and materials mobilization	<p>a. Coordinating with transportation institution to install traffic sign around the development of Patimban seaport location under ministerial regulation No.13 year 2014 about the traffic sign;</p> <p>b. Coordinating with police agencies to organize traffic around the Patimban seaport development location;</p> <p>c. Installing sign of construction warning signs in the entry and exit access of Patimban seaport development location;</p>	<p>a. Monitoring traffic condition;</p> <p>b. Identifying the accident number that occurred.</p>	<p>Implementation Package 1:</p> <p>The traffic condition affected by the project was monitored periodically. A vehicle volume survey was conducted once a month. During October to December 2019, no accident and traffic jam related to the project was reported. No occurrence was recorded of traffic jams at Pusakanagara road going to Jobsite confirmed because construction equipment and materials were transported during night time (as requirements). Also, the type/weight of equipment and speed were restricted.</p>

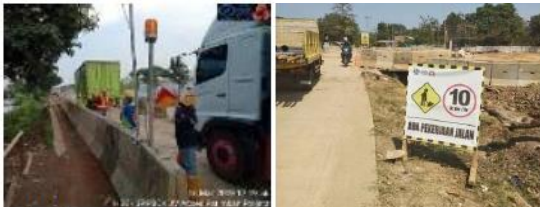
<p>Flagman for traffic control (left) and signage (right) See the attachment of land traffic conditions and accident numbers.</p>
3C	Sea traffic disruption	No occurrence of ship collision on the Patimban area	Heavy equipment and materials mobilization	<p>a.Coordinating with UPP (Port Operator Unit) Pamanukan about material transporting route on the sea;</p> <p>b.Coordinating with Tanjung Priok Navigation District about materials transporting sailing line;</p> <p>c.Socializing materials transporting route to the fishermen;</p> <p>d.Organizing material transporting time;</p> <p>e.Implementer contractors opening the communication with the ships around the materials transporting route.</p> <p><b>[DGST, CP1, CP2, CP3, CP4]</b></p>	<p>a.Monitoring sea traffic condition;</p> <p>b.Identifying the accident number that occurred.</p> <p><b>[CP1, CP2, CP3, CP4]</b></p>	<p>Sea traffic condition related to the project was monitored periodically.</p> <p>Implementation Package 1: From October to December 2019, no occurrence was recorded of ship collision at Patimban waters. Offshore activities coordinated with Patimban harbor master and necessary permits have secure before the start of works.</p>

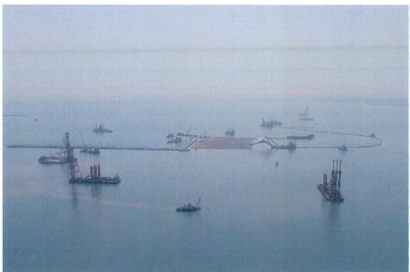
<p>Sea traffic condition (CDM Barge) in the construction area</p> <p>Implementation Package 2: No significant sea activity was conducted from October to December. No accident was reported.</p>

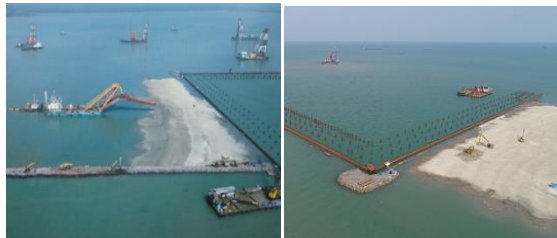
<p>CPM activities area was covered by rock-bund and Geotextile material as protecting and controlling the silt &amp; cement dispersion.</p>

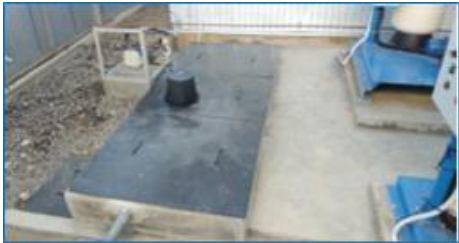
<p>Septic tank</p>
--	--	---------------------------	--------------------	-------------------------------------	----------------------	---

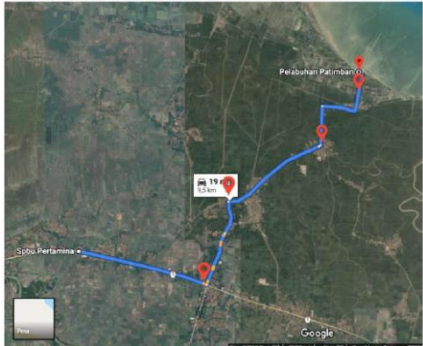
<p>Road damage inspection route</p>

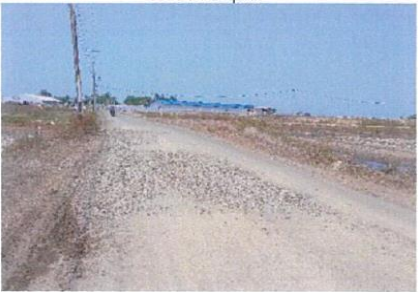
<p>The Road was fixed by contractor in November 2019</p> <p>Package 2: The contractor uses the public road for access to the site is restricted to light construction equipment and transporting during nighttime with limited speed. The road condition showed that no damage caused by the Patimban Port activity (No road damage reported from October to December 2019).</p>

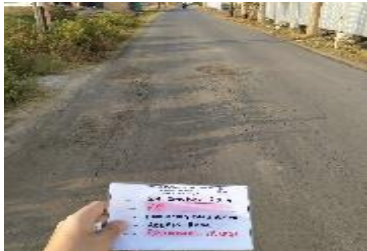
<p>Road condition around the port development area</p> <p>Meanwhile, the Sea route was used for the distribution/transportation of material and heavy equipment to avoid road damage.</p> <p>Package 3: The activity has not yet started.</p> <p>Package 4: Road repairs had been implemented.</p> <p>CP 1 Implementation:</p>
3B	Increasing noise.	Noise intensity, according to Ministerial decree	Equipment and materials mobilization.	a. Heavy equipment and materials mobilization using Patimban seaport construction	Conducting noise laboratory analysis, the results shall be compared with the noise

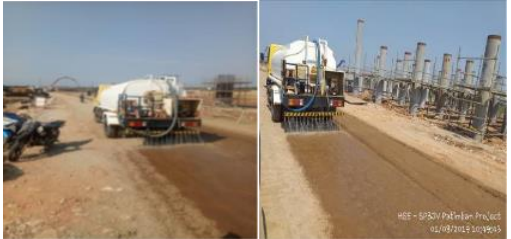
<p>Road sprinkled by water spray</p>

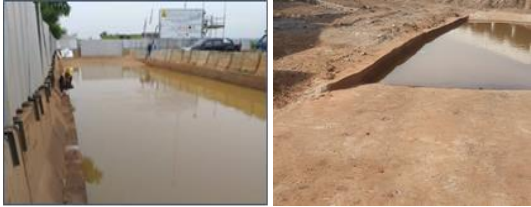
<p>vehicle wheel wash first at washing pond.</p>

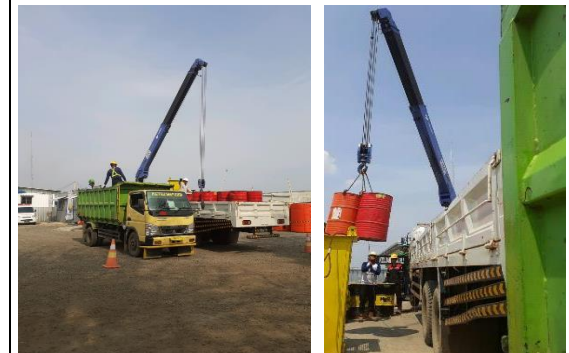
**Used oil waste**

To prevent the hazard contamination to the sea, the contractor has managed and transferred hazardous waste (used oil) from vessel to temporary shelter of hazard waste, and then they will be transported by the

transporter (refer to the Environment Permit from Ministry of Environment and forestry) dated July 25, 2019. The volume is 27 drums x 200 liters = 5.400 liters wastewater volumes.

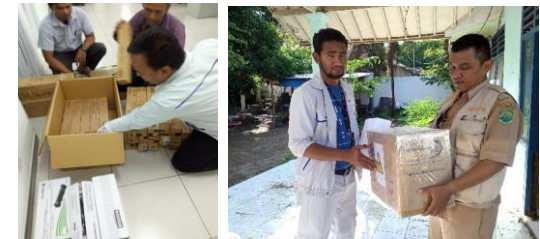
Medical waste was managed by third party PT. Tenang Jaya (3rd party licensed waste transporter) to dispose Non Hazard-waste (Industrial source) Management :

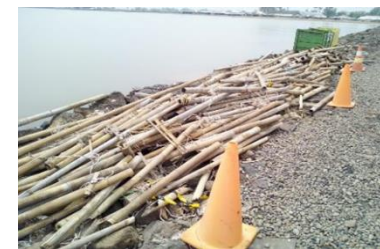
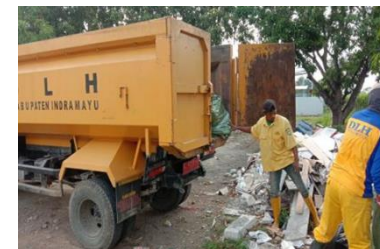
Industrial non-hazardous waste regular was stored at jetty or causeway before it disposed by the licensed waste transporter (3rd Party). PTRPW has collaborated with BANK SAMPAH (local provider form Patimban Village) for Domestic and Industrial waste management disposal coming from marine and office activity, meanwhile for accommodation area collaborated with Environmental Agency of Indramayu.

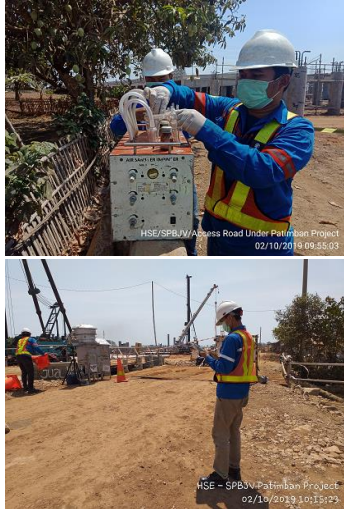
<p>2. Roads were sprinkled regularly to reduce dust pollution. Dust pollution was tended to be under control within limits &amp; speed control signed. The preventive action for dust polluted by Speed control sign for project vehicles on project access road</p>

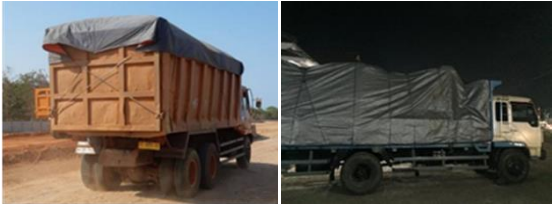
<p>4. Project access road &amp; Vehicle feasibility check</p>

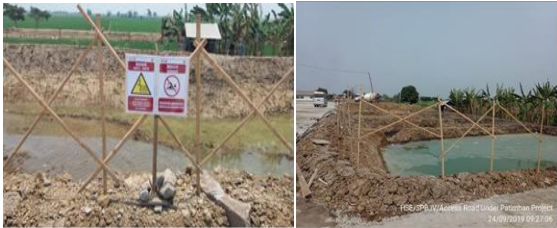
<p style="text-align: center;">Sedimentation treatment pond</p>
7E	Public unrest	No public unrest occurrence	Access road development	<ol style="list-style-type: none"> <li>1. Installing a bridge or other facilities to be able to cross to the access road;</li> <li>2. Installing fences along access road to secure safety and to prevent accidents of people or livestock;</li> <li>3. Establishment of Grievance Redress Center /Fast Response Team to accommodate and respond to public unrest related to the Patimban Seaport Development Project;</li> </ol> <p>[CP3, CP4]</p>	<ol style="list-style-type: none"> <li>a. Identification of the number of grievances raised due to access road operation activity;</li> <li>b. Identification by interview process using questionnaire (primary data)</li> <li>c. Identification of number protesting and demonstrating people against the project implementing representative office shall be achieved from related reports to local governments or to project implementing representative office (secondary data).</li> <li>d. Regarding the information and data that need to be explored deeper, shall conduct an in-depth interview</li> </ol>	<p>Handling complaints and problems due to access road development is still in progress. Until December 2019, the contractor already repair 58 houses impacted by access road development located at Pusakaratu Village, Kotasari Village, and Gempol Village, of total 264 houses.</p>

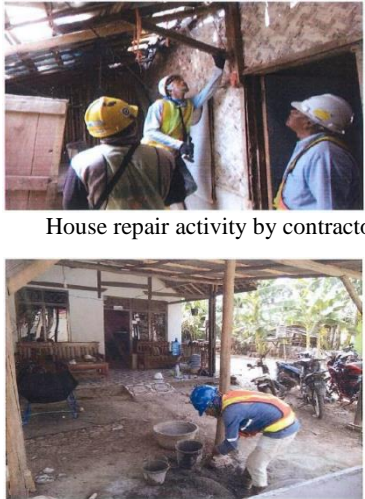
<p>House repair activity by contractor</p> <p>House repair activity by contractor</p>
--	--	--	--	--	---	---

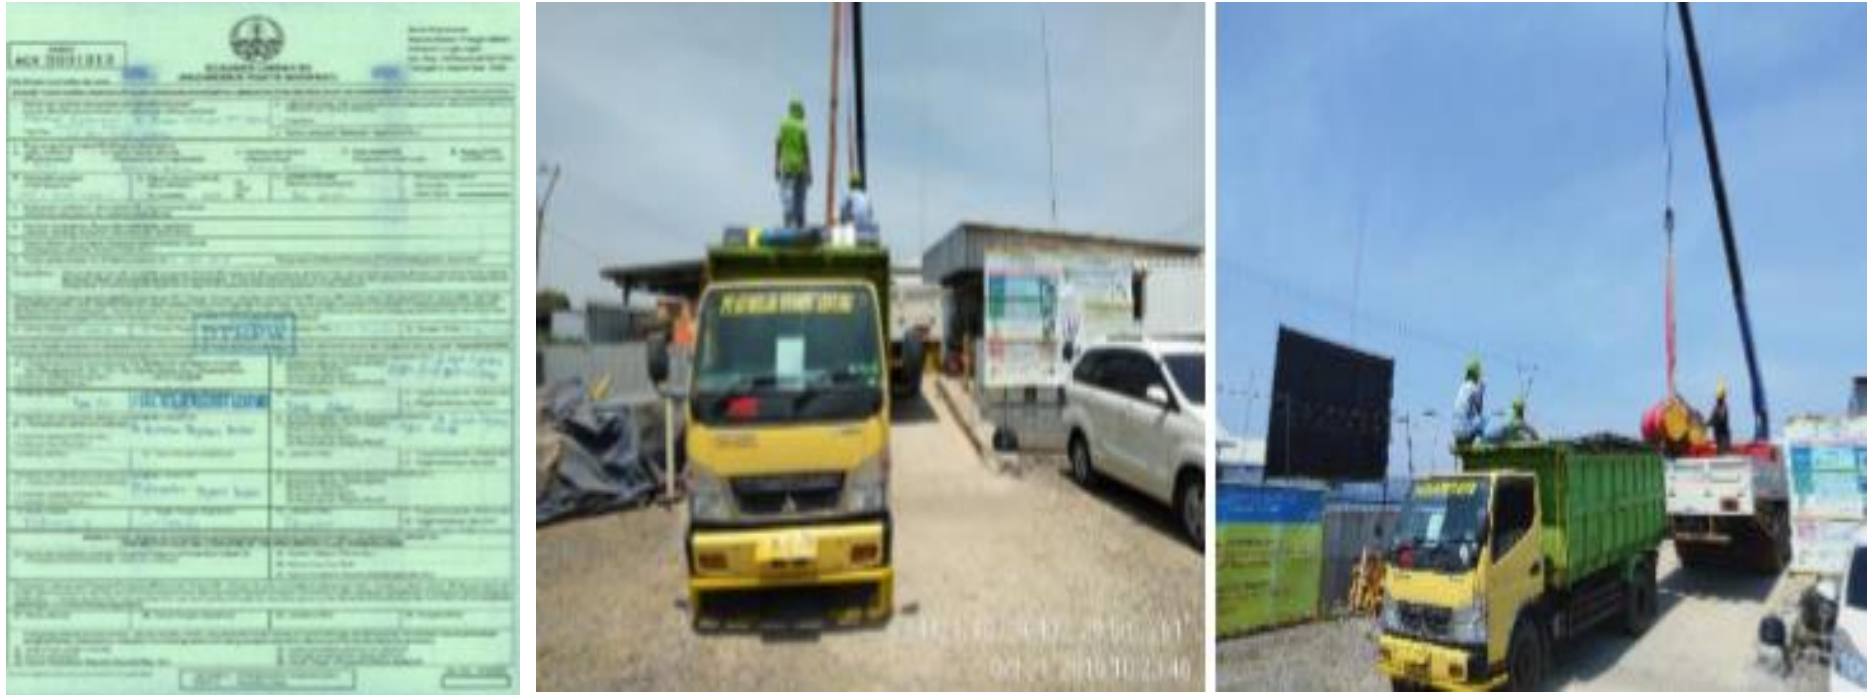
Figure 4. Industrial Waste Management (Hazardous Liquid-waste)

Note : Contractor has transferred hazardous waste (liquid/used oil) from vessel to shelter temporary hazardous waste storage. Then move out by transporter (license from Ministry of Forestry and Environment).
