**Thilawa Special Economic
Zone (Zone A) Development**

**Environmental Monitoring Report
(Operation Phase)**

**Myanmar Japan Thilawa
Development Limited.**

April 2019

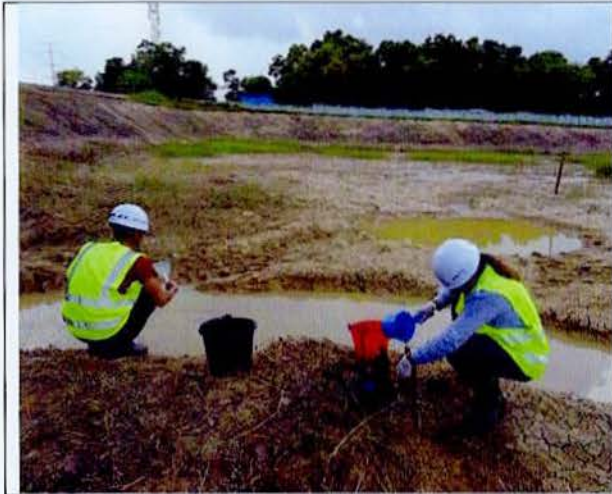
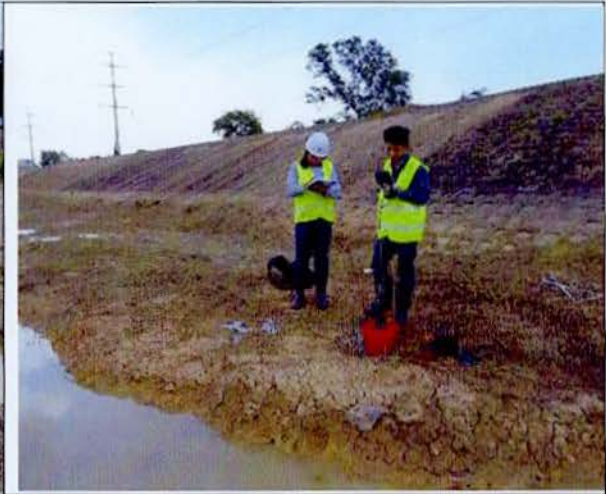
Surface water sampling and onsite measurement at SW-1

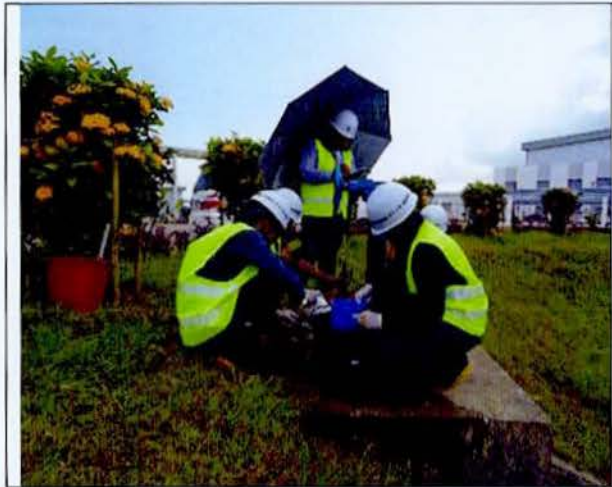
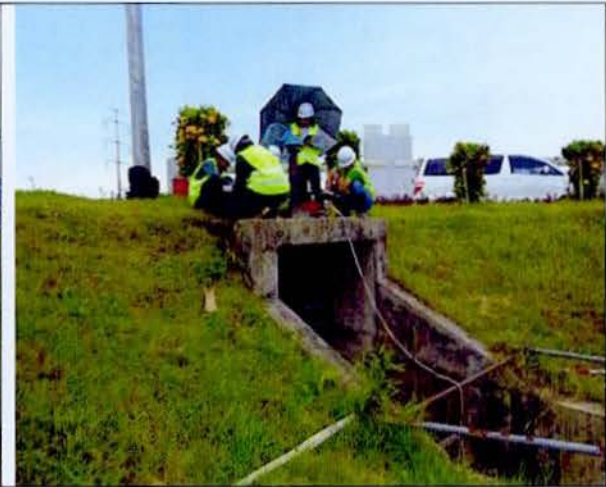
Surface water sampling and onsite measurement at SW-5

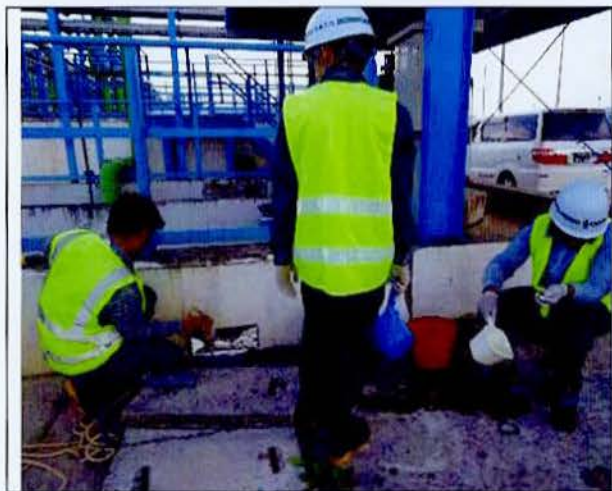
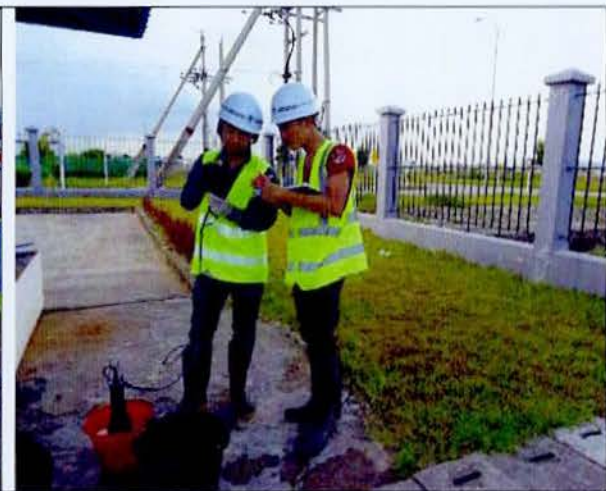
Surface water sampling and onsite measurement at SW-6

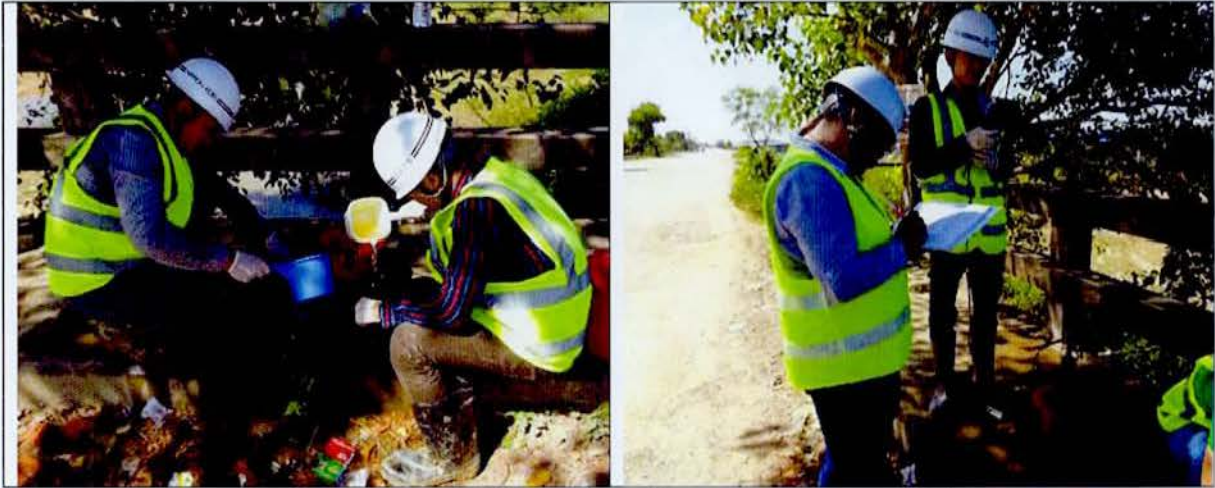
Surface water sampling and onsite measurement at SW-2

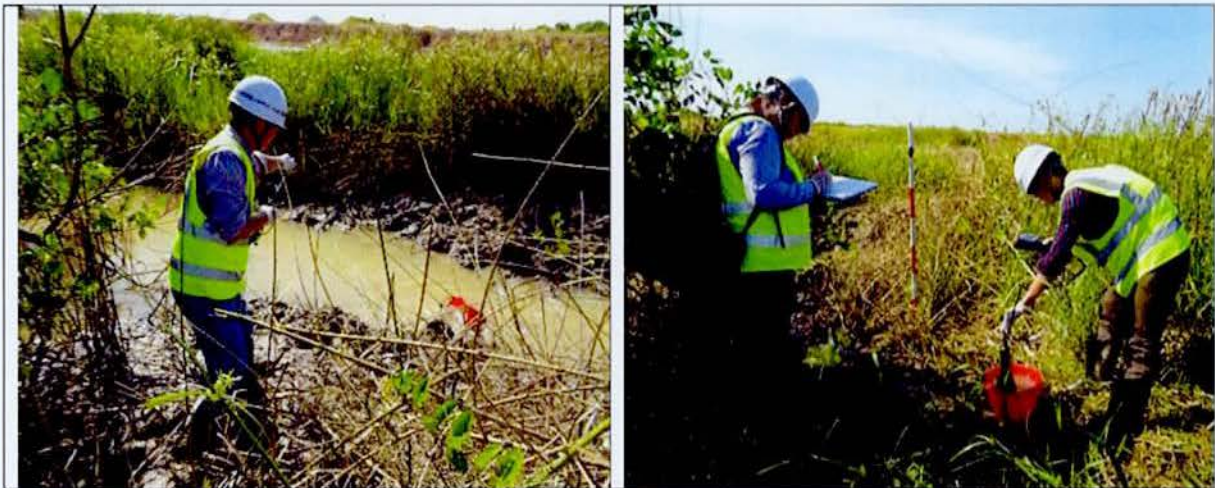
Surface water sampling and onsite measurement at SW-3

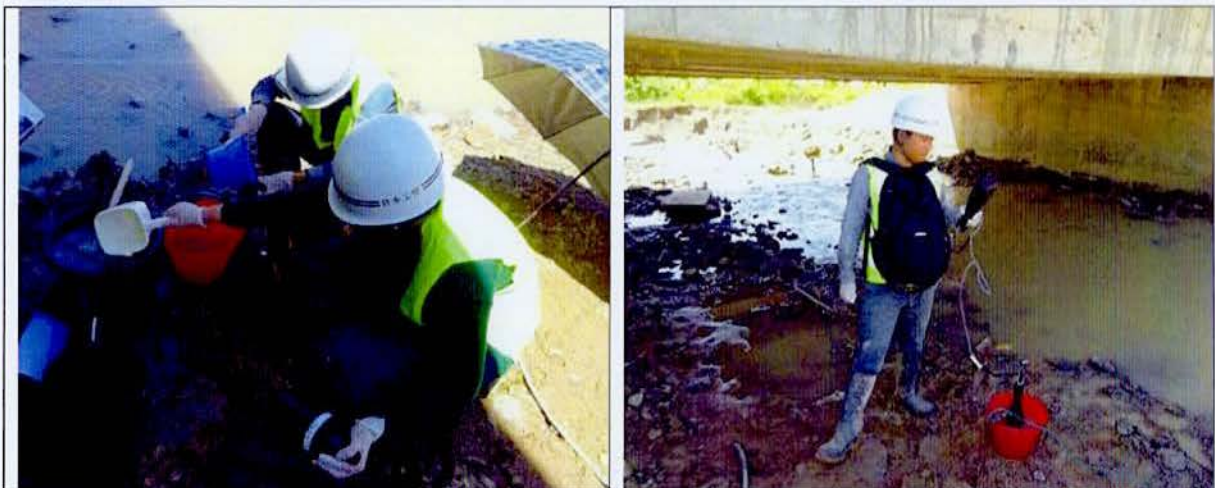
Surface water sampling and onsite measurement at SW-4

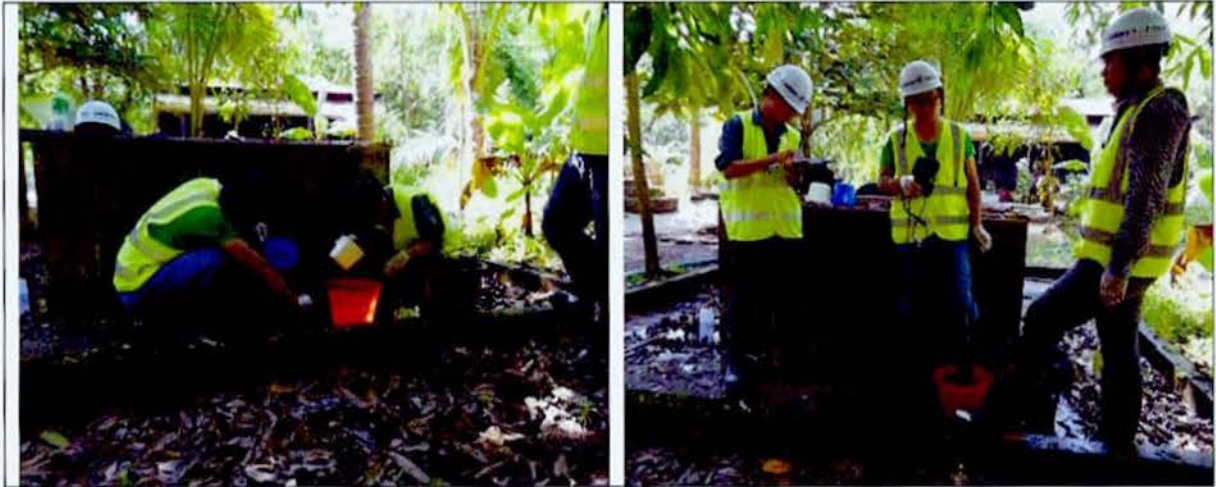
Ground water sampling and onsite measurement at GW-1

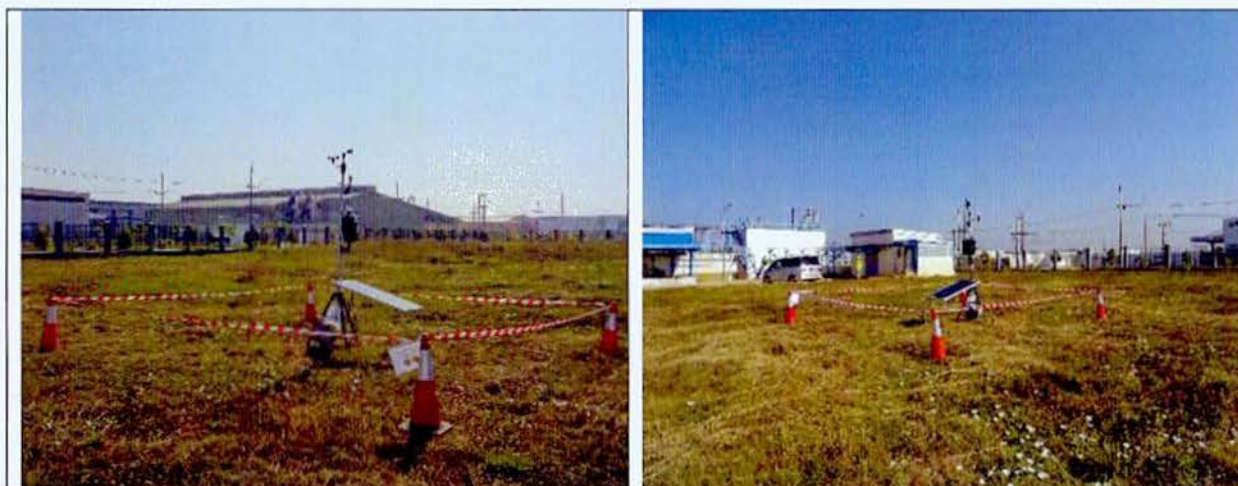
Figure 2.4-1 Status of Air Quality Monitoring Point

Monitoring of CO, NO₂, TSP, PM₁₀ and SO₂ were conducted by referring to the recommendation of the United States Environmental Protection Agency (U.S. EPA). The Haz-Scanner EPAS was used to collect ambient air pollutants. The EPAS measures automatically every five minutes and directly reads and records onsite for CO, NO₂, TSP, PM₁₀ and SO₂. Due to the limitation of the analytical equipment in Myanmar, TSP results were calculated as predicted value which is based on the results of PM₁₀. Therefore, the result of TSP was evaluated using the estimated TSP concentration values. The state of air quality monitoring is shown in Figure 2.4-1.

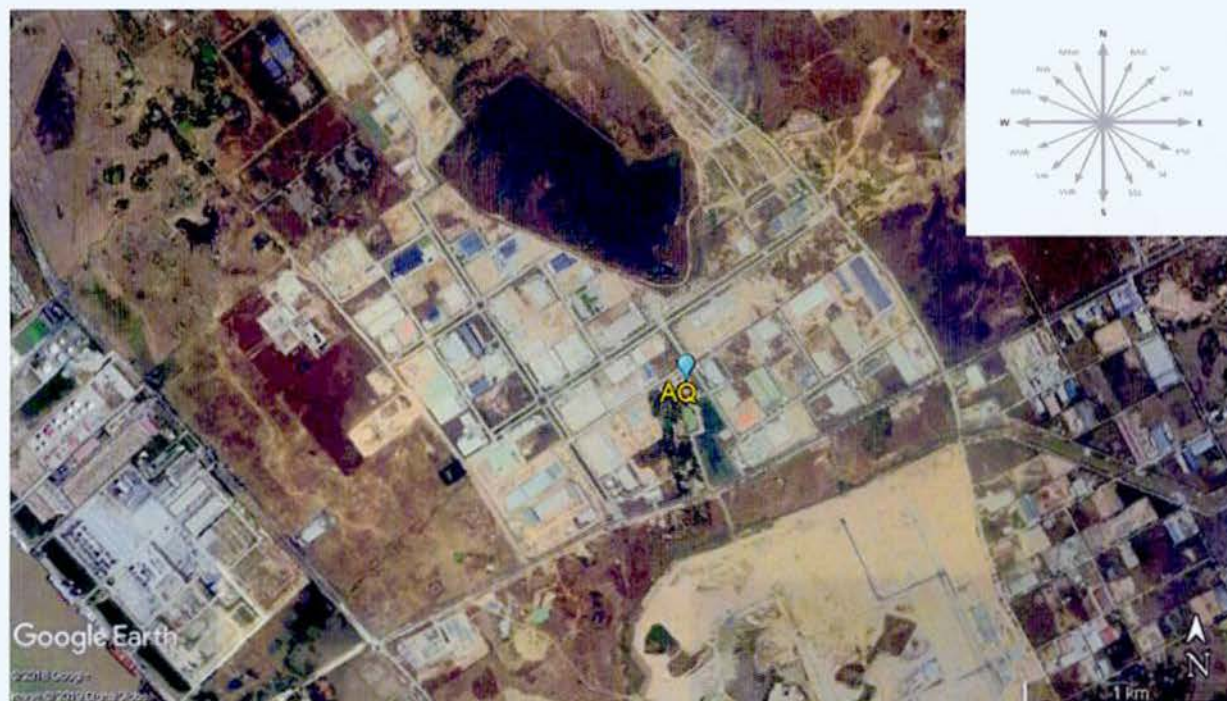
Figure 2.5-1 Status of Air Quality Monitoring Point and Wind Direction at AQ-1

Wind direction and wind speed were measured at AQ-1. Hourly average values of measured wind direction and wind speed data are described in Appendix 1. Status of air quality monitoring point and wind direction are described in Figure 2.5-1.

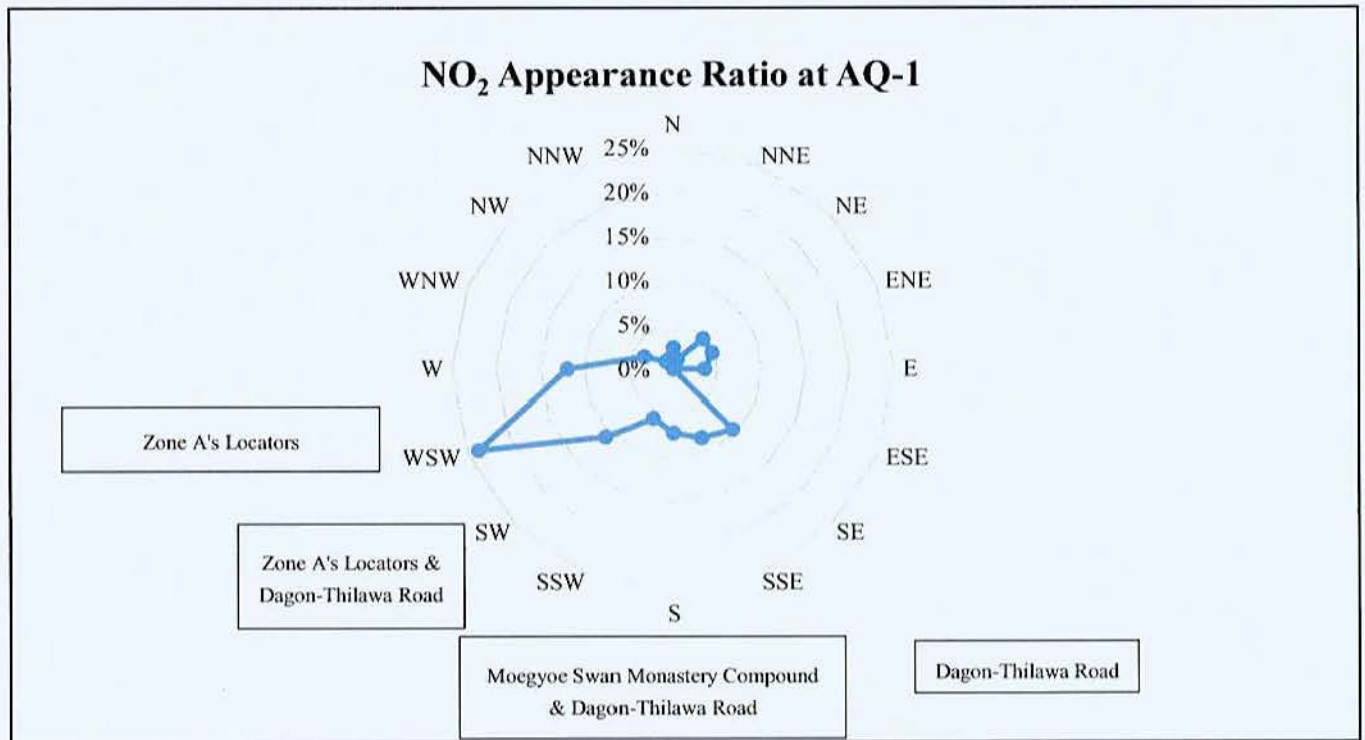
Figure 2.5-2 Wind Direction for NO₂ at AQ-1

The result of wind direction for NO₂ is shown in Figure 2.5-2. The air quality monitoring from 6 February 2019 to 13 February 2019 suggested that the prevailing wind direction is from West-Southwest (WSW) to West (W).

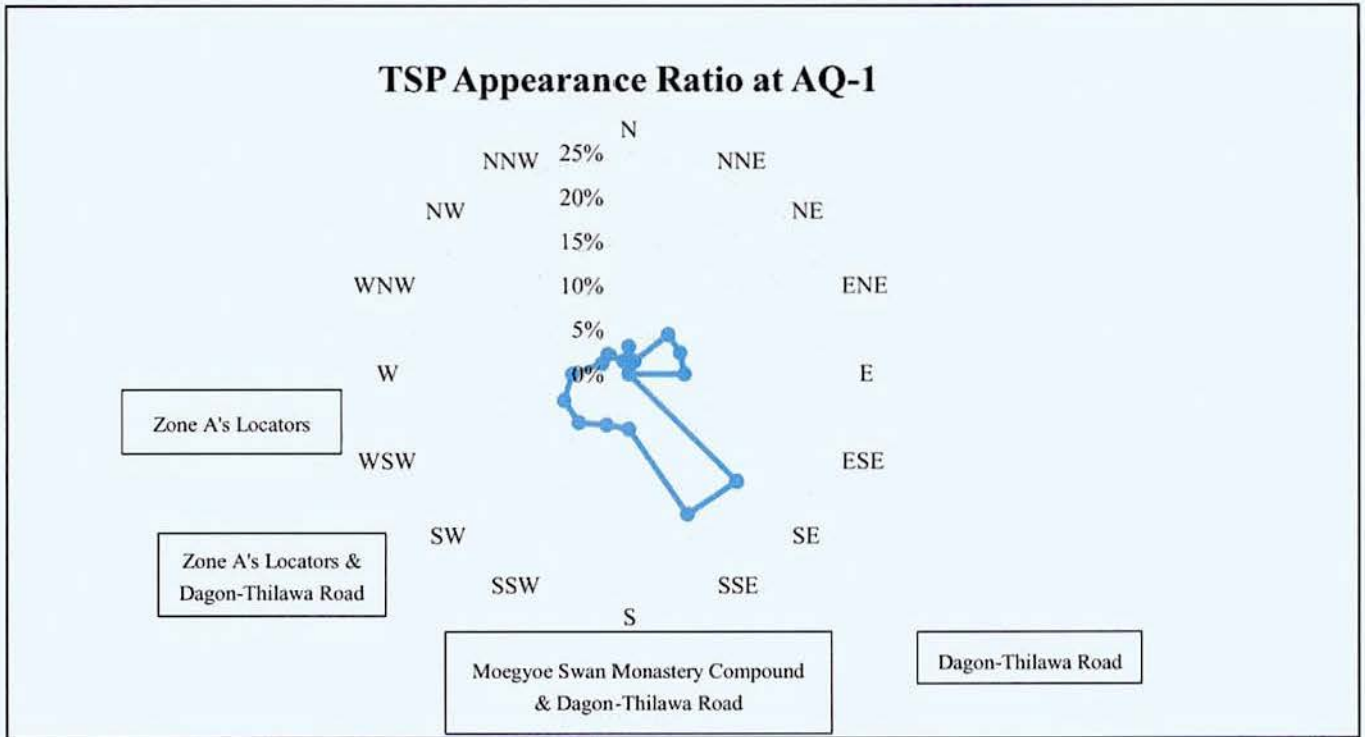
Figure 2.5-3 Wind Direction for TSP at AQ-1

The result of wind direction for TSP is shown in Figure 2.5-3. The air quality monitoring from 6 February 2019 to 13 February 2019 suggested that the prevailing wind direction is from Southeast (SE) to South-Southeast (SSE).

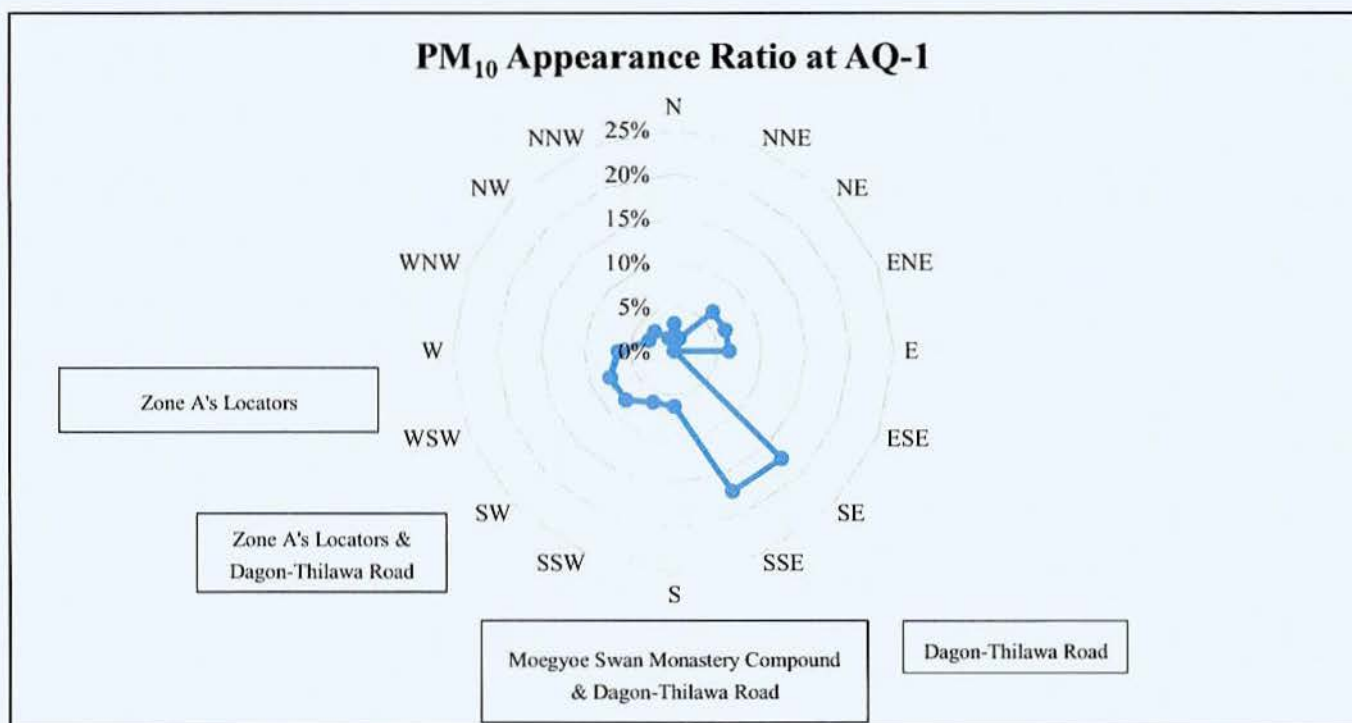
Figure 2.5-4 Wind Direction for PM₁₀ at AQ-1

The result of wind direction for PM₁₀ is shown in Figure 2.5-4. The air quality monitoring from 6 February 2019 to 13 February 2019 suggested that the prevailing wind direction is from Southeast (SE) to South-Southeast (SSE).

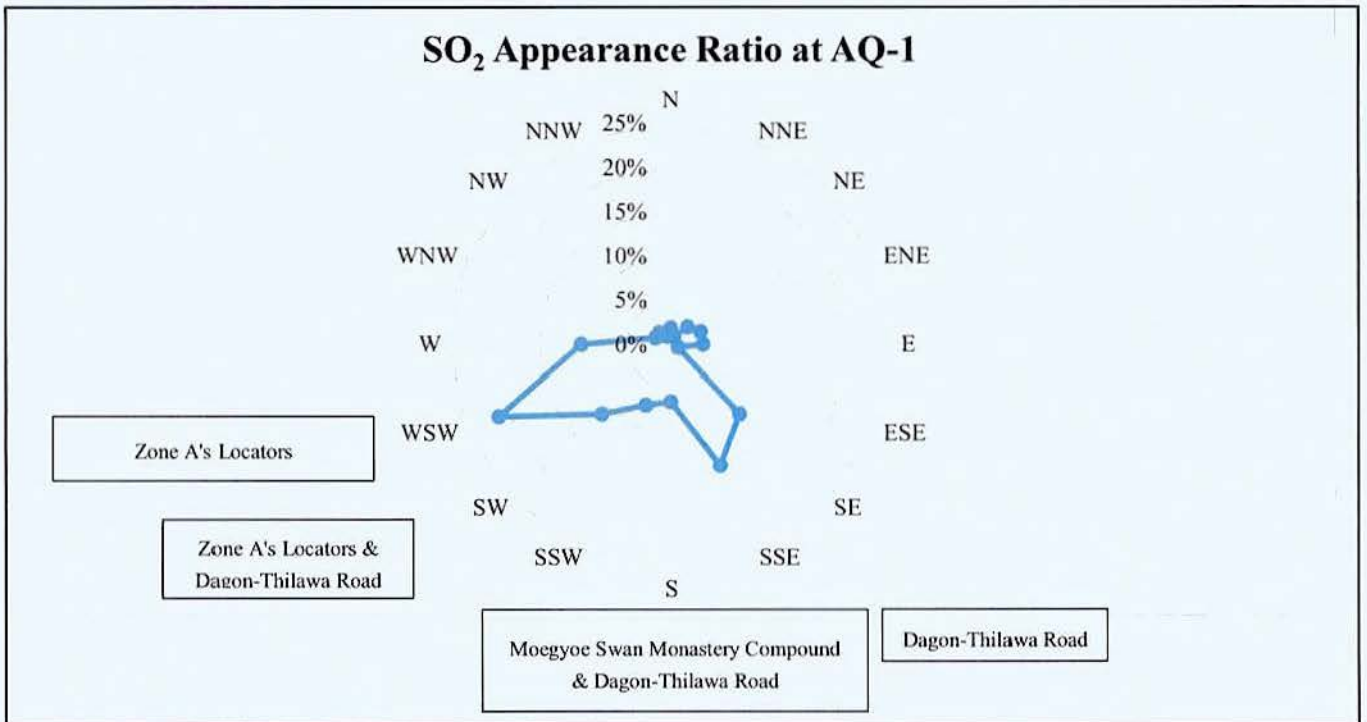
Figure 2.5-5 Wind Direction for SO₂ at AQ-1

The result of wind direction for SO₂ is shown in Figure 2.5-5. The air quality monitoring from 6 February 2019 to 13 February 2019 suggested that the prevailing wind direction is from West-Southwest (WSW) to West (W).

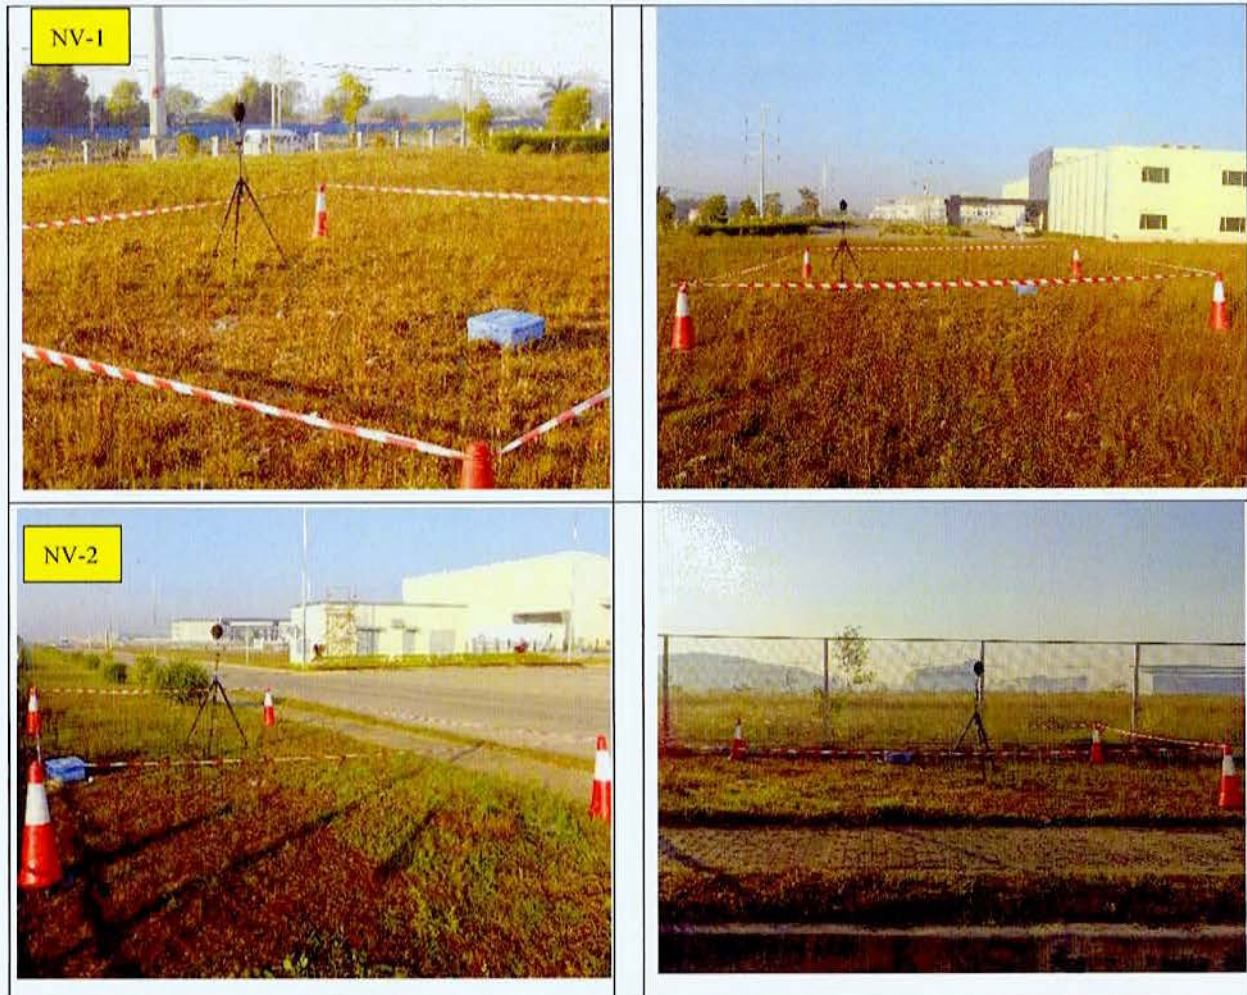
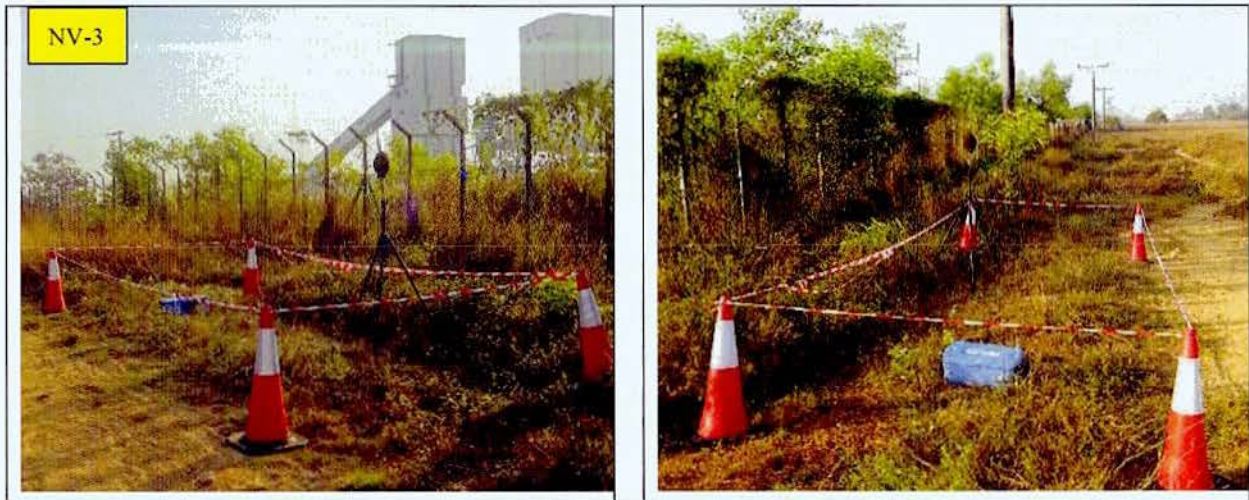
Figure 2.3-1 Status of Noise and Vibration Level Monitoring at NV-1, NV-2 and NV-3

Noise level was measured by “Rion NL-42 sound level meter” and automatically recorded every 10 minutes in a memory card. The vibration level meter was, VM-53A (Rion Co. Ltd., Japan), accompanied by a 3-axis accelerometer PV-83C (Rion Co., Ltd.) was placed on solid soil ground. Vertical vibration (Z axis), L_v , was measured every 10 minutes within the adaptable range of (10-70) dB at NV-1, (10-70) dB at NV-2, and (10-70) dB at NV-3 and recorded to a memory card.

The measurement period of noise and vibration was 24 hours for each monitoring point. The status of the noise and vibration level monitoring on NV-1, NV-2 and NV-3 are shown in Figure 2.3-1

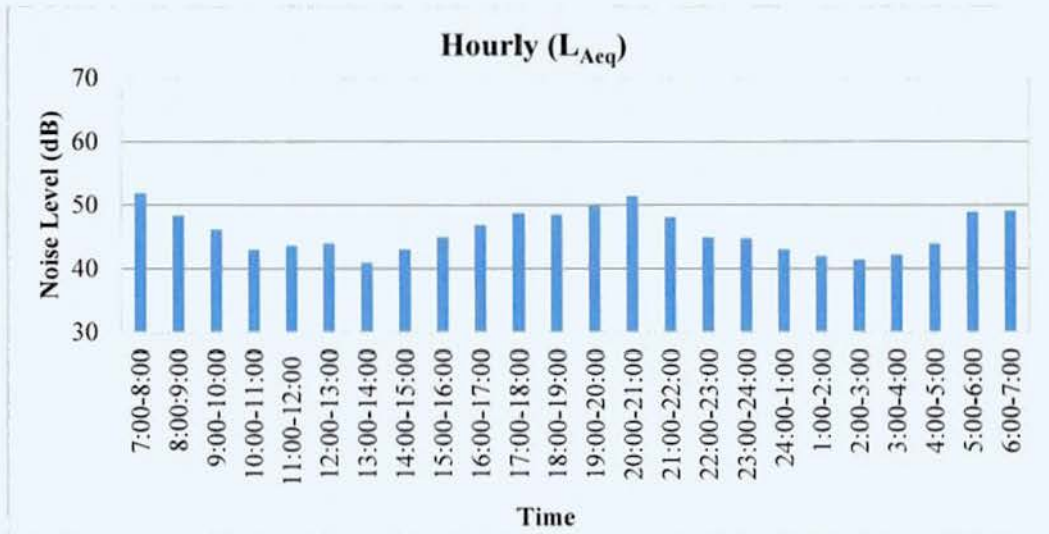
Figure 2.4-3 Results of Noise Levels (L_{Aeq}) Monitoring at NV-3

Date	Time	(L_{Aeq} , dB)	(L_{Aeq} , dB) Each Category	(L_{Aeq} , dB) Target Value
8 February – 9 February, 2019	7:00-8:00	52	47	70
	8:00-9:00	48		
	9:00-10:00	46		
	10:00-11:00	43		
	11:00-12:00	44		
	12:00-13:00	44		
	13:00-14:00	41		
	14:00-15:00	43		
	15:00-16:00	45		
	16:00-17:00	47		
	17:00-18:00	49		
	18:00-19:00	48		
	19:00-20:00	50	50	65
	20:00-21:00	51		
	21:00-22:00	48		
	22:00-23:00	45	45	60
	23:00-24:00	45		
	24:00-1:00	43		
	1:00-2:00	42		
	2:00-3:00	41		
	3:00-4:00	42		
	4:00-5:00	44		
	5:00-6:00	49		
	6:00-7:00	49

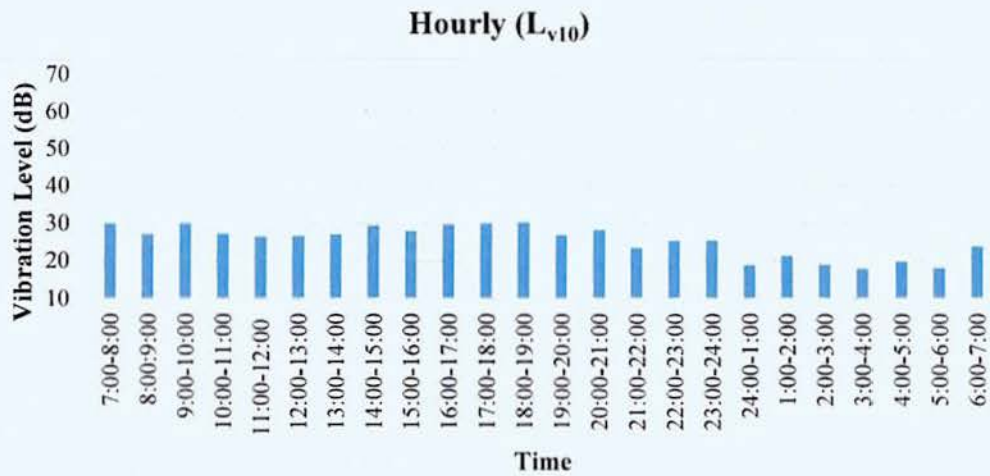
Figure 2.4-6 Results of Vibration Levels (L_{v10}) Monitoring at NV-3

Date	Time	(L_{v10} , dB)	(L_{v10} , dB) Each Category	(L_{v10} , dB) Target Value
8 February – 9 February, 2019	7:00-8:00	30	29	70
	8:00-9:00	27		
	9:00-10:00	30		
	10:00-11:00	27		
	11:00-12:00	26		
	12:00-13:00	27		
	13:00-14:00	27		
	14:00-15:00	29		
	15:00-16:00	28		
	16:00-17:00	30		
	17:00-18:00	30		
	18:00-19:00	30	27	65
	19:00-20:00	27		
	20:00-21:00	28		
	21:00-22:00	23		
	22:00-23:00	25	22	65
	23:00-24:00	25		
	24:00-1:00	19		
	1:00-2:00	21		
	2:00-3:00	19		
3:00-4:00	18			
4:00-5:00	20			
5:00-6:00	18			
6:00-7:00	24

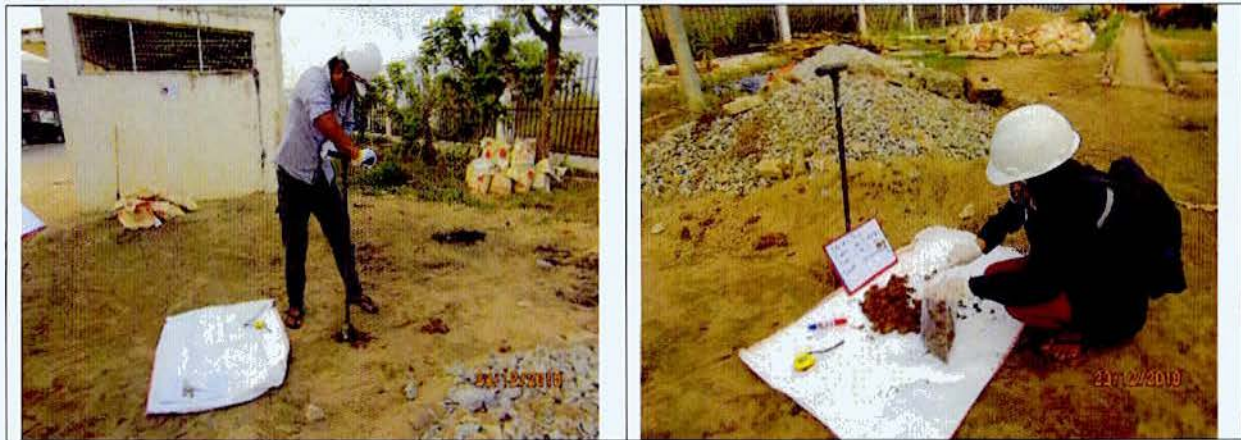
Figure 2 Soil quality sampling at S-1

S-1 is situated in the southern part of the Thilawa SEZ Zone (A) area, and distanced about 40 m from administration building. It was collected beside of the Trash Storage Building. Sometimes, wastewater after cleaning that domestic waste is leaked and may sink into the ground. The soil condition is fine to medium grained, reddish brown colored silty clay.

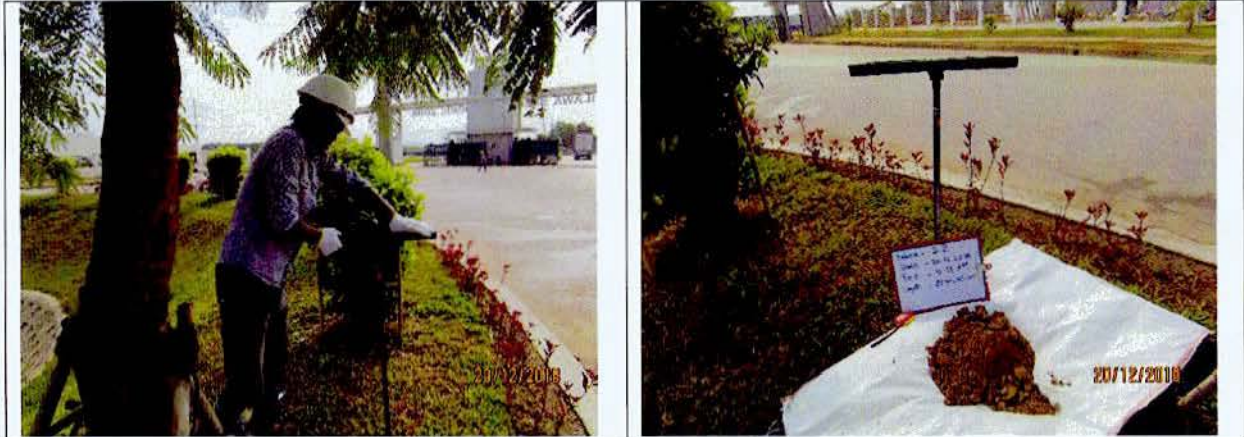
Figure 3 Soil quality sampling at S-2

S-2 was collected at the slope area of the retention canal, which is situated near the main gate of Thilawa SEZ (Zone-A). It is beside of the Thilawa SEZ car road and intended to plant the trees along the slop. The soil condition is fine to medium grained, reddish brown colored silty caly.

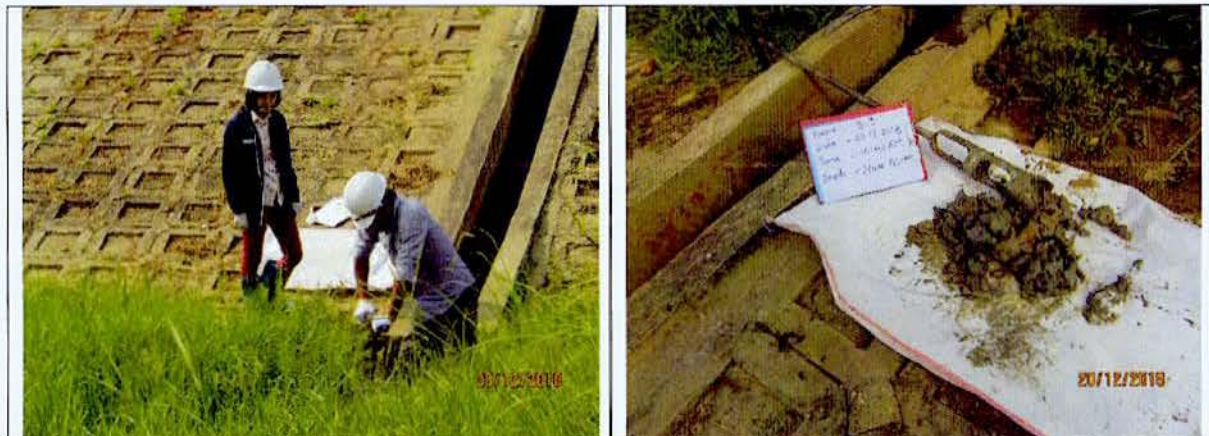
Figure 4 Soil quality sampling at S-3

S-3 is collected in the retention canal where wastewater from the centralized sewage treatment plant is flowing into the retention canal. It is distanced about 5 m away from the junction of wastewater discharge drainage and main rain water drainage. The soil condition is fine to medium grained, yellowish brown colored silty clay.

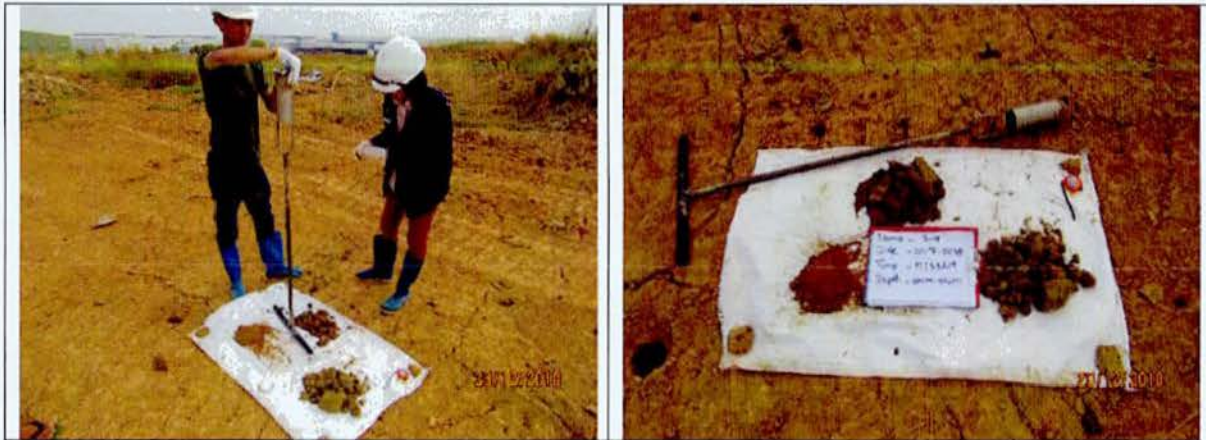
Figure 5 Soil quality sampling at S-4

S-4 is collected from the soil disposing site which is located near Plot No.E-1 of TSEZ Zone-A retention pond, about 40 m in distance. This dumping site is about 16,500 square meters where soil from Thilawa SEZ Zone-A (Phase-2). The soil condition is fine to medium grained, reddish brown colored silty caly.

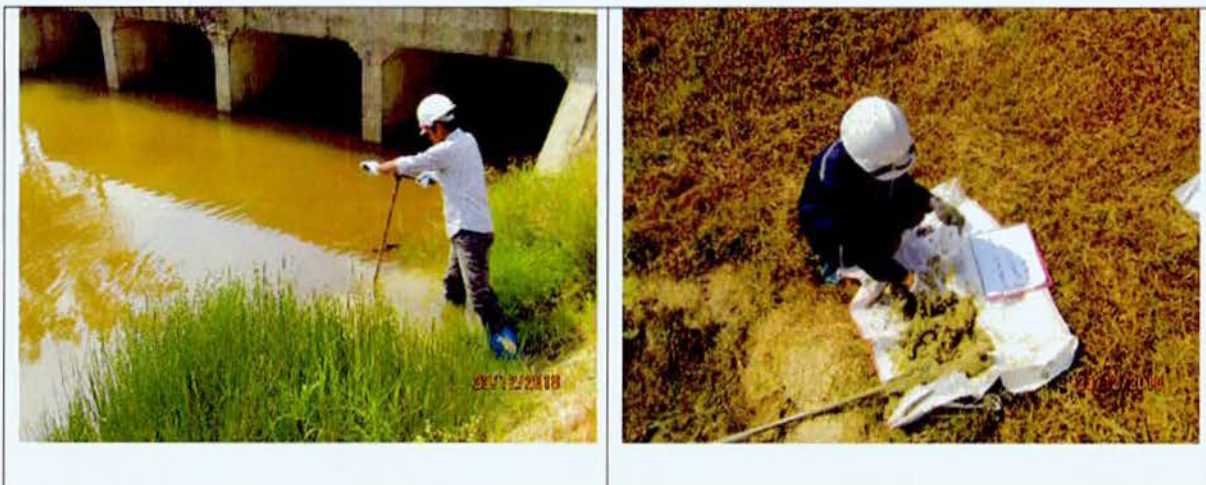
Figure 6 Soil quality monitoring at S-5

It is collected at the retention canal where wastewater is discharged from the retention pond of Plot No.E-1 of Thilawa SEZ Zone-A. S-5 is distanced about 100 m from this retention pond. The soil condition is fine grained, yellowish brown colored silty clay.
