Thilawa Special Economic Zone (Zone B) Development

Environmental Monitoring Report Phase-1 & 2 (Construction Phase)

Myanmar Japan Thilawa Development Limited.

June 2018

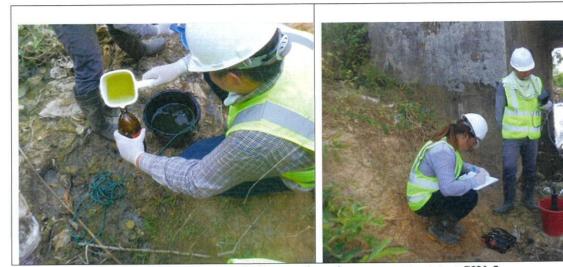
Surface water sampling and onsite measurement at SW-2

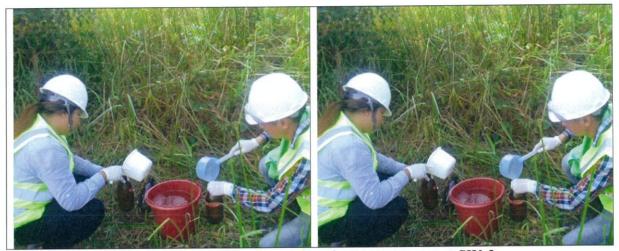
Surface water sampling and onsite measurement at SW-3

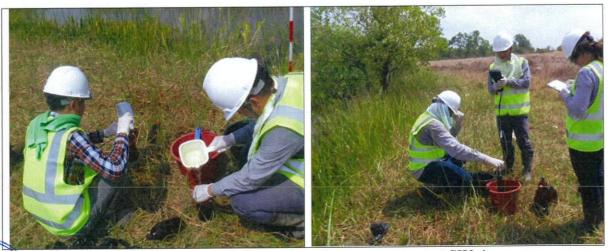
Surface water sampling and onsite measurement at SW-4

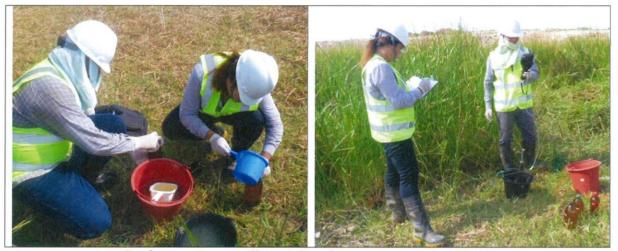
Surface water sampling and onsite measurement at SW-9

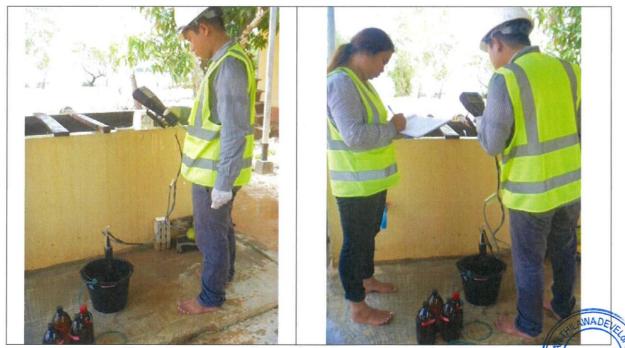
Ground water sampling and onsite measurement at GW-2

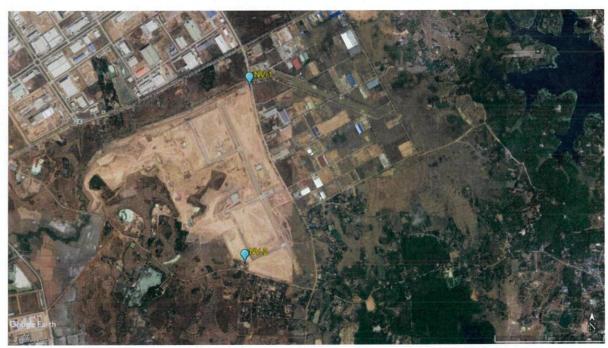
Figure 2.2-1 Location of Noise and Vibration Level Monitoring Points

Noise and vibration levels were measured at the northeast corner of the Thilawa SEZ Zone B, monitoring point (NV-1); N: 16°40'18.22", E: 96°17'18.18" for traffic noise concerned and at the south of the Thilawa SEZ Zone B, sampling point (NV-2); N: 16°39'24.90", E: 96°17'16.70", inside the monastery compound of Phalan village. The location of the noise and vibration monitoring points are shown in Figure 2.2-1.

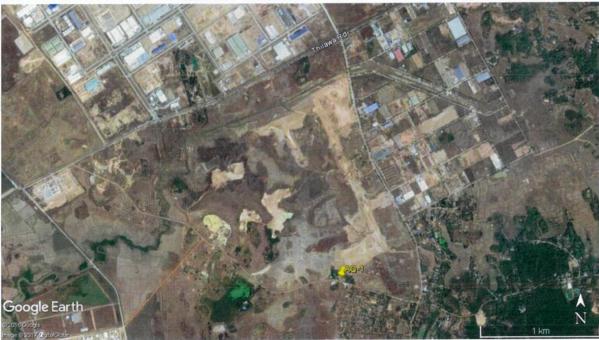
Figure 2.2-1 Location of Air Quality Monitoring Point

The air quality measurement equipment, "Haz-Scanner Environmental Perimeter Air Station (EPAS) was set up at the south of the Thilawa SEZ Zone B, N: 16°39′24.20″, E: 96°17′15.80″, inside the monastery compound of Phalan village, surrounded by the residential houses of Phalan village in the south and fields in west, Thilawa SEZ Zone A in north, local Thilawa Industrial Zone in northeast, and construction of Thilawa SEZ Zone B in east and northeast respectively. The air quality monitoring is carried out above location where is near to the residential houses of Phalan village. Possible emission sources are dust emissions from construction activities and exhaust gas emissions from construction fuel-burning equipment and daily human activities in Phalan village. The location of air quality monitoring is shown in the Figure 2.2-1.

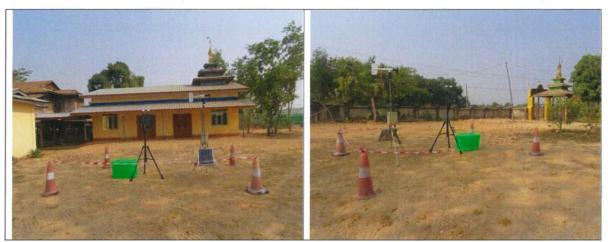
Figure 1.4-1 Status of Air Quality Monitoring Point

Monitoring of CO, NO₂, PM_{2.5}, PM₁₀, and SO₂ were conducted by referring to the recommendation of the United States Environmental Protection Agency (U.S. EPA). The Haz-Scanner EPAS was used to collect ambient air pollutants. The EPAS measures automatically every one minute and directly read and recorded onsite for CO, NO₂, PM_{2.5}, PM₁₀, and SO₂. The state of air quality monitoring is shown in Figure 2.4-1.

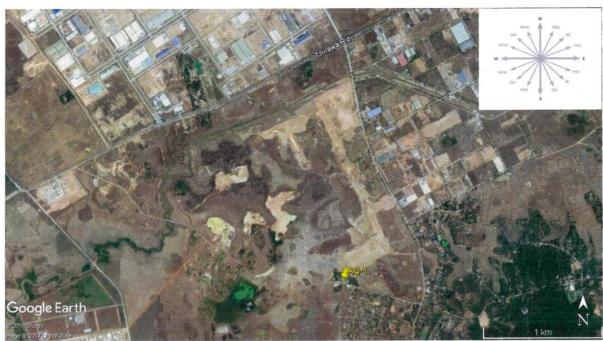
Figure 2.5-1 Status of Air Quality Monitoring Point and Wind Direction

Wind direction and wind speed were measured at AQ-1. Hourly average values of measured wind direction and wind speed data are described in Appendix 1. Status of air quality monitoring point and wind direction are described in Figure 2.5-1. Depending on the wind direction, West-Northwest (WNW), Northwest (NW), North-Northwest (NNE), North-Northeast (NNE), Northeast (NE), East-Northeast (ENE) and East (E) directions are assumed come from the construction site of Zone B.

During the seven days monitoring period, 148 hours results were exceeded for PM_{2.5}. According to wind direction of Zone B during the construction period, only 4 exceeded hours for PM2.5 were observed. Therefore, it can be concluded most of the exceeded hours for PM2.5 are come from another direction of Zone B. The monitoring point (near monastery) during the survey period are very close to the construction site of Zone B may be one of the reason for exceeded hours. Possible emission sources are affected from natural origin such as dust from unpaved vacant area, excavation and vehicles used for construction activities in Zone B, and transportation in and around the monitoring area. According to US Environmental Protection Agency (EPA) and WHO' health effect of particulate matter, there is no evidence of safe level of exposure or a threshold below which no adverse health effects occur. Exposure to PM2.5 reduces the life expectancy of the population of the Region by about 8.6 months on average. Short term (hours, days) exposure to PM_{2.5} can aggravate lung disease, causing asthma attacks and acute bronchitis, and may also increase susceptibility to respiratory infections. In people with heart disease, short term exposures have been linked to heart attacks and arrhythmias. However, healthy children and adults have not been reported to suffer serious effects from short term exposures. Long term exposures (months, years) have been associated with problems such as reduced lung function and the development of chronic bronchitis and even premature death.

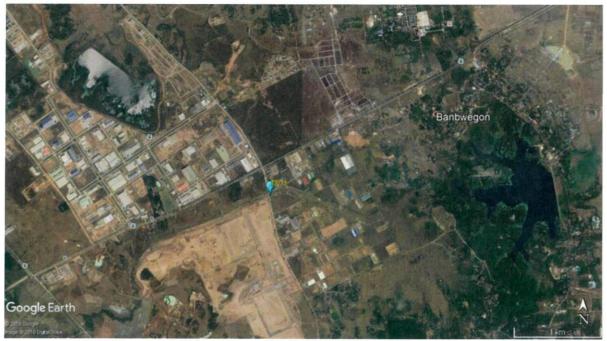
Figure 2.2-1 Location of Traffic Volume Monitoring Point

Traffic volume was measured at the northeast corner of the Thilawa SEZ Zone B, monitoring point (TV-1); N: 16°40'17.90", E: 96°17'18.20". The location of the traffic volume monitoring point is shown in Figure 2.2-1.

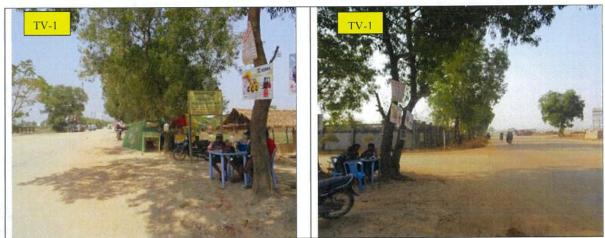
Figure 2.3-1 Status of Traffic Volume Monitoring at TV-1

The traffic volume monitoring was conducted for 24 hours at the same time as the traffic noise and vibration level monitoring. Traffic volume monitoring was conducted to count the numbers of vehicles moving in each direction. Manual count method is used and data are recorded using tally sheets. The status of the traffic volume monitoring on TV-1 is shown in Figure 2.3-1.
