3.2 Matsushima town and Shiogama city

3.3 Shichigahama town

3.4 Tagajo city and Sendai port (Miyagino ward, Sendai city)

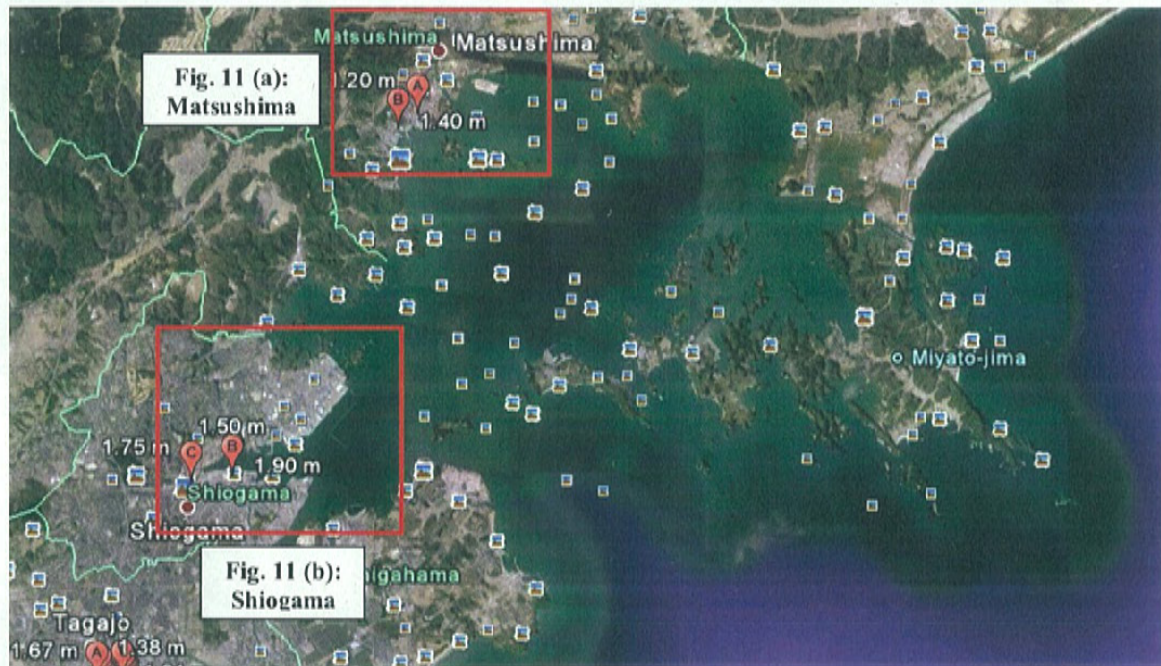
Fig. 10 Area map of Matsushima town and Shiogama city

Matsushima town and Shiogama city locate inside a bay with about 20 km far from Sendai city. There are about 260 tiny islands locate off Matsushima town that make the town become famous as one of the three best coastal views in Japan. Many souvenir shops and restaurant can be found in Matsushima and fresh Oyster is very famous. Because of the large number of small islands and shallow area inside the bay, Matsushima town was highly protected by this natural barrier. Low inundation depth and weak current acted like a flood causing small damage in Matsushima town (Fig. 11 (a)). As a result, the maximum inundation depth was measured to 1-2 m where other locations in Miyagi prefecture were larger than 10 m. (Fig. 12). Most of sightseeing place such as temples and islands survived with only small damages were observed (Fig. 13)

In the other hand, Shiogama city is the most dense population in Tohoku region and famous for sea food product. Sightseeing ferries are available for a trip between Shiogama and Matsushima. Similar to Matsushima town, Shiogama city was protected by the previous mentioned condition yield the average inundation depth of only about 2 m (Fig. 14). Sightseeing ferry terminal which was a designated evacuation building performed very well. People evacuated to the third floor and tsunami reached up to the second floor (Fig. 15).

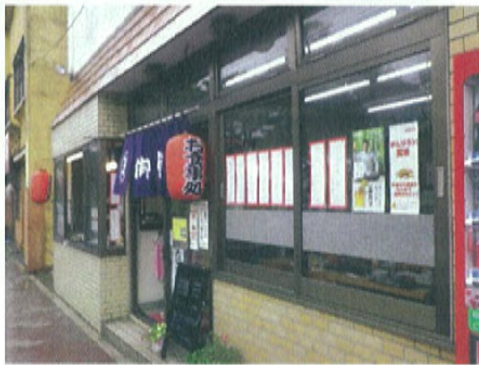
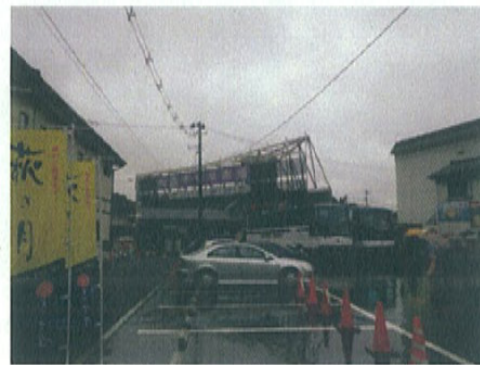
Fig. 12 (a) Inundation depth was lower than window level and (b) About 1.2 m depth in fish market

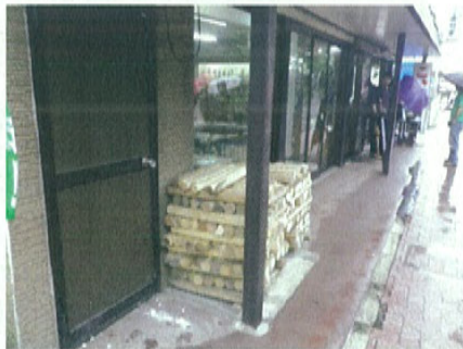
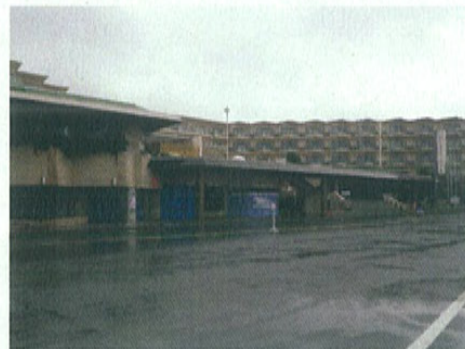
Fig. 12 (c) Damage in Souvenir shop (1.4 m inundation depth) and (d) Damage in hotel near the coast of Matsushima town

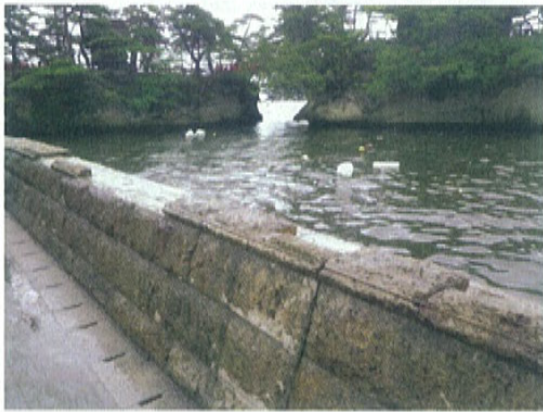
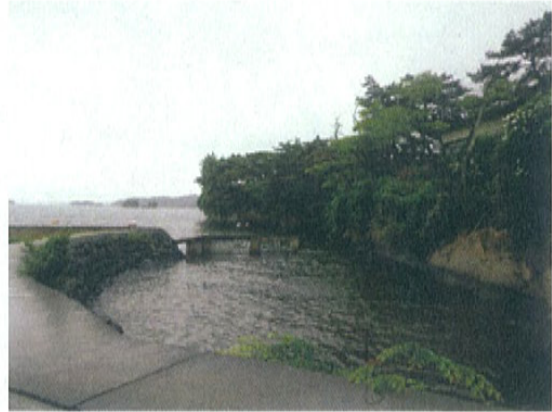
Fig. 13 Damages around Godaido temple

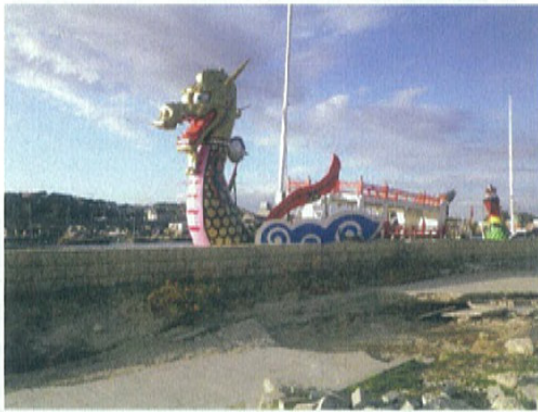
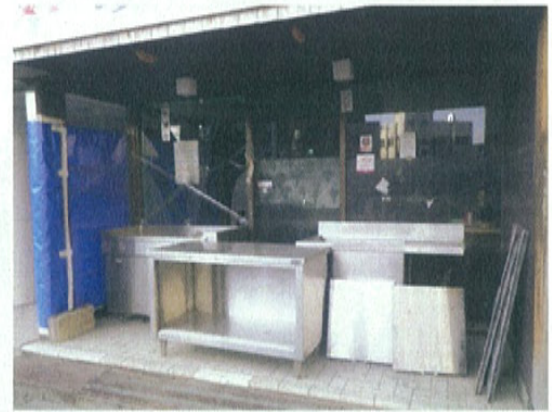
Fig. 14 Damaged sightseeing ferry from Shiogama to Matsushima and (b) Damaged shop near Shiogama station (1.75 m inundation depth)

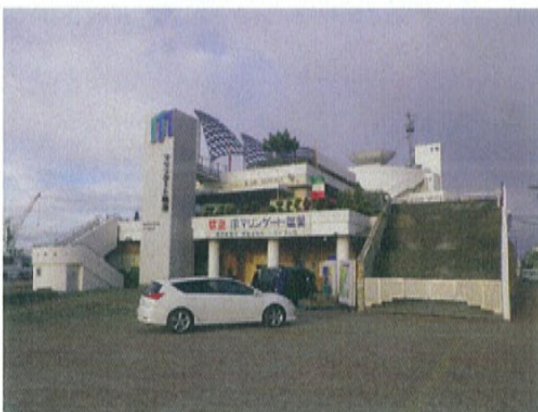
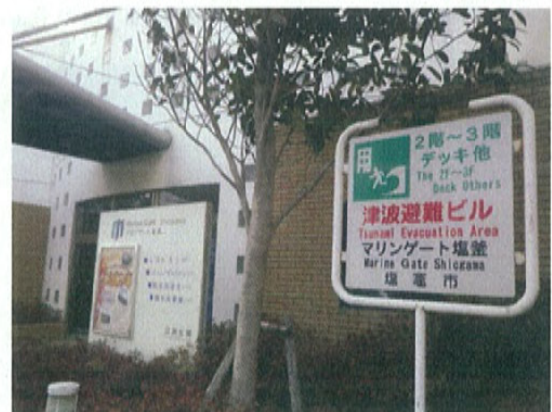
Fig. 15 Survived sightseeing ferry terminal used and designated evacuation building

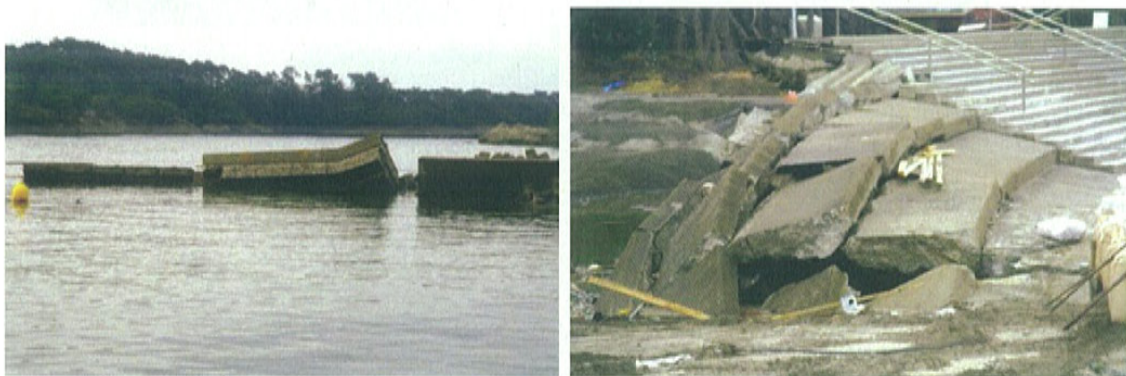
Fig. 17 Damaged breakwaters and seawalls

Shichigahama town is popular for its beaches during summer. The town was hit by almost 10 m of tsunami. Tsunami damaged breakwaters and seawalls (Fig. 17). As a result, most of the town area was inundated by the tsunami and reached over 2 km inland.

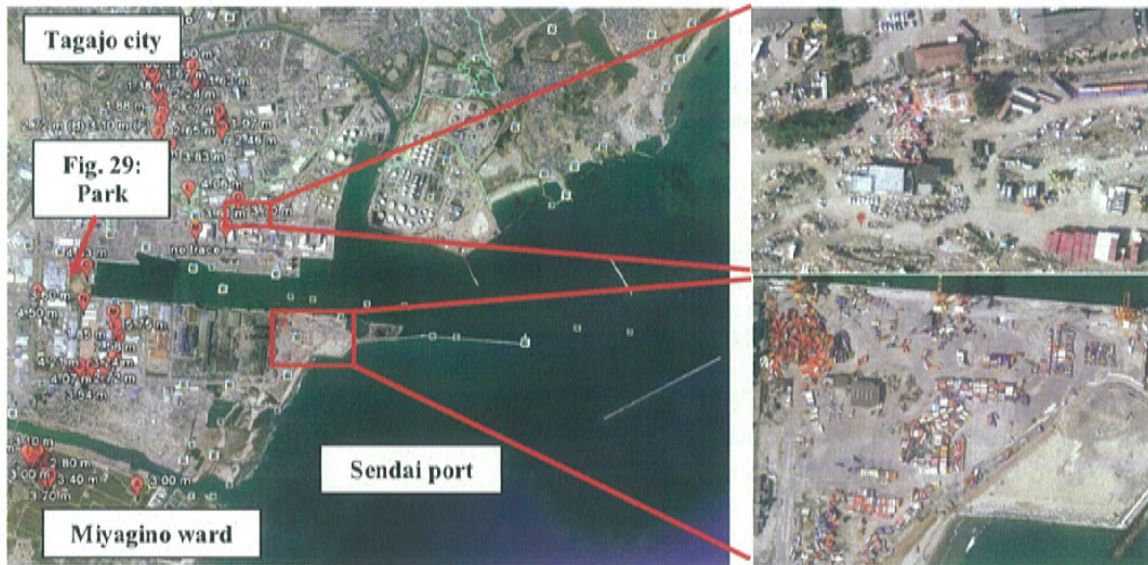
Fig. 19 Area map of Tagajo city and Sendai port (Miyagino ward, Sendai city) and damaged containers

Sendai port was opened in 1971 providing function as a commercial port and also later has become a distribution center in the Tohoku region. Thus, large number of damaged containers and cargo trains can be confirmed from the satellite images shown in Fig. 19. There are many factories that were damaged by the tsunami, for example, beer, washing powder (Fig. 20 (a)) and instant noodle (Fig. 20 (b)). Elevated Park located just at the end of the port also survived from the tsunami. Tsunami trace from debris line is shown in Fig. 21, about 5 m from the ground.

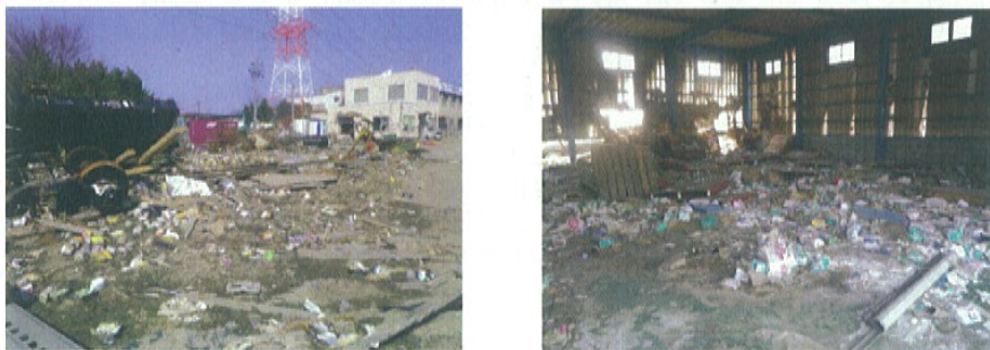
Fig. 20 Damaged factories and containers, instant noodle (a) and washing powder (b)

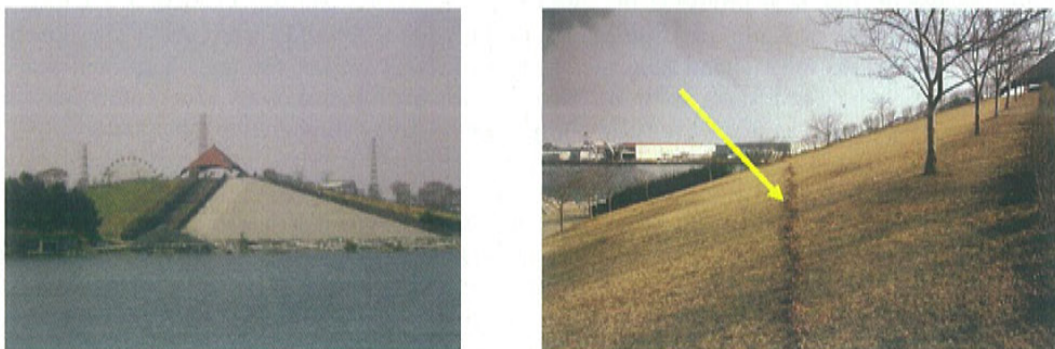
Fig. 21 Elevated park and tsunami trace

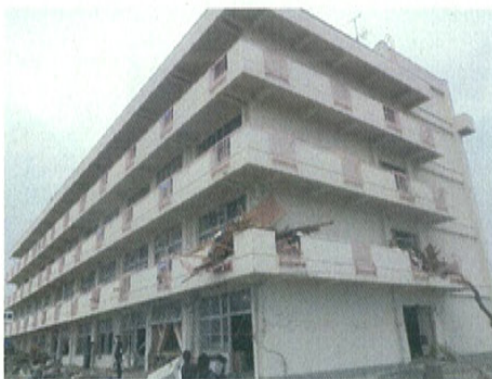
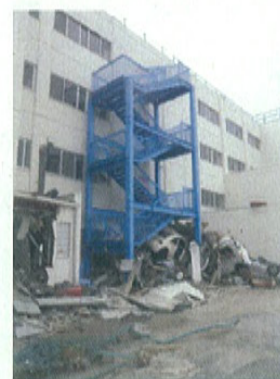
Fig. 38 Arahama primary school, stair for emergency event was built behind the building

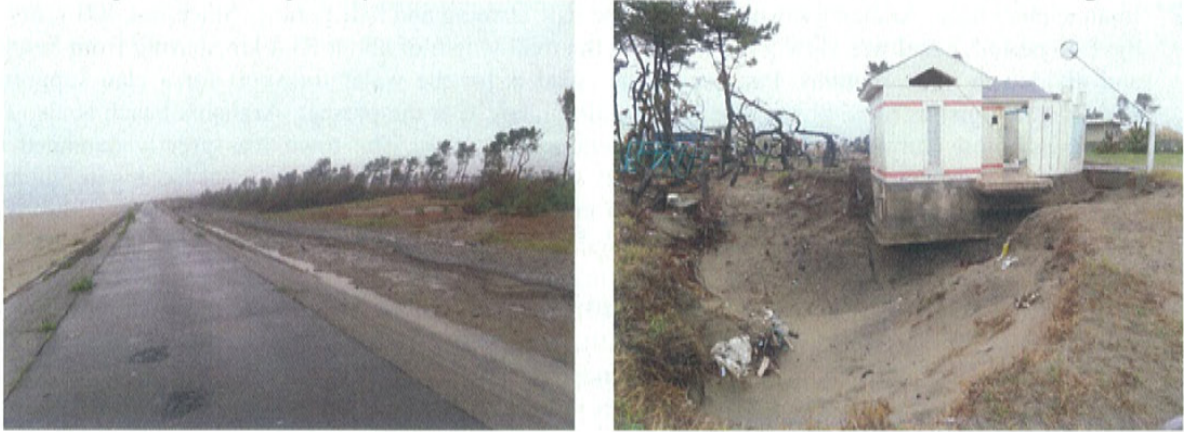
Fig. 39 (a) Damaged seawall and control forest and (b) Severe scouring at house's footing

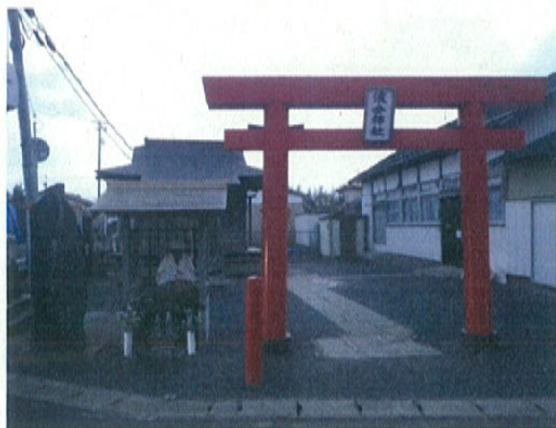
In an ancient time, Arahama town are said to be half farming and half fishing. Since last 400 years ago in the Edo period, canal was slowly digging with the total length of about 33.4 km starting from Sendai port and divided in three sections. Purpose of the canal is for the water transport for a clan supported the budget as a logistics route to send the rice to Edo or Tokyo at the present. Arahama beach is also famous for a swimming during middle of July to middle of August. The town was greatly damaged by the tsunami and most houses were washed away as shown in Fig. 37. Arahama town locates in Sendai plain where the maximum inundation distance was 5 km. Only way to survive from the tsunami is the Arahama primary school (Fig. 38) which was inundated until the second floor (about 4 m inundation depth). Damaged seawall and control forest is shown in Fig. 39 (a) where severe local scour is shown in Fig. 39 (b). Tsunami warnings sign was found (Fig. 40) which providing hazard map information based on the simulation of Miyagi oki earthquake (M7.5-8.0) and tsunami. Hence, the inundation area in Fig. 40 was relatively much smaller compared to the inundation area by present tsunami. Figure 41 is Namiwake shrine where legend of the 869 Jogan tsunami is remained.
